Case report

Fracture of a 40-mm BIOLOX Delta Femoral Head

Ian M. Duensing, MD^{*}, Samuel Stanley, MD, Michael Bolognesi, MD

Department of Orthopaedics, Duke University, Durham, NC, USA

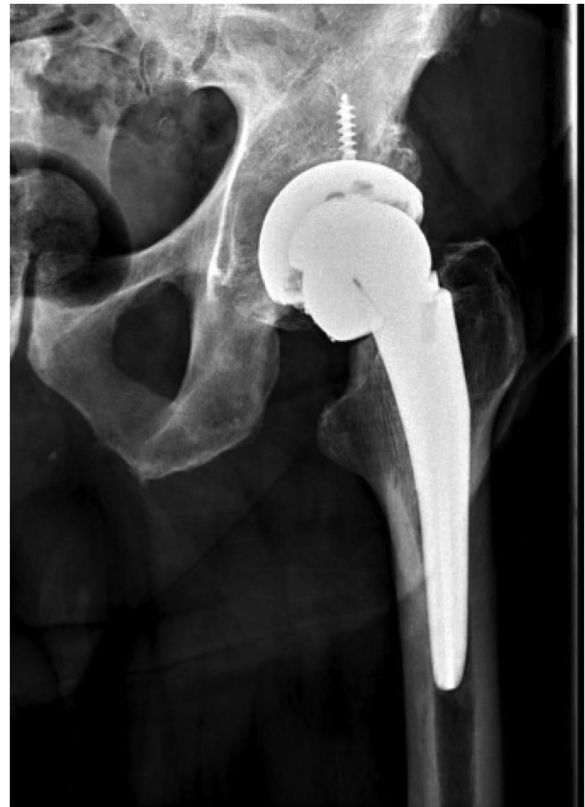
Figure 2. Left hip radiographs taken in emergency room at the time of presentation showing comminuted ceramic femoral head fracture.

Five years after the index surgery, the patient presented to the emergency department for orthopedic evaluation after acute-onset of atraumatic hip pain encountered during community ambulation. Radiographs of the pelvis and left hip at the time of presentation revealed fracture of the ceramic head (Fig. 2). Presenting examination of the left lower extremity revealed well-healed posterior surgical incision with active and passive motion of the hip limited by pain and notable for palpable crepitus. Sensory and motor examination revealed no deficits with the exception of the previously mentioned dorsiflexion and great toe extension weakness.

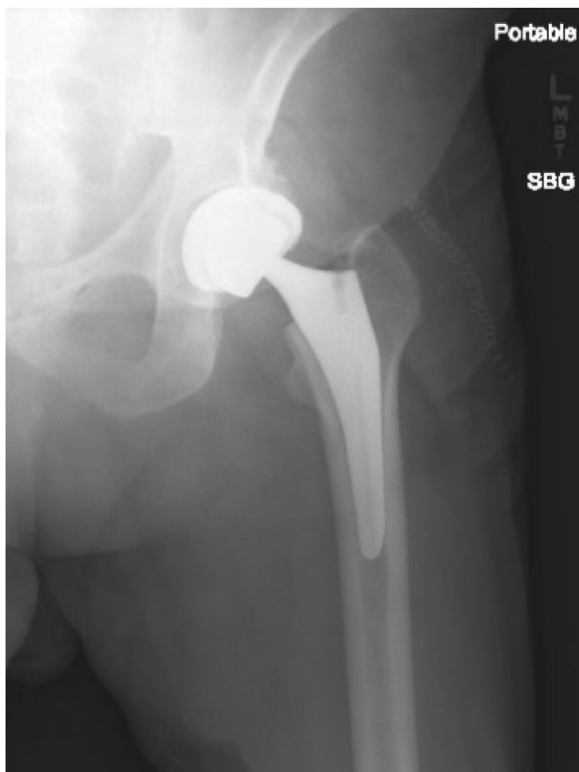
Figure 1. Preinjury left hip radiograph showing intact femoral head and components positioned within acceptable limits.

polyethylene acetabular liner (Fig. 1). The patient was noted post-operatively to have a partial palsy of the peroneal branch of his sciatic nerve with diminished sensation and weak but intact dorsiflexion strength compared with the contralateral limb. This deficit was mild but persisted and was managed conservatively without bracing. Otherwise, he recovered from his index arthroplasty uneventfully. There were no wound issues nor additional post-operative complications, other than the nerve palsy, noted by the patient and was generally considered to have had a good outcome.

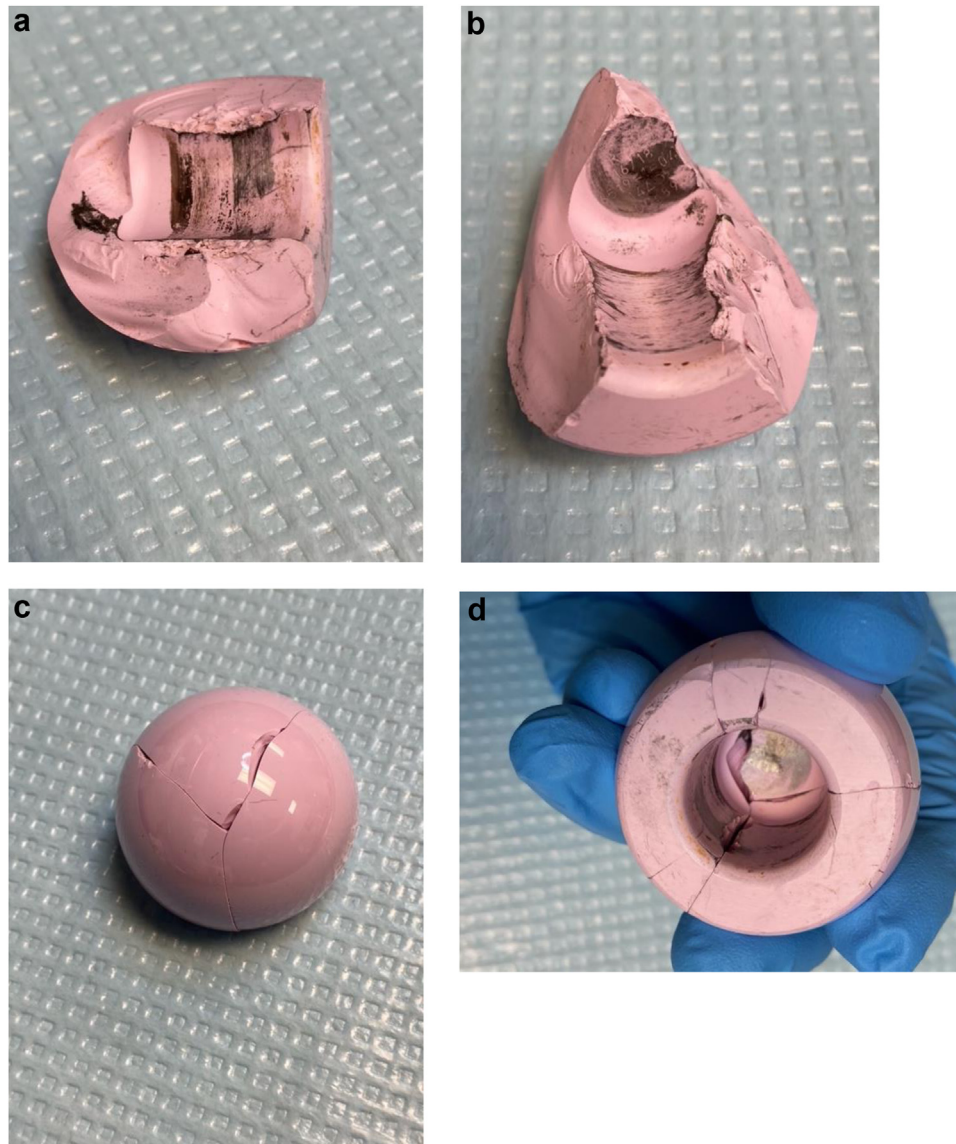
Figure 3. (a-d) Clinical photographs of ceramic head fracture after explant.

Preoperative evaluation included radiographs and computed tomography scan which showed, in addition to the previously seen ceramic comminution, the acetabular cup position appeared to have anteversion within acceptable parameters and inclination of 32 degrees. While this patient did not have ideal cup position, it was felt that component position was acceptable, and the decision was made to leave the acetabular component. He was diagnosed with a failed left THA with fracture of the ceramic femoral head. He was indicated for revision surgery and was taken to the operating room the following day. The hip was accessed through a standard posterior approach through the prior incision, and the fractured ceramic head was encountered. There were several large fragments still contained within the acetabular shell and, as expected, a number of smaller, comminuted pieces (Fig. 3a-d) all of which were

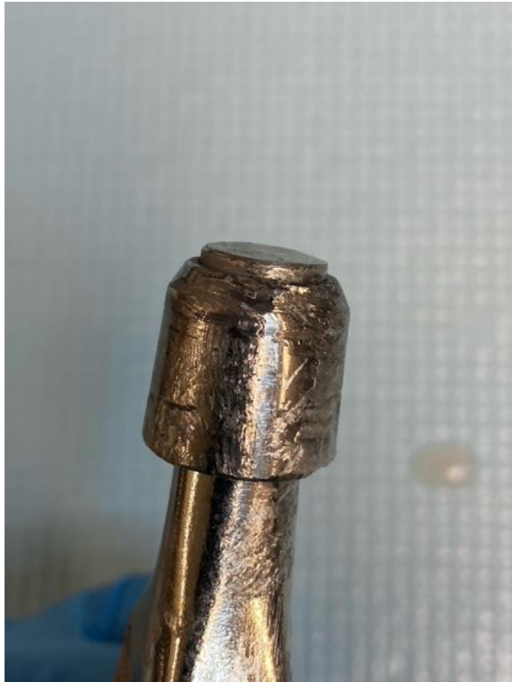
Figure 4. Clinical photograph of trunnion and sleeve after explant.

this unfortunate and rare complication. The intraoperative assessment of the components suggested severe damage to the titanium sleeve allowing for cold-welding of the sleeve to the trunnion as well as a significant amount of damage to the neck distal to the trunnion suggestive of impingement on a relatively flat cup. The decision to use a 40-mm head in a 56-mm cup, while not unheard of, is an unusual combination which may suggest intraoperative instability or impingement. True occurrences of cold-welded components happen infrequently and suggest malalignment during impaction of the head, which may indicate inadequate visualization and exposure which also predispose to debris interposition between the trunnion and the head. While impossible to determine the exact mechanism of failure, this case brings to light potentially modifiable variables to prevent further occurrences of these unfortunate events.

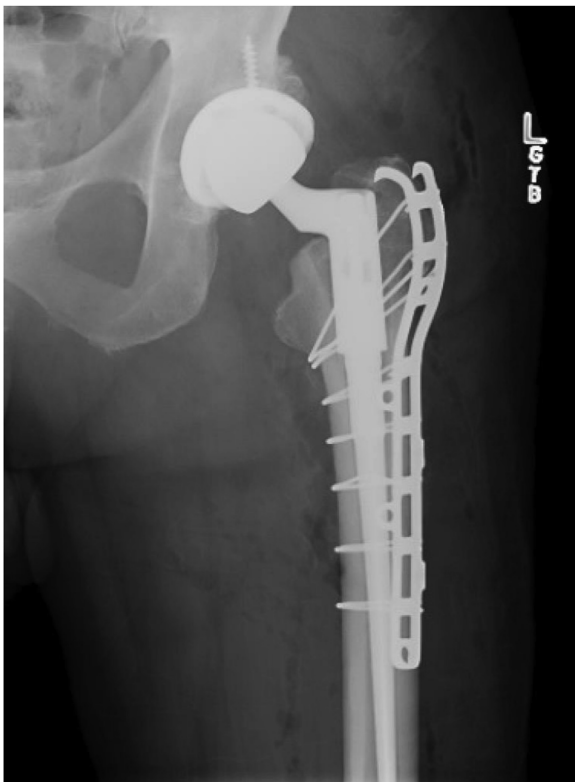
Figure 5. Postrevision left hip radiograph showing revision components and well-reduced extended trochanteric osteotomy.
