Article

Optical Sensor for Monitoring Leakage Current and Weather Conditions in a 500-kV Transmission Line

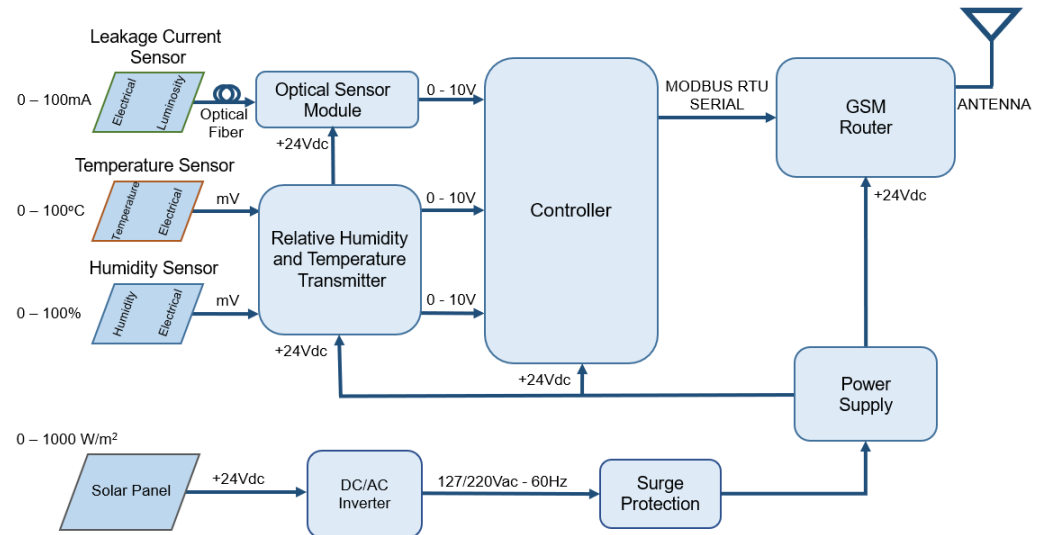
Figure 2 shows the block diagram of the remote unit (RU). It comprises three sensors (leakage current, temperature, and air humidity), a programmable logic controller (PLC), and a router. The PLC, run by software written in LADDER, reads the three sensors, calculates the dew point, and transmits these data via a local serial bus to the router containing a cell phone chip, allowing communication with the internet via GPRS. The PLC, the router, the temperature and humidity sensors, and the power supply are commercially

available from Novus Automation, Inc., Canoas, Brazil. The system is energized by a solar panel and an inverter. The controller reads the sensors every 30 s and stores the data via comma-separated values (CSV) in its internal memory, to send the bulk data once a day to the laboratory server.

Figure 2. Block diagram of the Remote Unit.

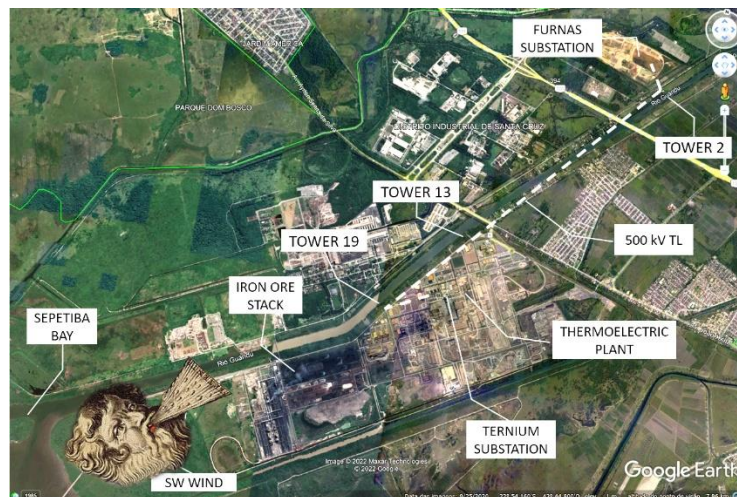
Figure 5. The transmission line and the three towers, with the sensors installed. The transmission line transports the energy generated by the Ternium Steel Co. thermoelectric plant to the Furnas National Grid Substation.

Three leakage current systems were installed on the 500-kV transmission line, according to the satellite picture shown in Figure 5. The objective of this choice was to completely monitor the entire LT, since the first tower, which is closer to the sea and the iron ore stack, might show a higher pollution accumulation than the other towers. However, we did not observe different degrees of pollution when comparing data from different towers, which confirmed that the LT was relatively short and completely encompassed by the local micro-climate. In this section, we show the different situations combining leakage currents and weather conditions. The system has already been installed in the field for three years, producing a huge amount of data but, in this paper, we have only presented the days where increased LC activity has been observed, combined with the weather parameters. In all graphs in the figures below, the orange line is the humidity, the blue line is the temperature, the gray line is the dew point, and the yellow line is the leakage current.

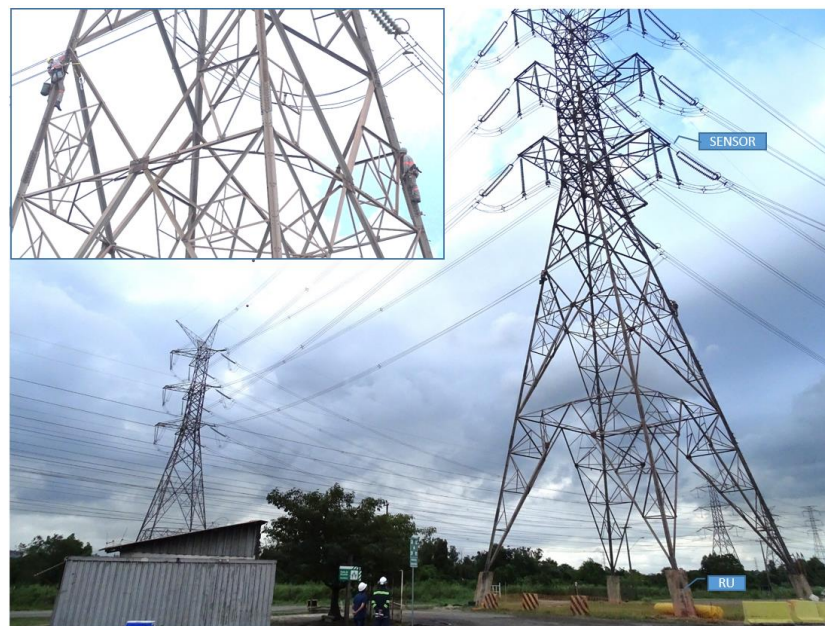
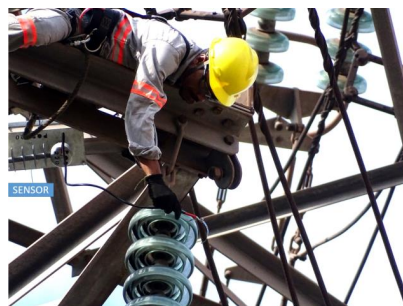
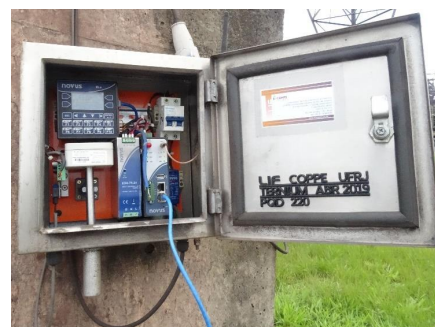
Figure 6a shows two live-line personnel climbing Tower 19, one on each side, and in Figure 6b, the technician is connecting the sensor (center-left of the picture) between the two last sheds of a 25-unit insulator string, consisting of typical glass discs. The remote units (RU) were installed on the foot of the tower, Figure 6c, and are energized by a photovoltaic system installed on the tower.

Figure 6. (a) Live-line personnel climbing Tower 19 for the installation of the sensor; (b) The technician is connecting the sensor between the two last sheds of a 25-unit insulator string; (c) The remote unit (RU), fixed at the foot of the tower.

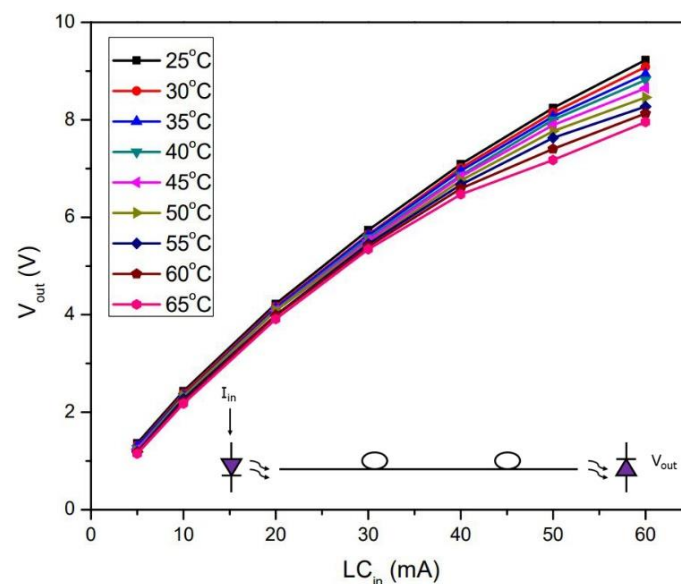
Temperature does not cause fiber losses; however, it does change the LED performance as well as the photodiode sensitivity. For checking these effects on the sensor system, the optical transmitter, a 50-m length of fiber optic cable, and the receptor were placed in an oven and the system performance was measured at temperatures from 25 °C to 65 °C. Figure 7 shows the result of such a test for the different leakage currents. It is possible to deduce that as the temperature increases, the LED output power decreases and the photodetector response decreases for any current. Bearing in mind that the average leakage current is around 20 mA, the uncertainty at this temperature range is about 3.8%, which is perfectly acceptable for the type of information that we require.

Figure 7. The temperature drift of the sensor from 25 °C to 65 °C, considering the input current on the green LED, varying from 0 to 60 mA, and using a 50-m length of POF cable.

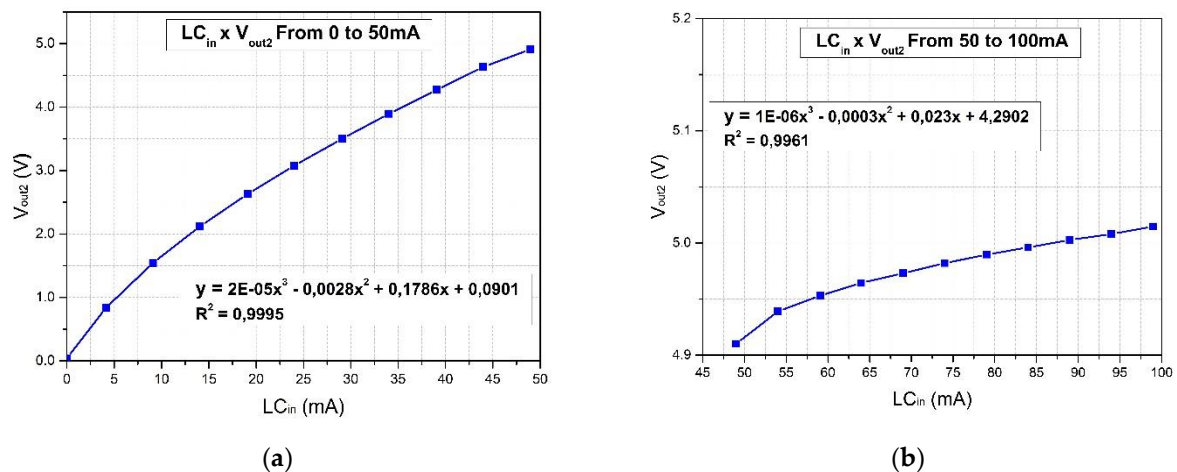
The next test is the calibration of the whole system, which was conducted by injecting a variable DC current into the sensor terminals and monitoring V_{out2} (see Figure 1). This result is shown in Figure 8 and is saved into the PLC memory. They are separated into two ranges to ensure better sensitivity since the response of the system tends to saturate after 50 mA, but the LED supports up to 100 mA.

Figure 8. The calibration procedure of the sensor consists of the input of a current to the sensor and measurement of the output voltage at point V_{out2} (see Figure 1). (a) Calibration curve for an input range of between 0 and 50 mA; (b) calibration curve for an input range of between 50 and 100 mA.

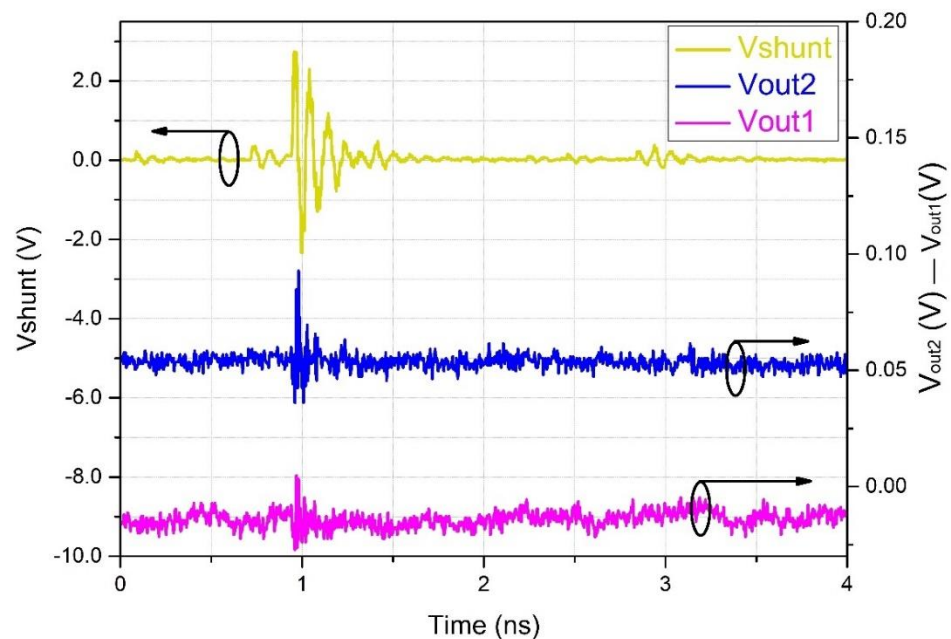
Figure 10 shows a typical PD pulse, as seen at the shunt (upper trace) and recovered by the OSM (lower traces). It is composed of a short burst of 0.5 ns duration, superimposed with an oscillation of about 10 MHz. This result demonstrates the system's capacity to detect high-frequency pulses; although the 3 dB cutoff frequency was much smaller (see Figure 9a), the transducer was capable of detecting high-frequency pulses.

Figure 10. Partial discharge burst, with a frequency of about 10 MHz. Upper trace: PD signal, captured by the 10- Ω shunt resistor. Center trace: signal captured by the OSM before the RMS converter. Bottom trace: signal after RMS conversion (black circles around curves indicate the related vertical axis).

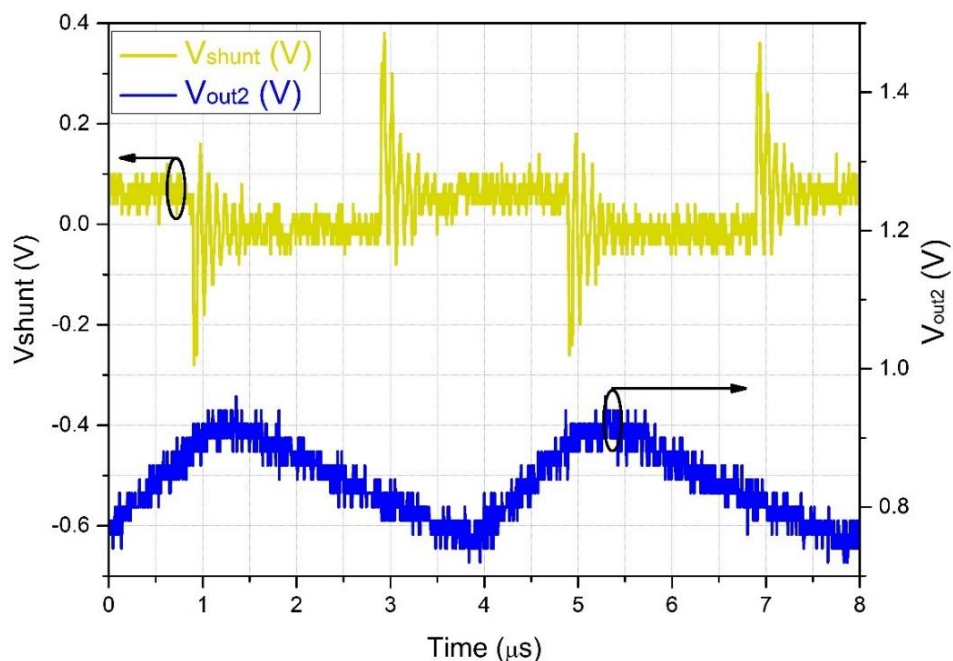
Figure 11 shows a typical PD repeatability, with 10-MHz short bursts at a repetition frequency of about 250 kHz. As mentioned before, the analog to digital converter (ADC) of the commercial PLC used in the RU cannot acquire the high frequencies produced by the PD and LC; for this reason, we included an RMS converter on the OSM circuit with a programmable integration time. In Figure 11, the lower trace is the RMS equivalent of the LC, as identified by the OSM, which can easily be converted by the ADC of the PLC.

Figure 11. Partial discharge pulses with a frequency of about 10 MHz, with a repetition rate of about 250 kHz. Upper line: signal captured by the shunt resistor. Bottom line: signal captured by the OSM after the RMS converter (black circles around curves indicate the related vertical axis).

Figure 12 shows the same scenario as in Figure 11, but with a lower horizontal scan frequency. It is possible to deduce that the RMS equivalent of the LC follows the PD bursts in amplitude, showing higher amplitude when the bursts increase in power. Similarly, as seen in Figure 13, for wider PD bursts, the RMS also shows wider pulses. In the long run, the RMS pulses present a repetition rate of about 60 Hz and are, therefore, capable of being acquired by the PLC.

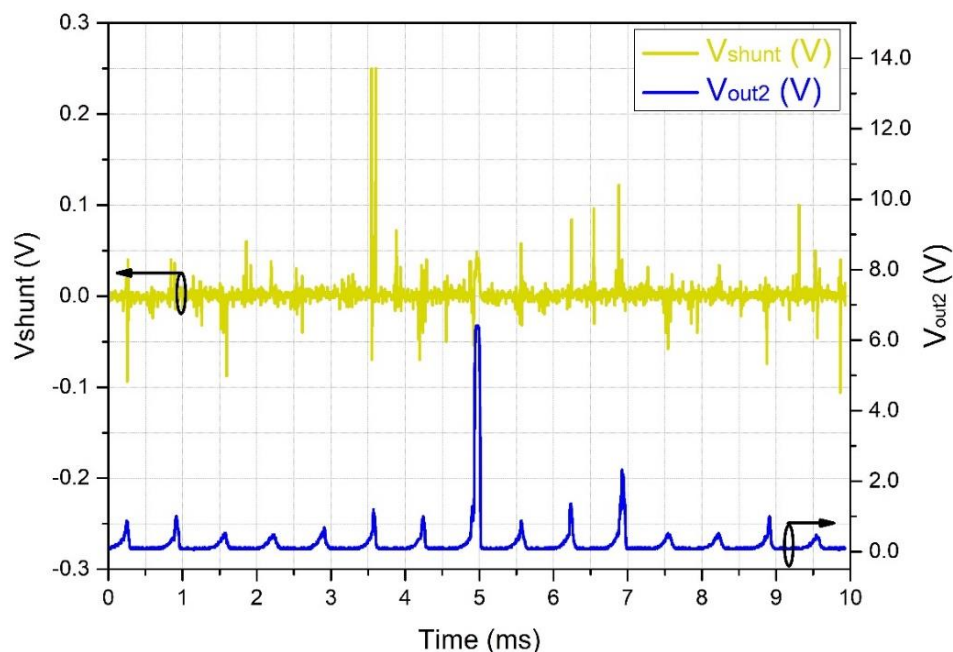
Figure 12. Partial discharge pulses of the leakage current. Upper line: signal captured by the shunt resistor. Bottom line: signal captured by the OSM after the RMS converter, showing higher amplitude when the bursts increase in power (black circles around curves indicate the related vertical axis).

The 60 Hz repetition rate of the bursts shown in Figures 12 and 13 also appears in the work of Chen et al. [5]. Basically, the PDs occur at the top of the high-voltage sinusoidal waveform and are either positive or negative since the zero-crossing periods do not present enough voltage to generate PDs. In their work, pulses of 12 kHz were seen superimposing the peaks of the 60 Hz sinusoidal waveform. These peaks are equivalent to the bursts we see in Figure 11, which were converted into simple peaks due to the low-frequency response of their system.

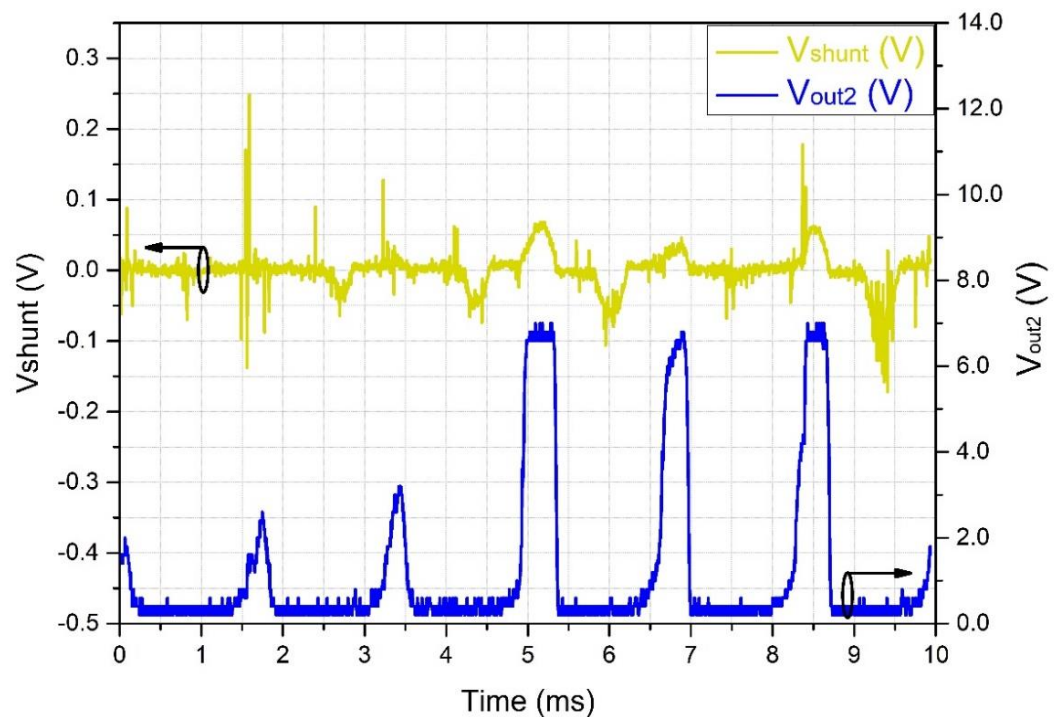
Figure 13. Effect of the RMS converter on partial discharge pulses. Upper line: signal captured by the shunt resistor. Bottom line: signal captured by the OSM after the RMS converter, showing wider pulses when the bursts increase in length (black circles around curves indicate the related vertical axis).

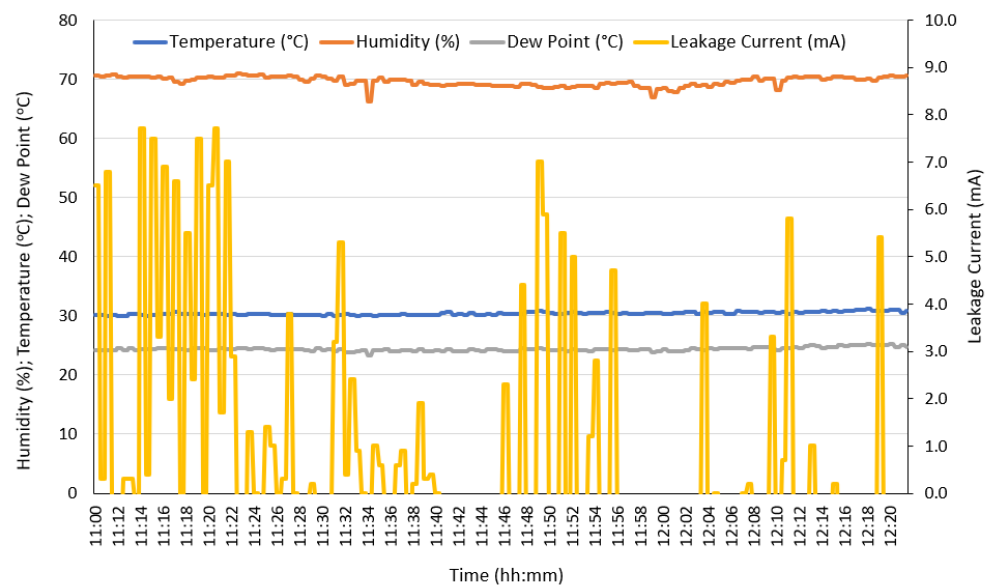
This test was performed according to the block diagram shown in Figure 4, to test the transmission capability of the RU. The protocol was essentially the same as that used for the tests performed in the previous section, except that the oscilloscope was used to check the measurements. Here, the system acquires the leakage currents, together with the local weather parameters, compacts these data into a CSV format, and sends them via GPRS to the laboratory server in that format. Figure 14 shows the data acquired and transmitted over a period of 1 h 20 min. During this time, we maintained a fog stream in the test chamber and a working voltage of 20 kV.

Figure 14. The data acquired in the test chamber and transmitted via GPRS to the laboratory server over a period of 1 h 20 min.

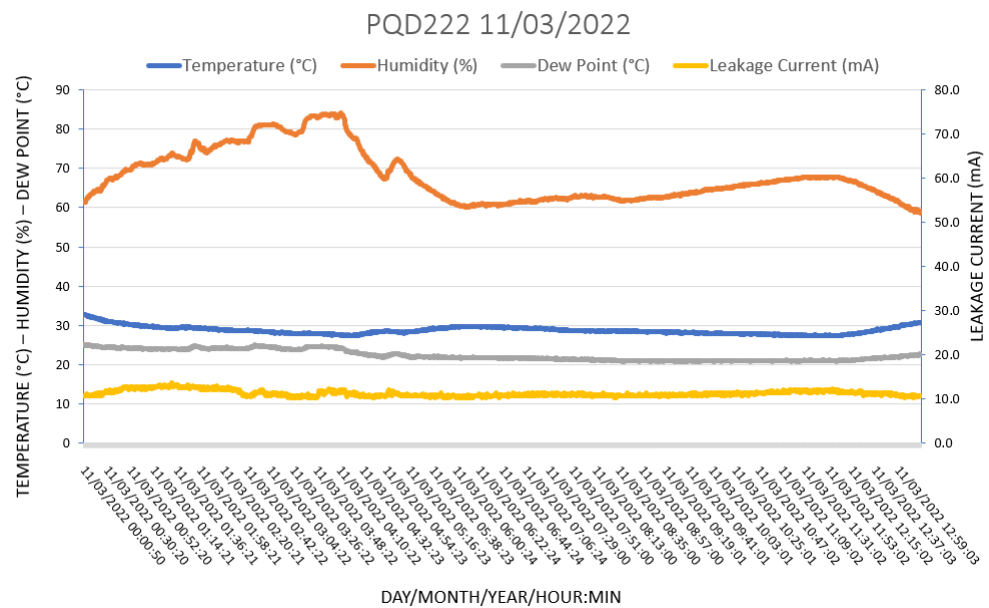
Figure 15 shows favorable weather conditions in which the insulator remains at an average leakage current below 15 mA. Although the humidity rises to almost 90%, no increase in leakage current was observed, confirming that in dry conditions, no LC occurs. Roman et al. [14] concluded in their work that the LC increases from 0.01 mA to 0.08 mA when the humidity rises to up to 90% and the temperature drops to about 5 °C. By inputting these weather conditions in Equation (1), we find a dew point of 3 °C, which is below the local temperature; therefore, no humidity would accumulate on the insulator surface. This explains the low LC. In the present work, the humidity also increased but the local temperature remained above the dew point, which guaranteed a constant LC.

Figure 15. Favorable weather conditions in which the insulator remains at an average leakage current below 15 mA but no LC peaks are recorded, in particular, because the dew point is well below the local temperature.

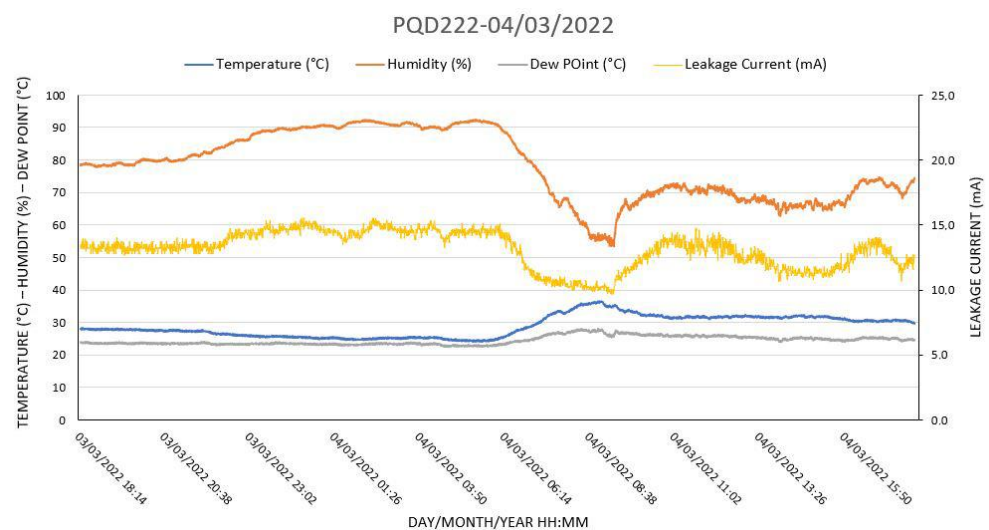
Figure 16 shows a sudden increase in humidity above 90% at midnight, together with a temperature drop that is close to reaching the dew point. The consequent increase in the insulator surface humidity has made the LC rise to 15 mA. However, just after dawn at 8 a.m., the temperature rose to 38 °C and the humidity dropped to 50%, with the consequent dropping of the LC to 10 mA.

Figure 16. During the night, the humidity rose above 90%, together with a temperature drop that was close to reaching the dew point, producing a small rise of the LC to 15 mA. Note that just after dawn, the temperature rose to 38 °C and the humidity decreased to 50%, dropping the LC to 10 mA.

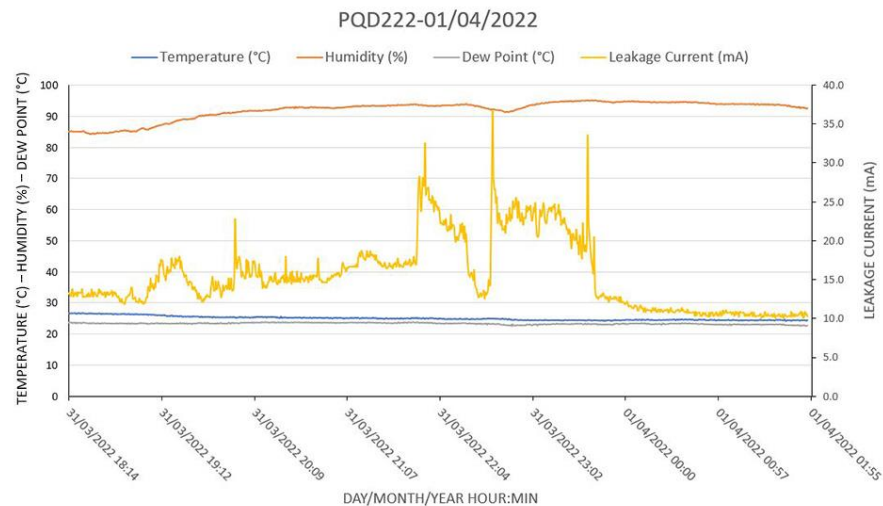
Figure 17 shows some of the worst conditions that a polluted insulator can experience: high humidity, cool weather, and heavy rain, but these conditions can warn the operators that a flashover is imminent. In this specific case, the dew point was reached by 7 p.m. and partial discharges started to show. PDs, when triggered, generate dry bands; that is, during the arc propagation process, the path that the discharge follows over the insulator is dried out due to the generated heat, stopping the current. Normally, new paths can occur intermittently, which is the scenario shown in Figure 16. However, if there is heavy rain, all possible paths are open again after drying, and the leakage current increases, presenting a situation in which LC peaks or even a flashover can occur. In the case shown in Figure 17, there was heavy rain by 8 p.m., then there was a thunderstorm from 9 p.m. to 11 p.m., followed by light rain and mist. These conditions triggered the LC peaks to rise to 35 mA, as seen on the graph. Notice that a current of just 35 mA under 500 kV generates a heat of

17.5 kW. This heat dissipates quickly; however, many discharges occurring within a short period can damage the insulator.

Figure 17. Some of the worse conditions that a polluted insulator can experience: high humidity, cool weather, heavy rain, and the temperature dropping to the dew point. The system detected an LC peak of 35 mA.

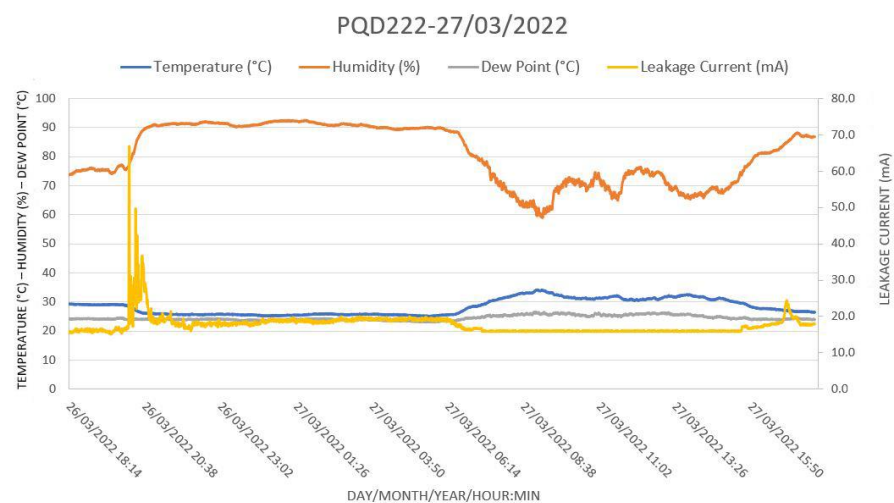
Figure 18 shows another situation in which a sudden thunderstorm by 8 p.m. increased the humidity above 90% and dropped the temperature, which then reached the dew point. This situation immediately triggered a peak in LC. By 9 p.m., the thunderstorm changed to light rain that did not support LC peaks but instead kept the LC to 20 mA. By 6 a.m., the temperature rose with the dawn; the humidity dropped, and the leakage current decreased to 15 mA.

Figure 18. A sudden thunderstorm by 8 p.m. increased the humidity above 90% and dropped the temperature, which reached the dew point, triggering a peak of LC to 70 mA. By 9 p.m., the thunderstorm had changed to light rain, keeping the LC at 20 mA. By 6 a.m., at dawn, the temperature rose, the humidity dropped, and the leakage current decreased to 15 mA.
