Fracture of the delivery catheter system during transcatheter aortic valve implantation

Xavier Armario¹, MD; Liesbeth Rosseel¹, MD; Faisal Sharif^{1,2}, MBBS, PhD; Darren Mylotte^{1,2*}, MB BCh, MD, PhD

1. Department of Cardiology, Galway University Hospital, Galway, Ireland; 2. National University of Ireland Galway, Galway, Ireland

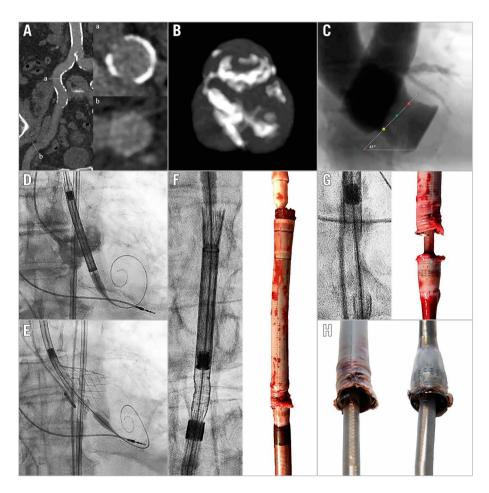
Figure 1. Delivery catheter system fracture during TAVI. A) Moderately calcified and tortuous iliofemoral arteries. B) & C) Moderately calcified and angulated trileaflet aortic valve. D) & E) Positioning, deployment and recapture of a 34 mm Evolut R valve. F) – H) Fractured delivery catheter system. Reproduced with permission from Medtronic.

An 87-year-old male with severe symptomatic aortic stenosis was accepted for transcatheter aortic valve implantation (TAVI) via transfemoral approach (Figure 1). Multislice computed tomography demonstrated moderately calcified and tortuous iliofemoral arteries (minimal lumen diameter 10.4 mm) (Figure 1A), and a moderately calcified and angulated trileaflet aortic valve (aortic annulus perimeter 85.0 mm; aortic root angulation 45°) (Figure 1B, Figure 1C), suitable for implantation of a 34 mm Evolut™ R valve (Medtronic, Minneapolis, MN, USA) as per standard practice at our centre. After vascular pre-closure with two Perclose devices (Abbott Vascular, Santa Clara, CA, USA) and valve predilatation with a 24 mm NuCLEUSTM balloon (NuMED, Cornwall, ON, Canada), a 16 Fr EnVeo™ PRO delivery catheter system (DCS) (Medtronic) easily traversed the iliofemoral vessels and the aortic valve. Deployment of the transcatheter heart valve (THV) was challenging due to recurrent migration towards the left ventricle, despite guidewire manipulation and rapid ventricular pacing (Figure 1D, Figure 1E). During a third recapture manoeuvre, the THV would not completely re-enter the DCS capsule, and further rotation of the delivery handle (either direction) did not move the THV. The DCS was retrieved into the descending aorta where fluoroscopy revealed a fracture at the proximal end of the capsule (Figure 1F-Figure 1H). As the DCS was attached to its capsule, it was possible to remove the entire DCS en bloc via the transfemoral access by gentle retraction, without the requirement for additional manoeuvres. Surgical back-up was on stand-by in case of access-site complications. Haemostasis was achieved using the Perclose sutures. The patient suffered no additional complications

Technical analysis of the DCS by the manufacturer confirmed complete fracture of the capsule and delamination of the nitinol-reinforcing frame. The DCS was otherwise intact and functioning appropriately. As no definitive cause was confirmed, a multifactorial origin was suggested. Potential causes include excessive tension and torque on the DCS due to anatomical factors (vascular calcification, tortuosity and angulation) and repeated recapture or over-capture of the THV. As such, careful patient selection and device manipulation during deployment and retrieval are advised, and adherence to the manufacturer recommendations of a maximum of three recapture manoeuvres is advised.
