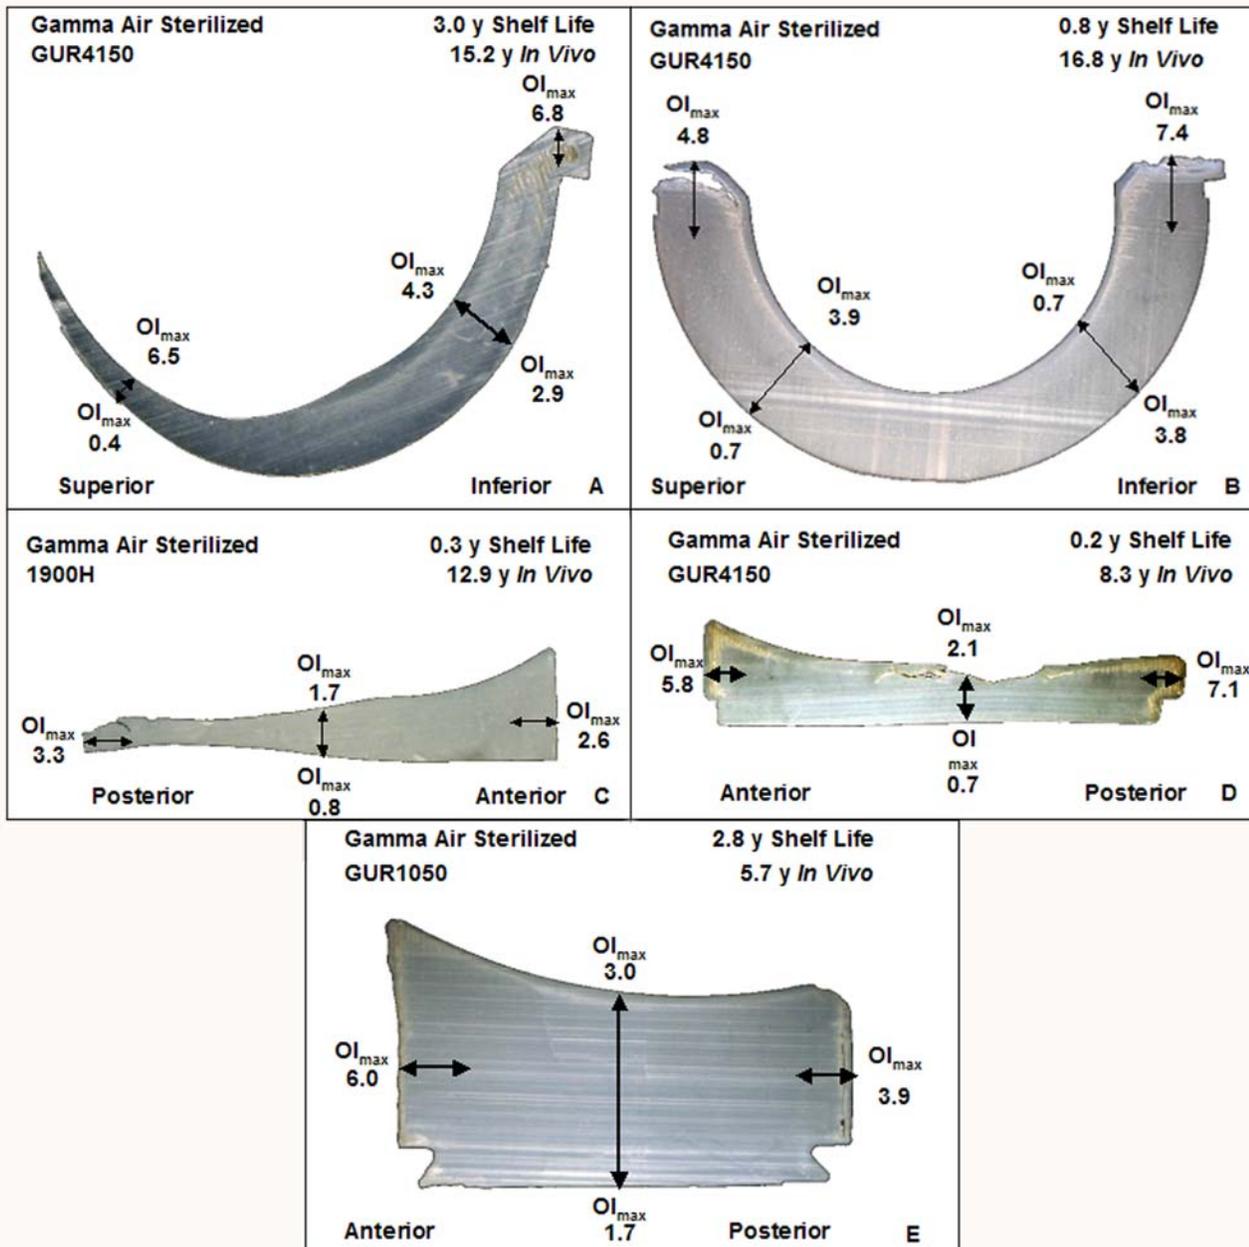
Fig. E-1
 Darkfield optical micrographs of microtomed sections corresponding to historical (gamma-air-sterilized) extruded GUR 4150 polyethylene acetabular liners (A and B) as well as historical direct-compression-molded 1900H tibial inserts (C), extruded GUR 4150 tibial inserts (D), and molded GUR 1050 tibial inserts (E). The maximum ASTM (formerly American Society for Testing and Materials) oxidation index (OI) is also indicated. Subsurface white bands (areas of high oxidation) were evident in the historical retrievals.

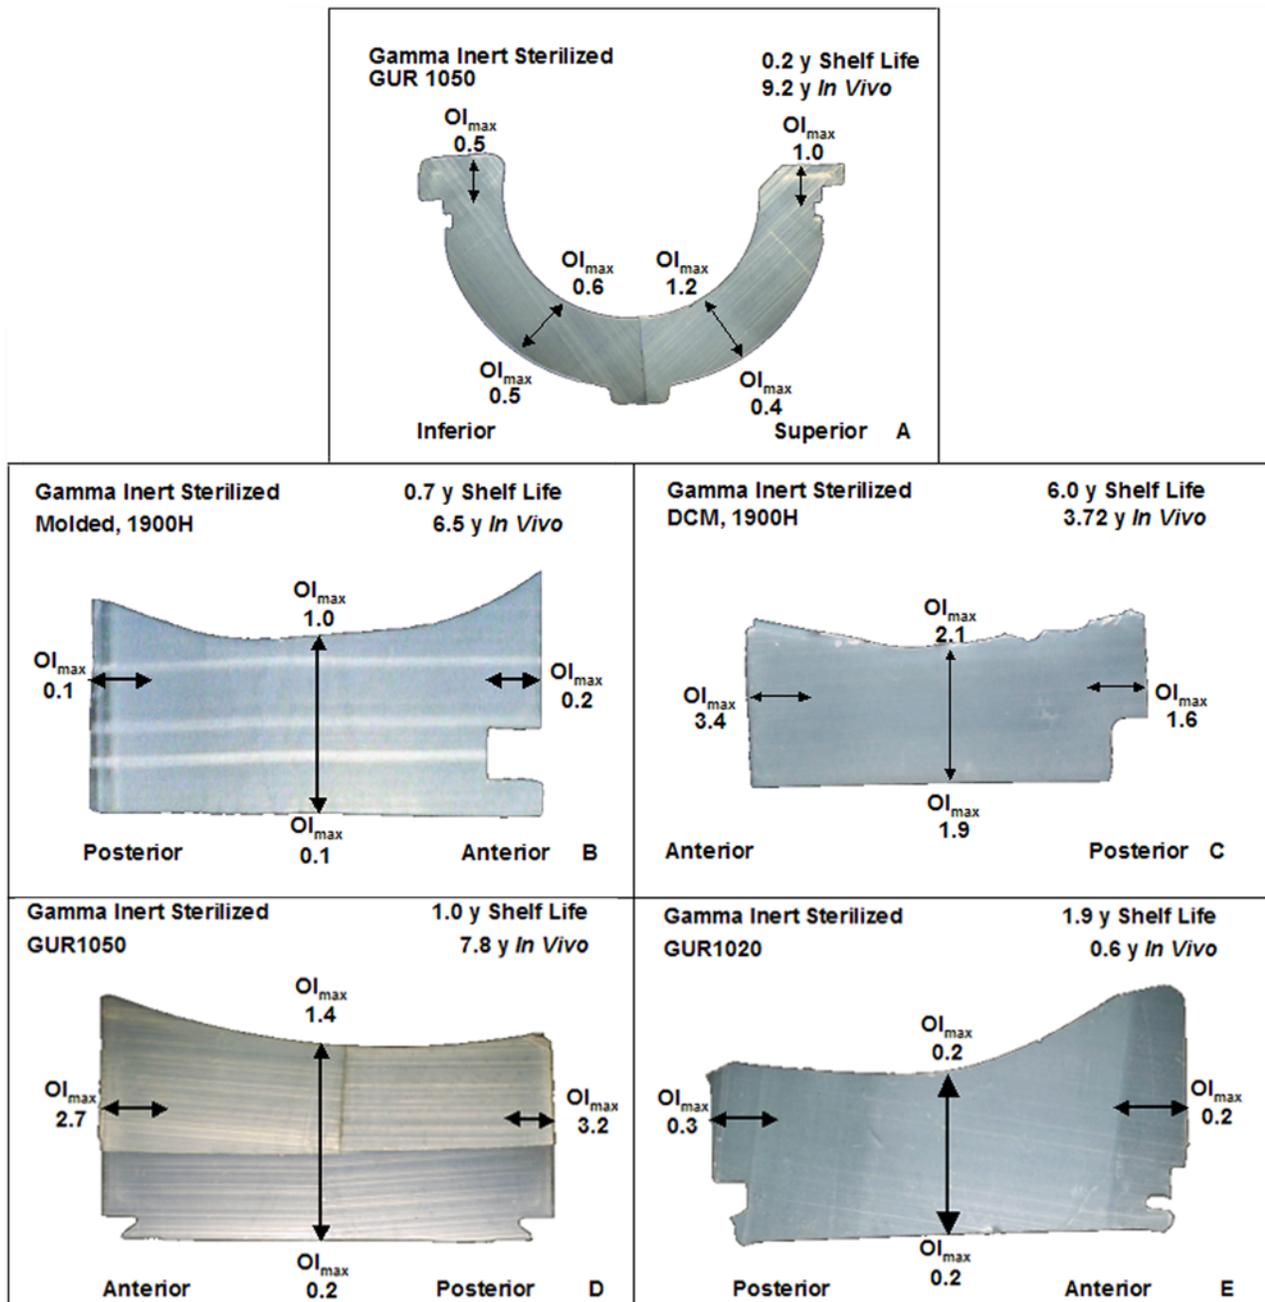
Fig. E-2 Darkfield optical micrographs of microtomed sections corresponding to conventional acetabular liners (A) as well as molded 1900H tibial inserts (B), direct compression molded 1900H tibial inserts (C), molded GUR 1050 tibial inserts (D), and molded GUR 1020 tibial inserts (E). The maximum ASTM (formerly American Society for Testing and Materials) oxidation index (OI) is also indicated. Subsurface white bands were less evident but still present, especially in regions exposed to body fluids.

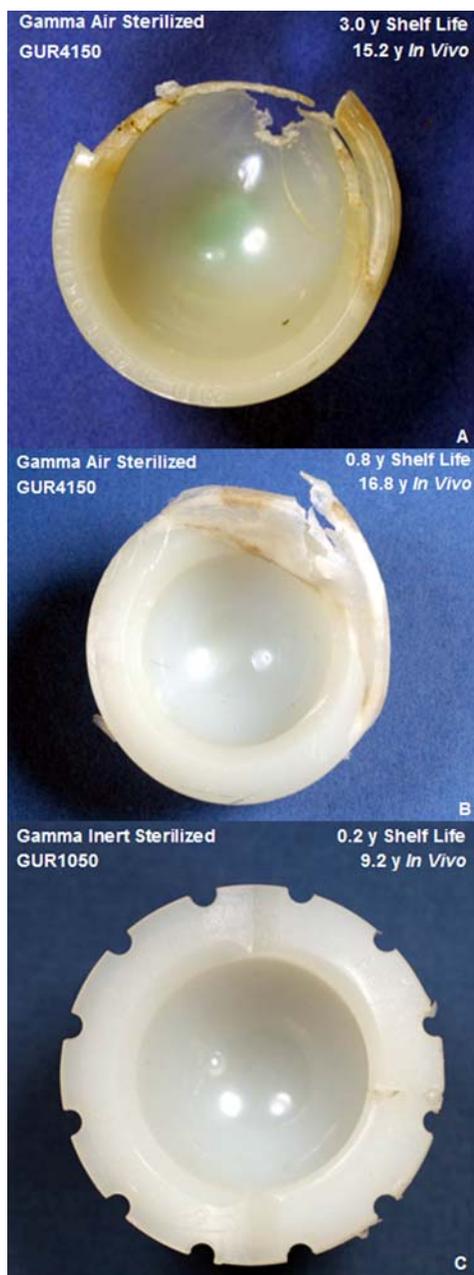
Fig. E-3
Historical (A and B) and conventional (C) sterilized acetabular liner retrievals showed indistinguishable penetration wear rates. However, some of the historical liners were worn through and exhibited considerable damage.

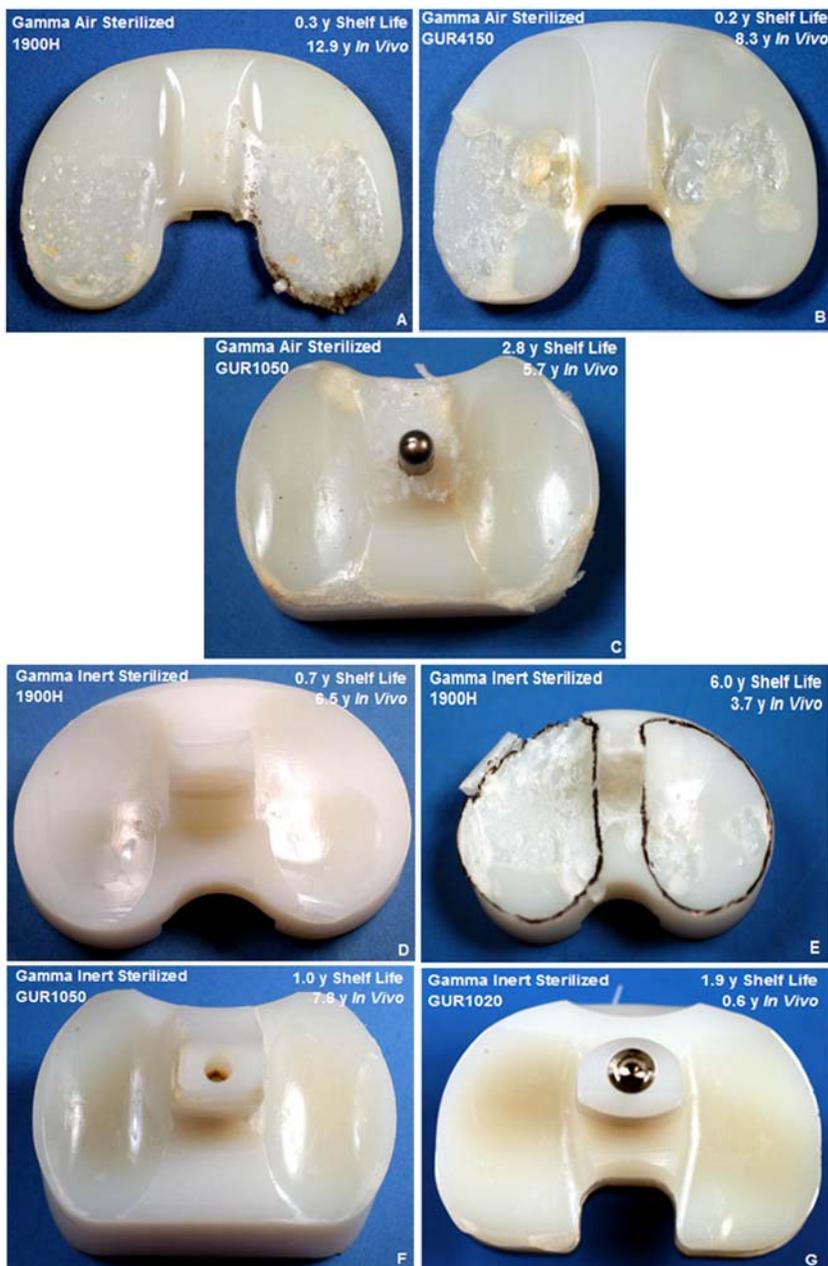
Fig. E-4

Typical photographs of surface damage to the superior surface are shown for historical direct-compression-molded 1900H knee components (A), extruded GUR 4150 knee components (B), and molded GUR 1050 knee components (C) as well as conventional molded 1900H tibial inserts (D), direct compression molded 1900H tibial inserts (E), molded GUR 1050 tibial inserts (F), and molded GUR 1020 tibial inserts (G). Delamination was more prevalent in retrieved historical tibial inserts than in conventional knee retrievals.
