Supplementary figure 3 (S3)

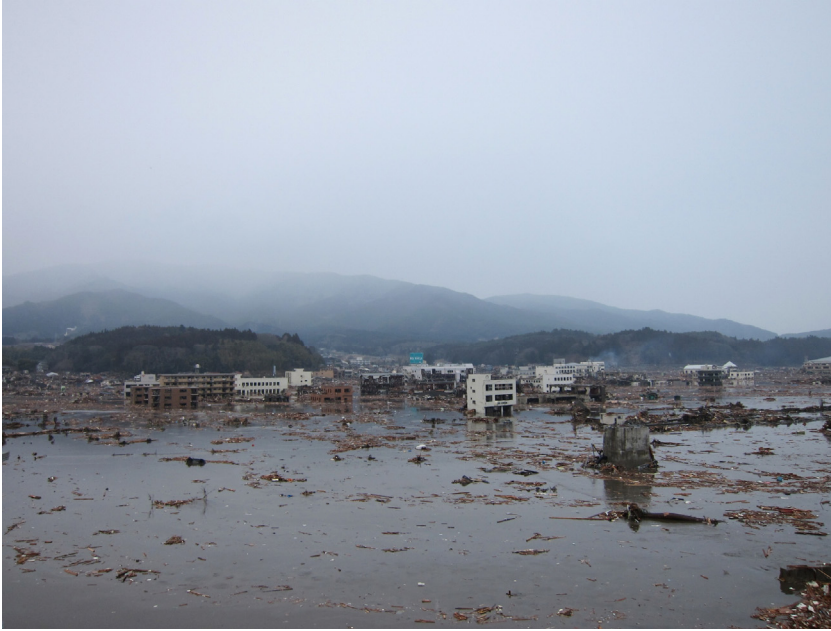
Photo A was shot from the hospital rooftop, showing the city of Rikuzentakata after the waves had ebbed away. The tsunami flooded almost the entire lowland area, where it caused catastrophic damage. Ordinary houses that had once stood in the low-lying area were washed away without a trace. Only the smashed shells of a few reinforced steel-framed houses and office buildings were left behind. It can be seen from this photo that the tsunami destroyed the low-lying areas, but left the higher ground intact.

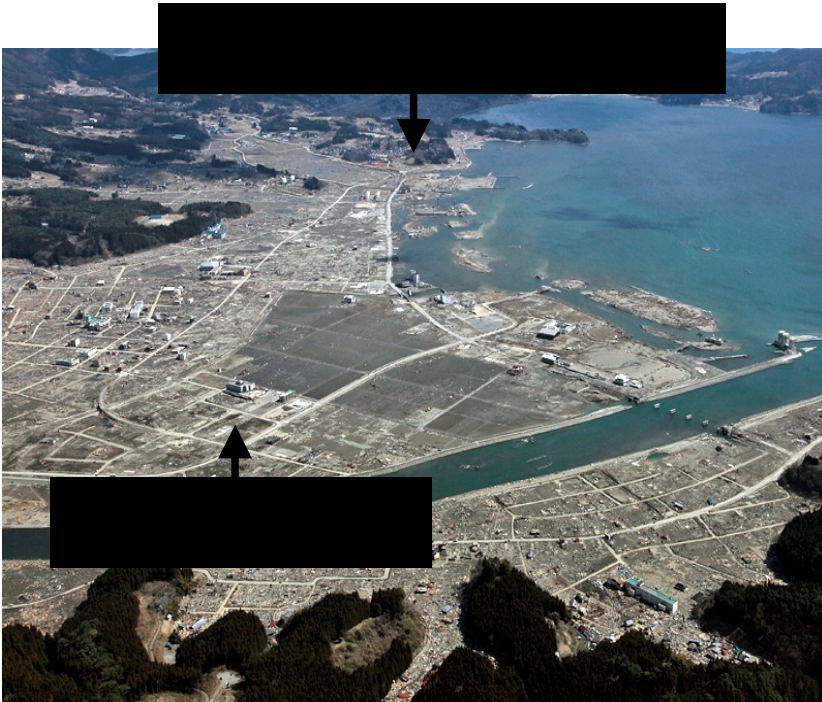
Photo B is an aerial shot of Rikuzentakata City after the onset of the tsunami. It can be seen that most of the houses in the plains area simply disappeared. However, houses in upland areas surrounding the plain suffered no damage. Shown in the upper and middle part of the photograph is the location of the Yonezaki Community Center, where a temporary emergency clinic was installed after the disaster. The location where the Rikuzentakata Hospital once stood can also be seen.

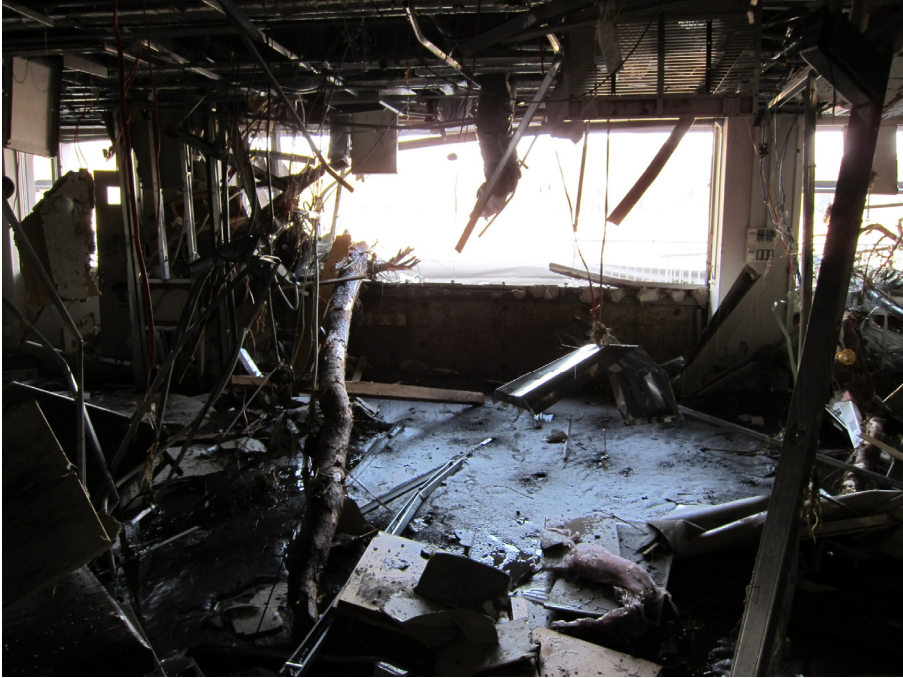
Photo C shows the interior of the hospital after the tsunami. The interior suffered catastrophic damage, bringing hospital operations to a complete halt. It can be seen that all hospital functions, including the power supply system, were destroyed.
