# **Major Transport Mechanisms of Pyrethroids in Residential Settings and Effects of Mitigation Measures**

## **Supplemental Material**

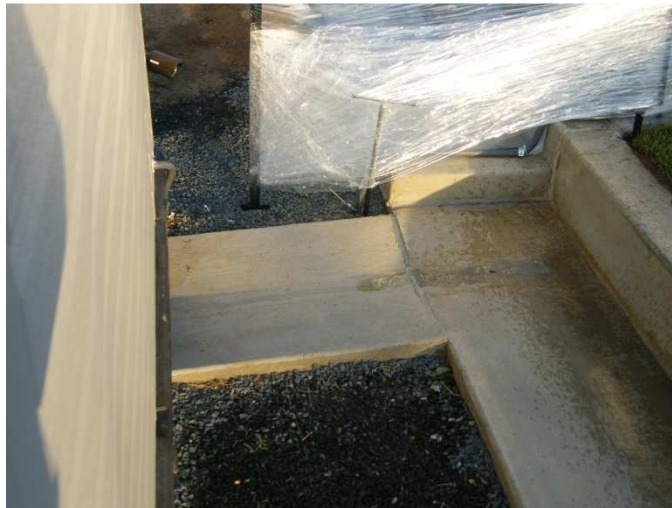
**Figure S1-3.** Movement from curb to flow and sampling equipment.

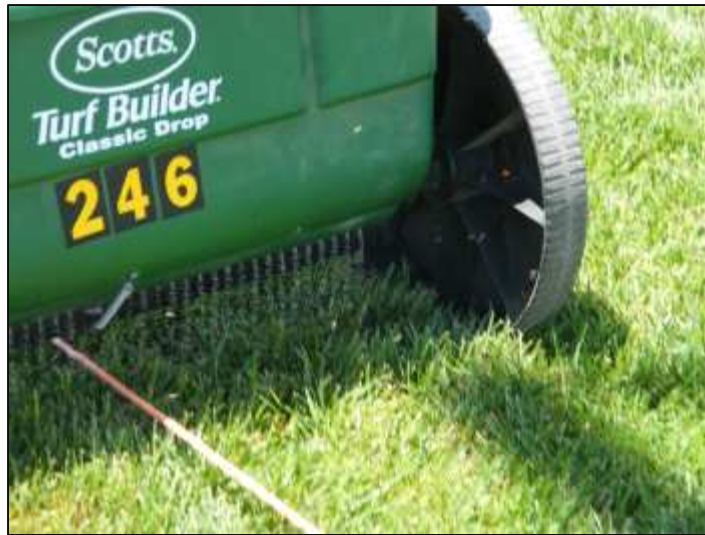
**Figure S4-1.** Scotts Classic Drop Spreader as the granular product is being dispensed. This spreader was only used on lots 2, 4, and 6. A separate drop spreader was used for the remaining three lots.

The granular lawn application was only performed at the first application event in August, 2011. The granular lawn applications were made with Scotts Classic Drop Spreaders (Figure S4-1), producing a 20 inch output swath. A separate spreader was used for each treatment scheme (either lots 1, 3, and 5 or lots 2, 4, and 6). The drop spreaders were calibrated by catching the output test substance in a mounted PVC tray over eleven passes of 52 feet and adjusting the output dial to achieve the desired output. This rate was chosen because it represents an area equal to the large section of lawn at each house lot. Three catches were made per treatment. The collected output of each catch was weighed and the average weight was used along with the area to be treated (1020 sq. ft.) to calculate the target output per lawn. Eleven passes were made to the main lawn section (west of each lot's driveway) and two passes were made to each 5-foot grass strip (east of each lot's driveway). The remaining test substance was weighed back to confirm each application output.

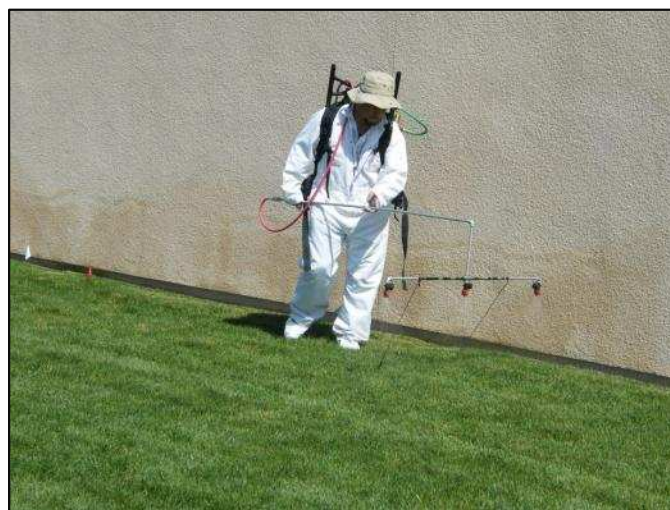
**Figure S4-2.** A single pass was made to achieve the grass perimeter application. A three-nozzle spray boom was used to produce the desired spray width of 5 feet.

Applications to the grass perimeter were made using a three-nozzle boom and Tee Jet flat fan 8010 nozzles. The total treated area for this surface was approximately 285 square feet per plot. Separate spray booms and mix tanks were used for each treatment scheme. A single pass was made on each section of lawn (Figure **Error! Reference source not found.**S4-2).

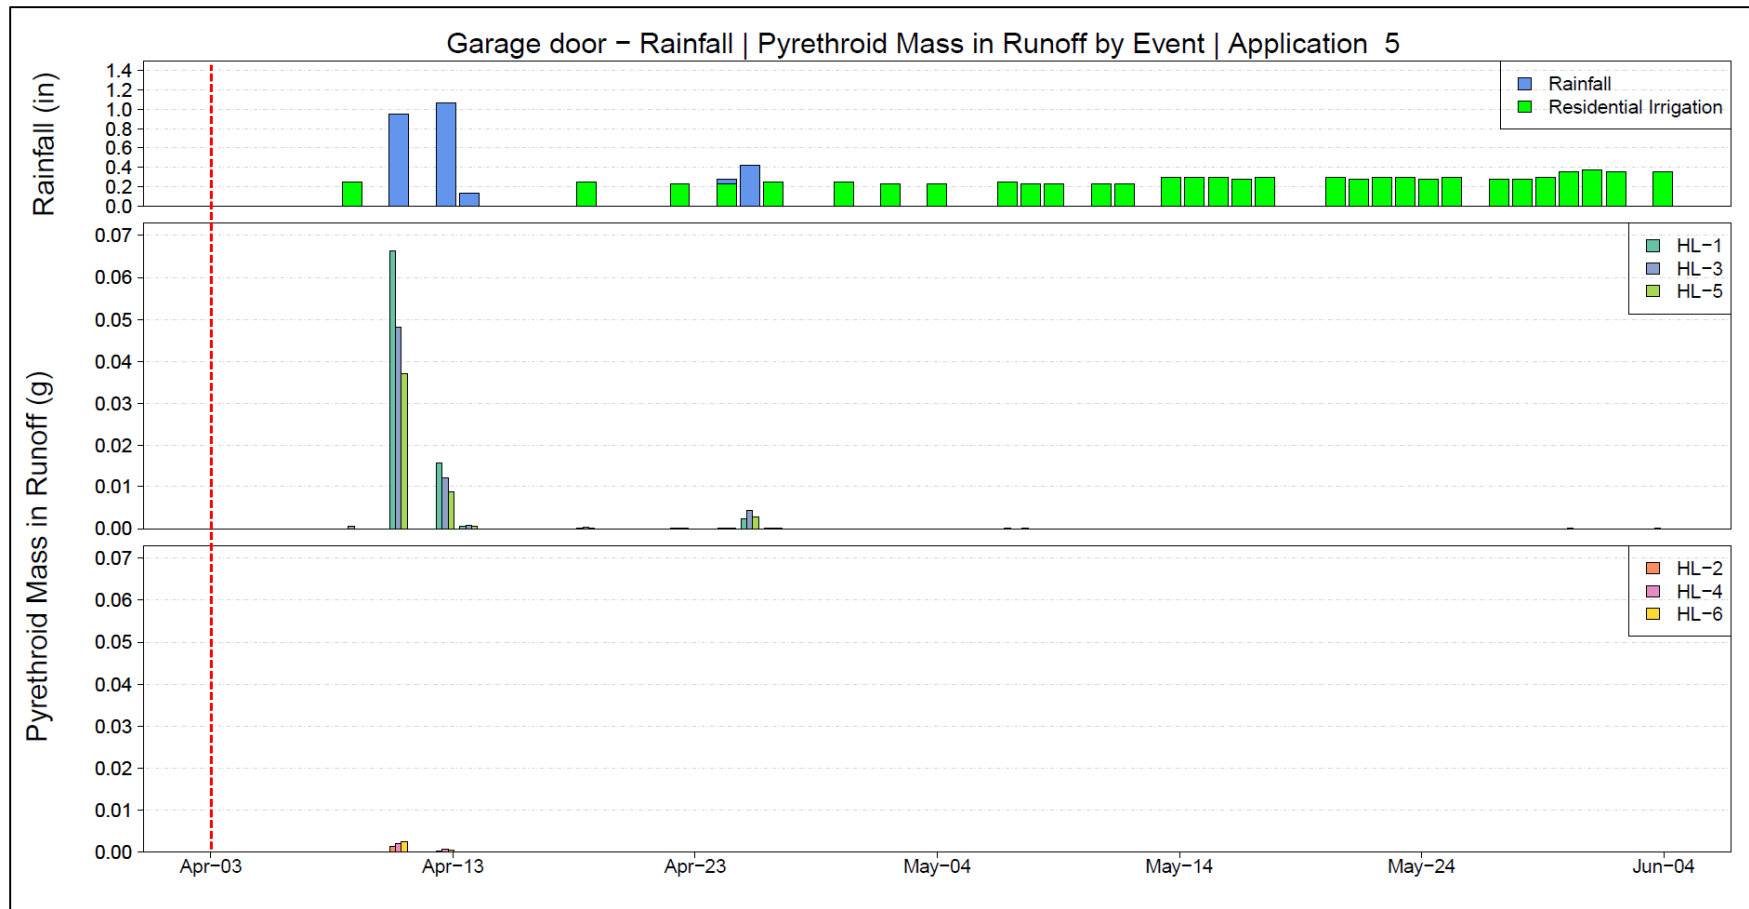
**Figure S7-11.** Runoff losses from the garage door and adjacent walls by event for each of the six house plots between the fifth and sixth sets of applications. The fifth application event occurred on April 3, 2012, as denoted by the vertical red dashed line.

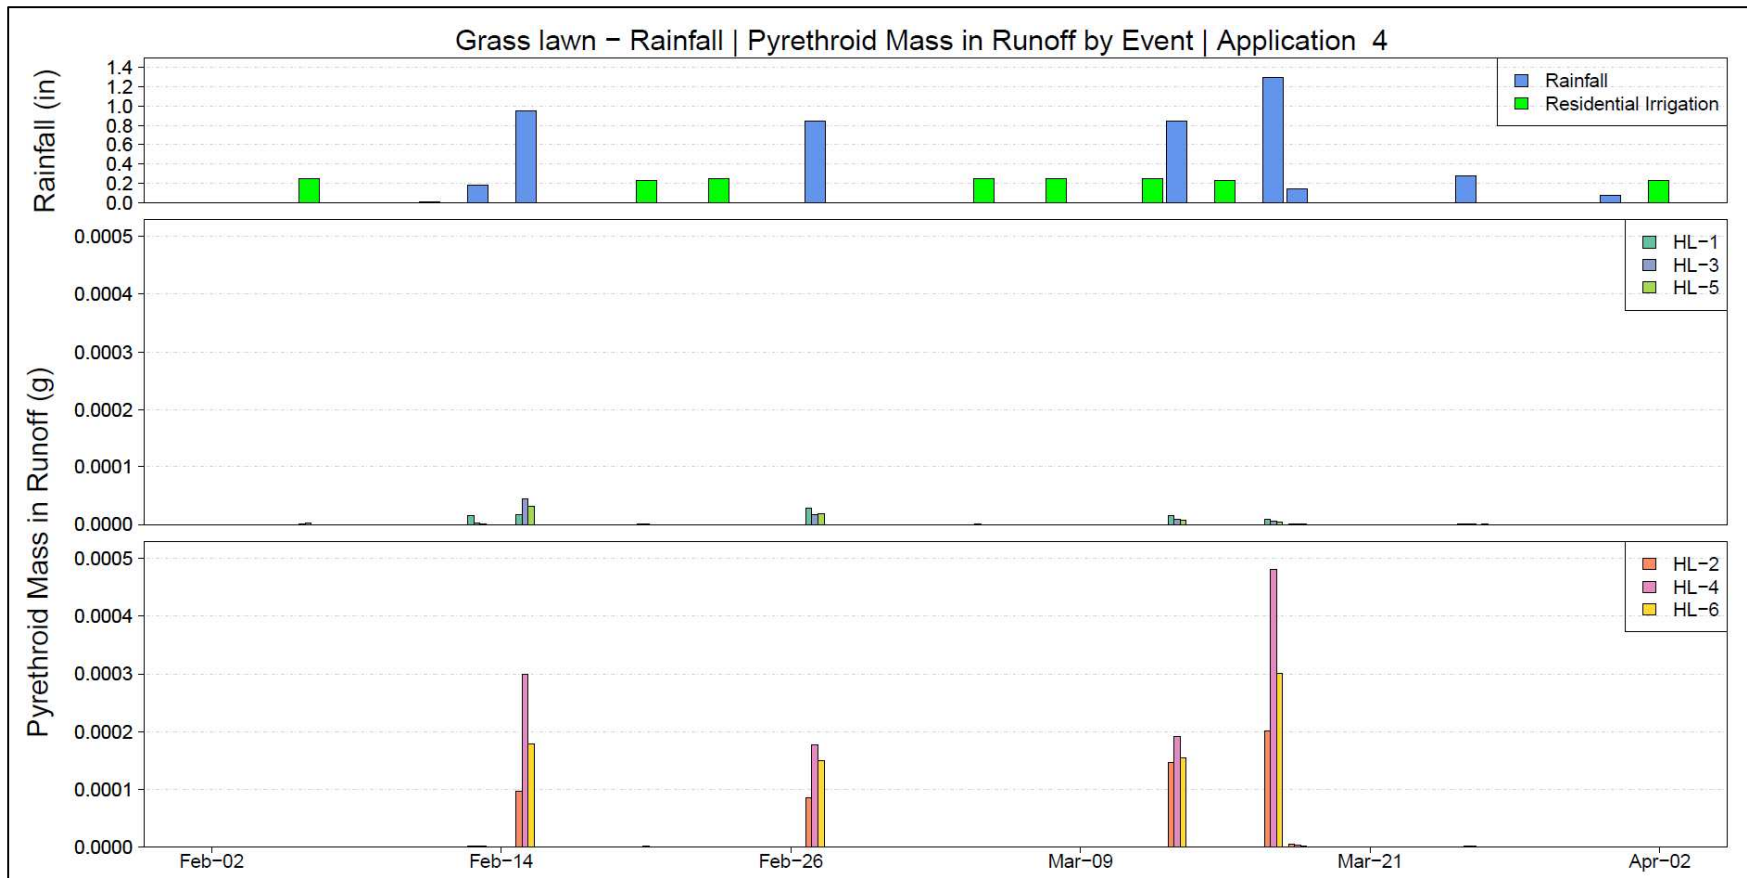
**Figure S7-16.** Runoff losses from the grass lawn by event for each of the six house plots between the fourth and fifth sets of applications (the lawn received an application only during the first set of applications).

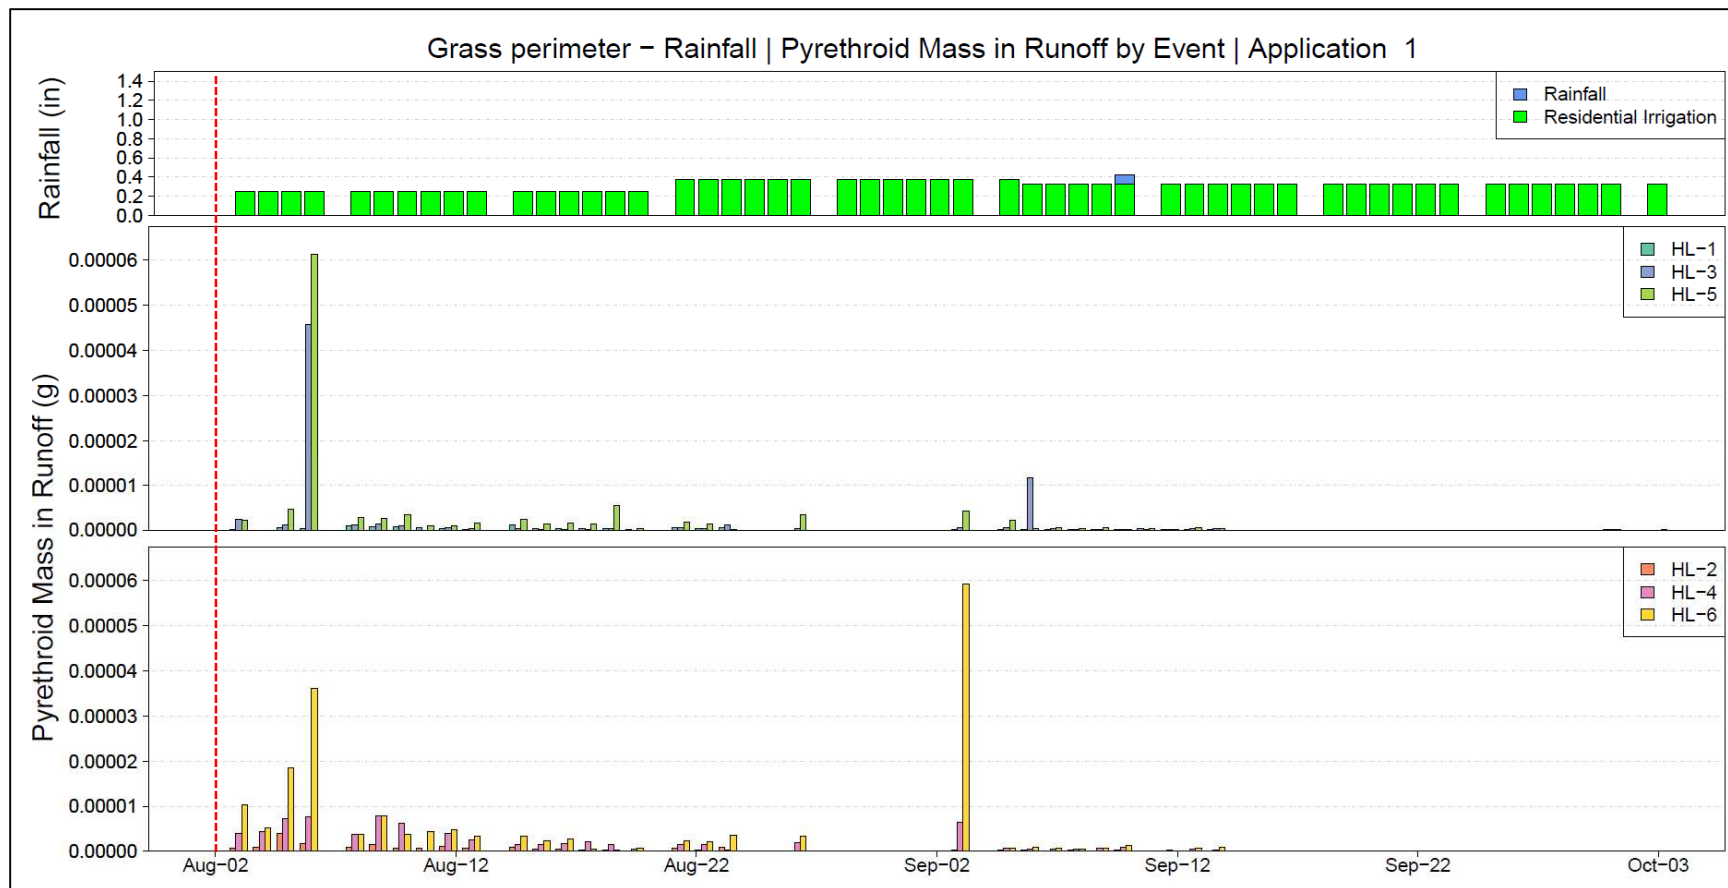
**Figure S7-19.** Runoff losses from the grass perimeter by event for each of the six house plots between the first and second sets of applications. The first application event occurred on August 2, 2011, as denoted by the vertical red dashed line.

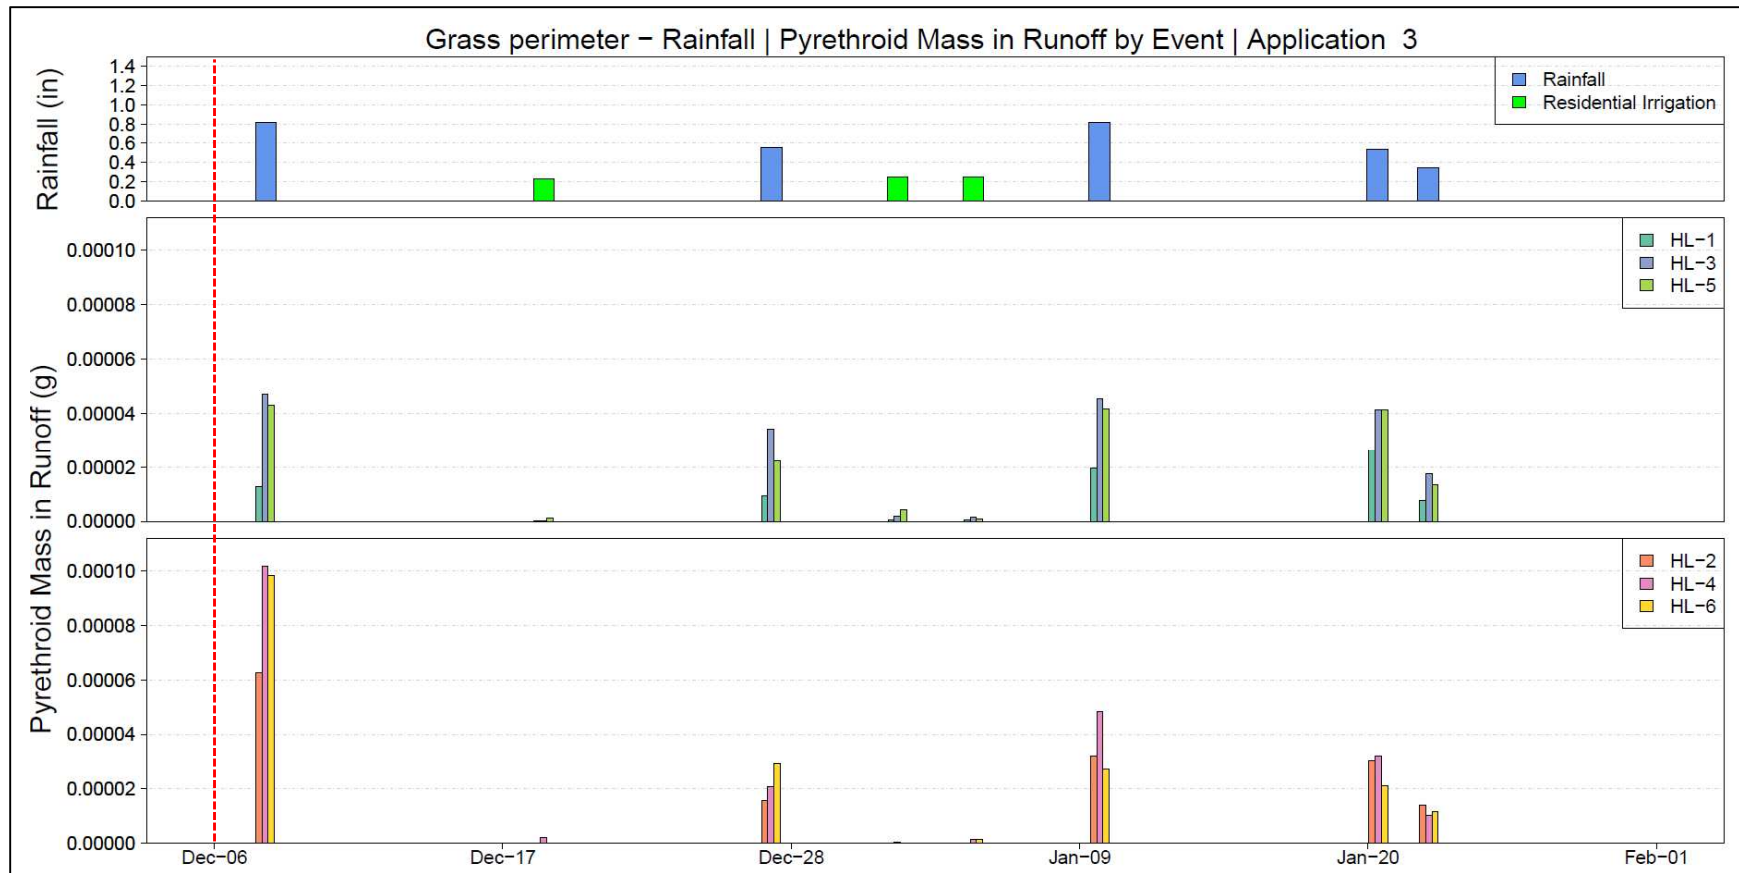
**Figure S7-21.** Runoff losses from the grass perimeter by event for each of the six house plots between the third and fourth sets of applications.

The third application event occurred on December 6, 2011, as denoted by the vertical red dashed line.

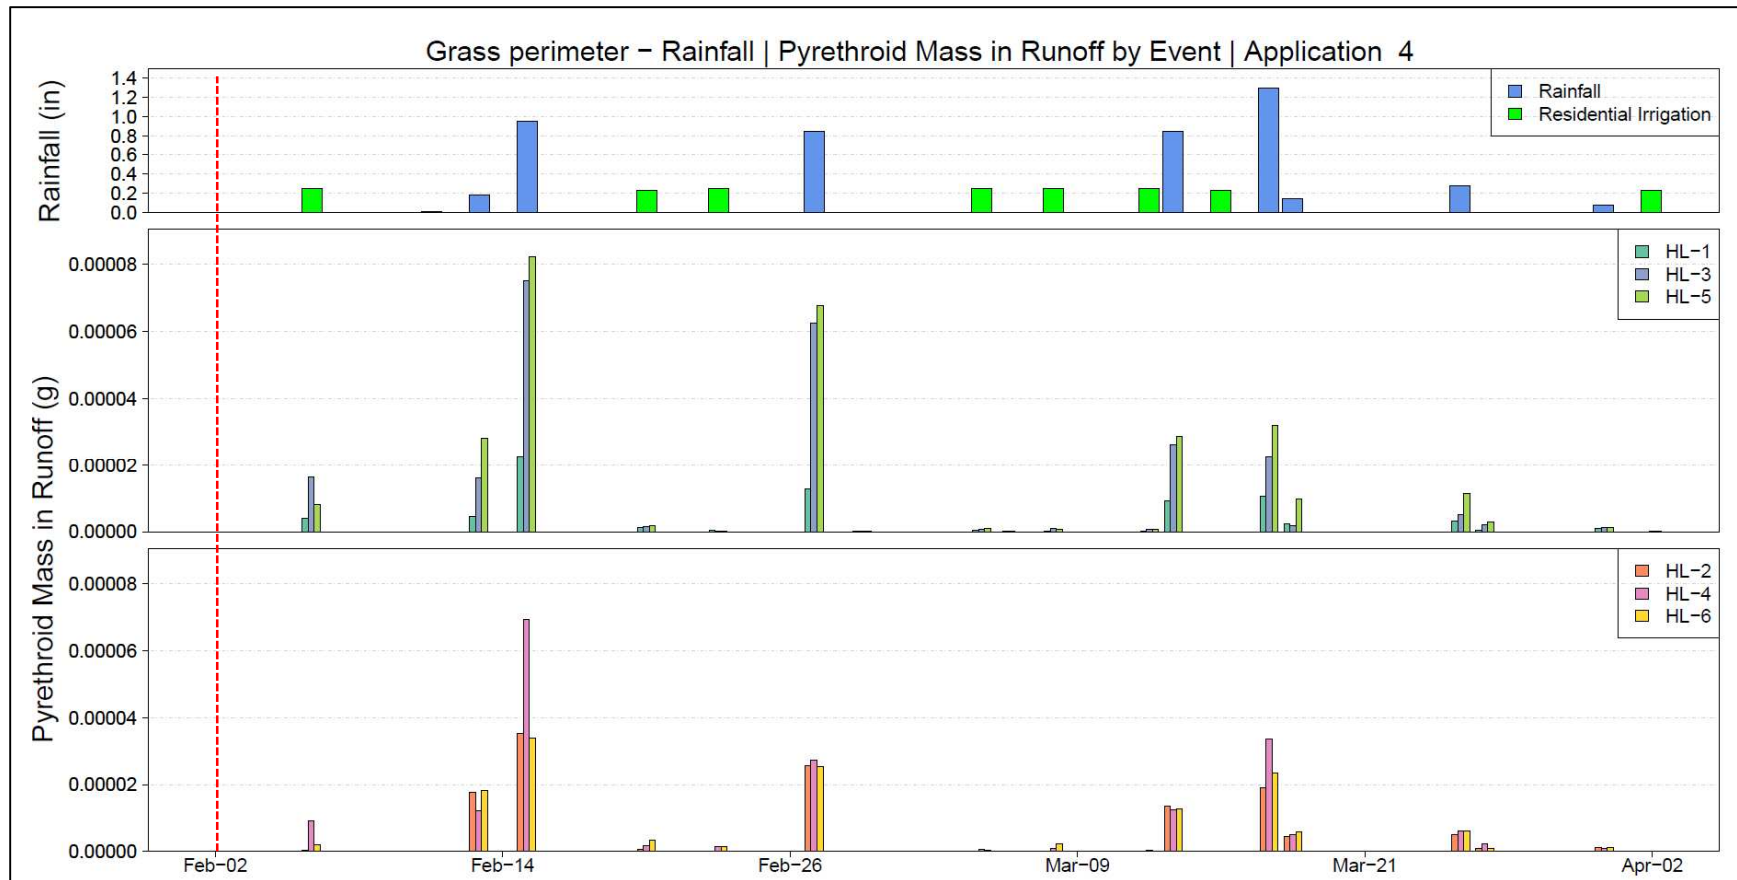
**Figure S7-22.** Runoff losses from the grass perimeter by event for each of the six house plots between the fourth and fifth sets of applications. The fourth application event occurred on February 2, 2012, as denoted by the vertical red dashed line.

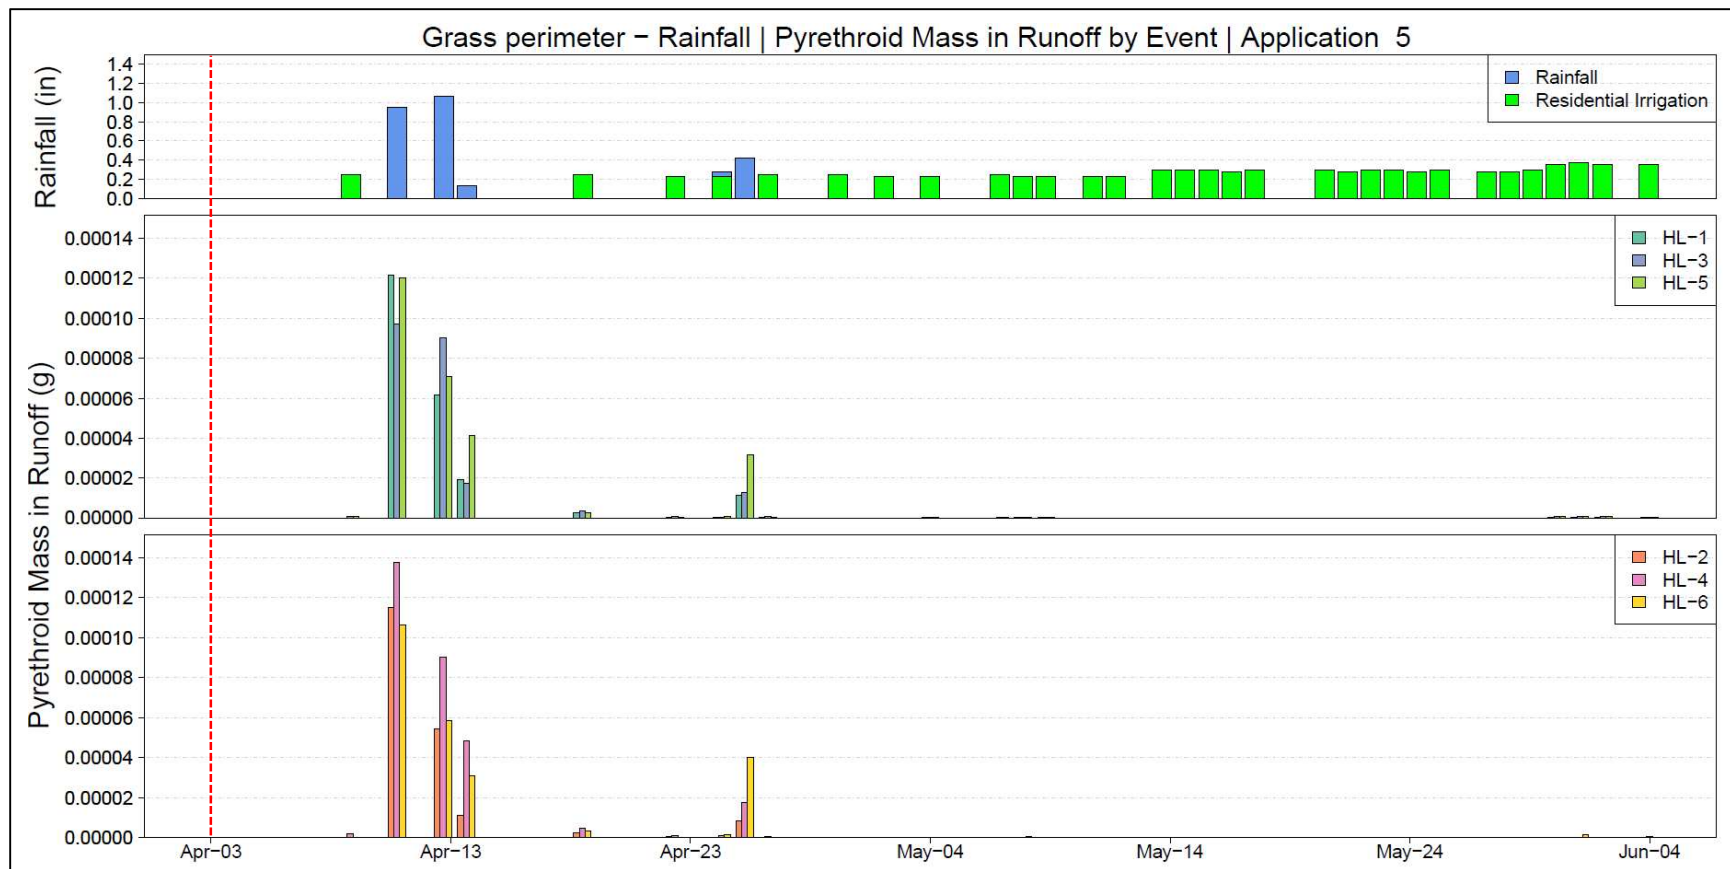
**Figure S7-23.** Runoff losses from the grass perimeter by event for each of the six house plots between the fifth and sixth sets of applications. The fifth application event occurred on April 3, 2012, as denoted by the vertical red dashed line.

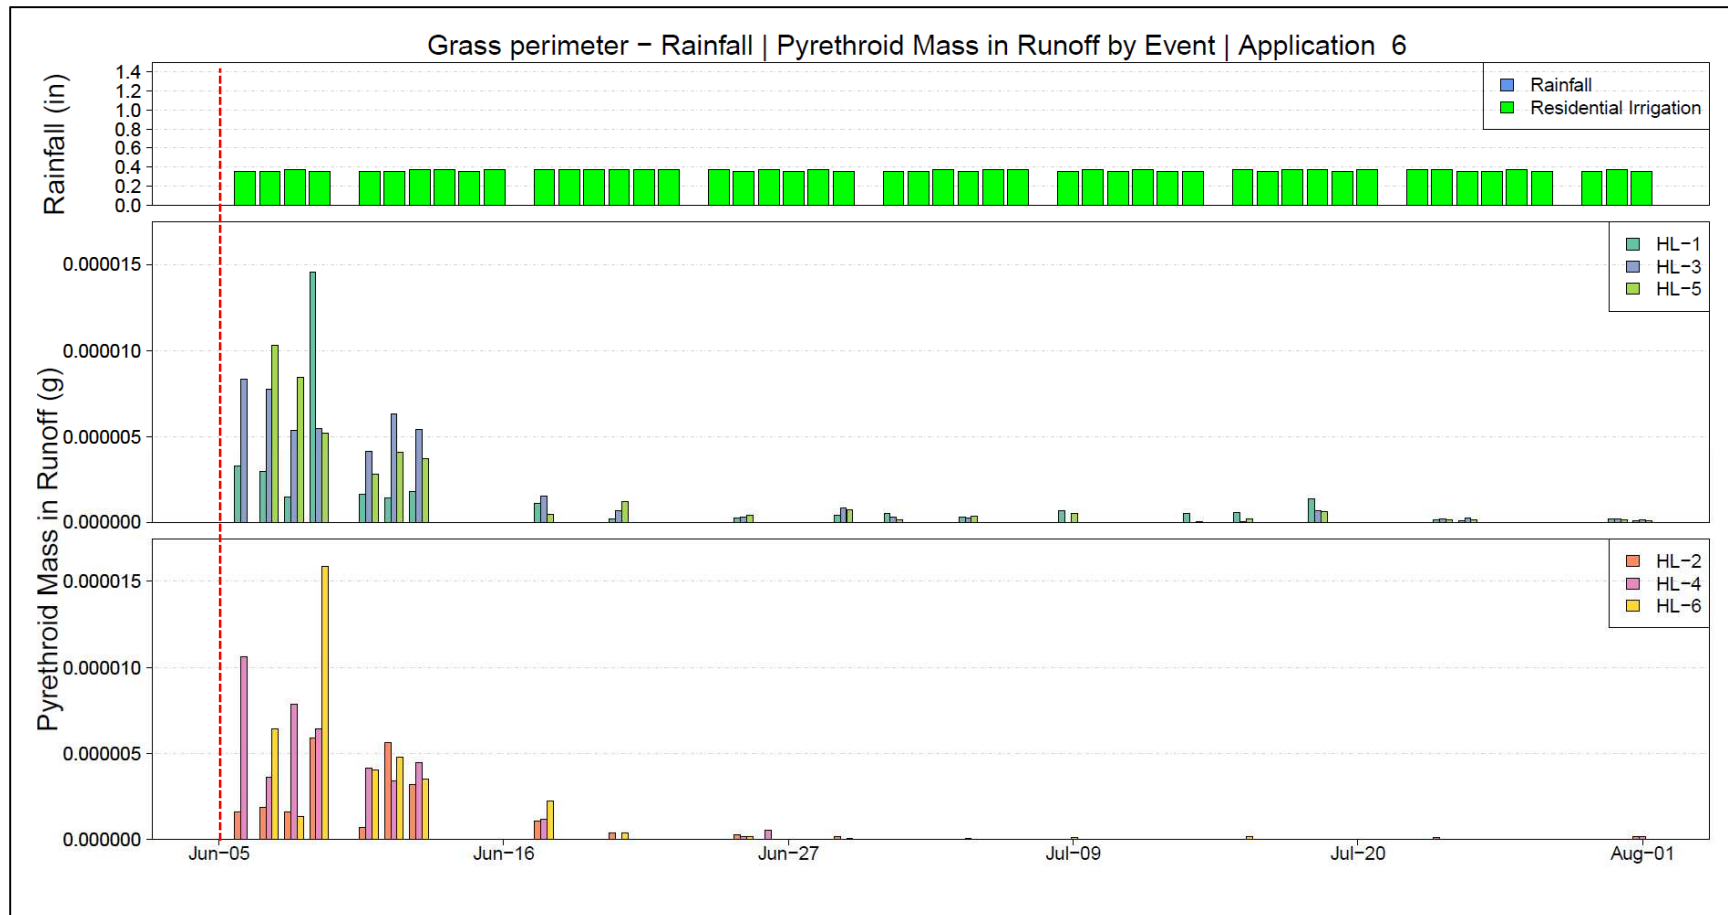
**Figure S7-24.** Runoff losses from the grass perimeter by event for each of the six house plots between the sixth application and the end of the study. The sixth application event occurred on June 5, 2012, as denoted by the vertical red dashed line.
