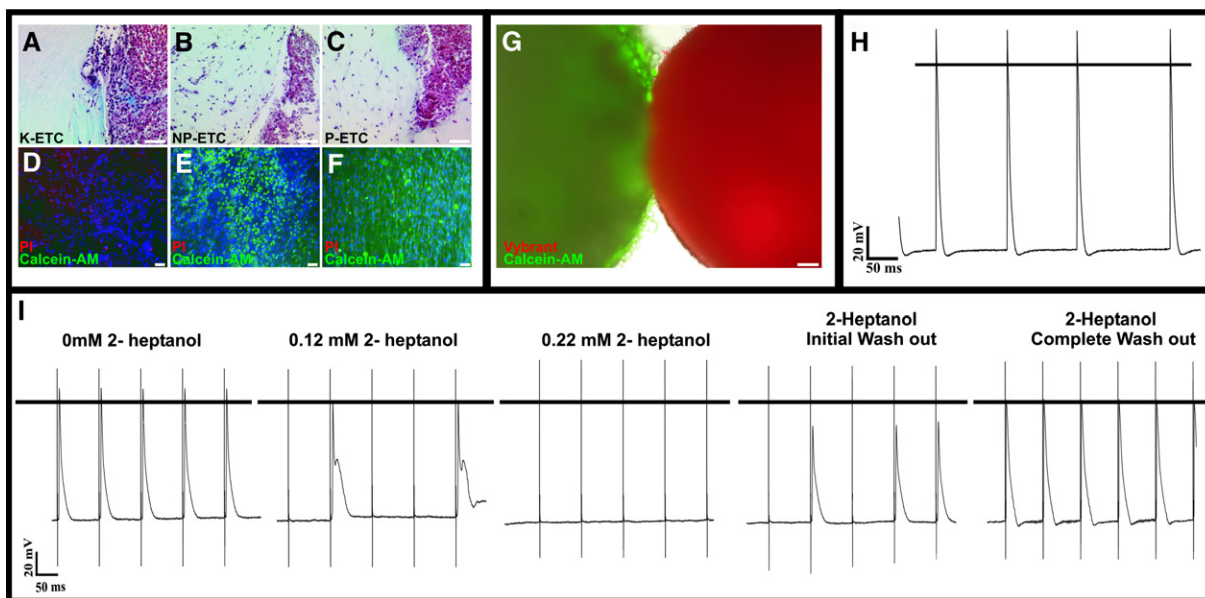
FIGURE E1. Masson’s trichrome staining of the co-culture samples at the junction of (A) killed engineered tissue construct (*K-ETC*)/EHS and (B) nonpreconditioned engineered tissue construct (*NP-ETC*)/EHS shows poor grafting, whereas (C) preconditioned engineered tissue construct (*P-ETC*)/EHS shows close contact of adjacent tissues. D-F, Staining of ETCs shows a majority of dead (propidium iodide positive) cells for *K-ETC* (D), whereas *NP-ETC* (E) and *P-ETC* (F) show mainly vital (calcein AM positive) cells. G, Macroscopic fluorescence picture of Vybrant Dil (*red*) labeled EHS co-culture with calcein AM (*green*) labeled EHS to show poor attachment of adjacent tissues. H, Spontaneous AP of EHS. I, APs of *P-ETC*/EHS co-culture during 2-heptanol treatment and after washout. Scale bars = 50 μ m.
