Additional File 1

Surgical procedure in animal No.3.

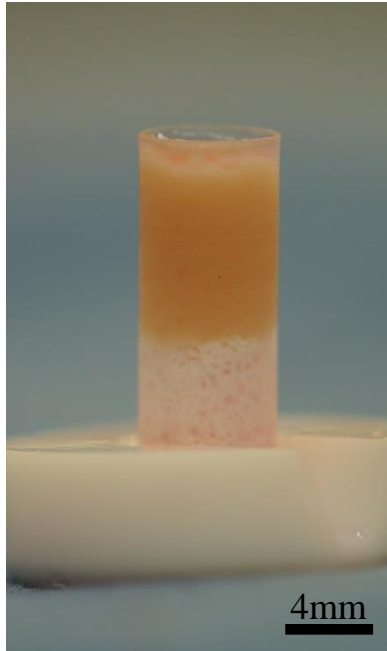
A Columnar construct

A columnar construct (6 mm in diameter and 8 mm in height) composed of about 1150 spheroids of AT-MSCs (A). A elliptic cylindrical osteochondral defect in each groove (B). Two constructs were autografted into the defect of the right hind limb (C). No implantation was in the left limb (B).

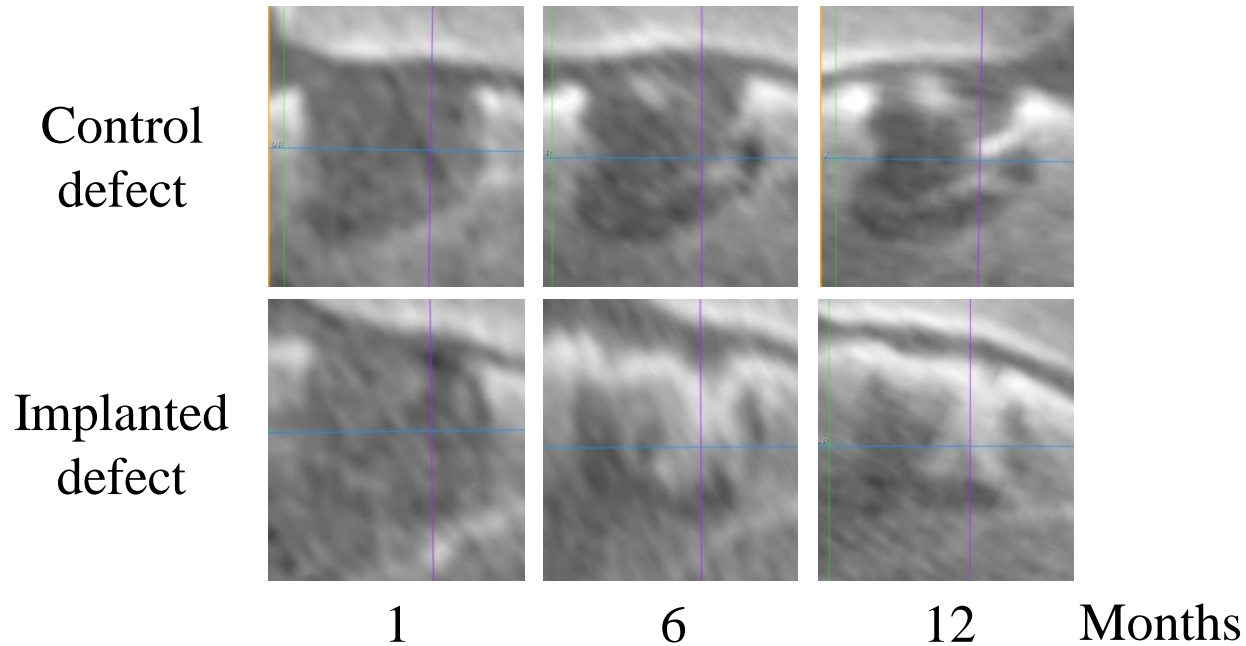
CT images after the surgery in animal No.3.

One cross-section of the multi-planar reconstruction images 1, 6, and 12 months after the surgery in animal No.3. In the implanted site, the radiopaque area gradually progressed, and filled throughout the osteochondral defect after 12 months. However, in the control site, the spread of radiopaque area was limited in the shallow layer, and no bone formation was in the deep layer.

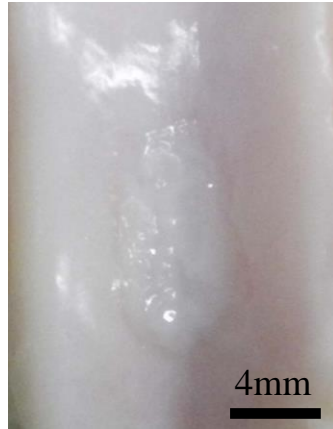
A Implanted defect

Macroscopic findings of the articular surface in animal No.3

The surface was completely covered with abundant cartilageous white tissues.

The boundary to the surrounding normal cartilage was not different between the implanted site (A) and the control site (B).

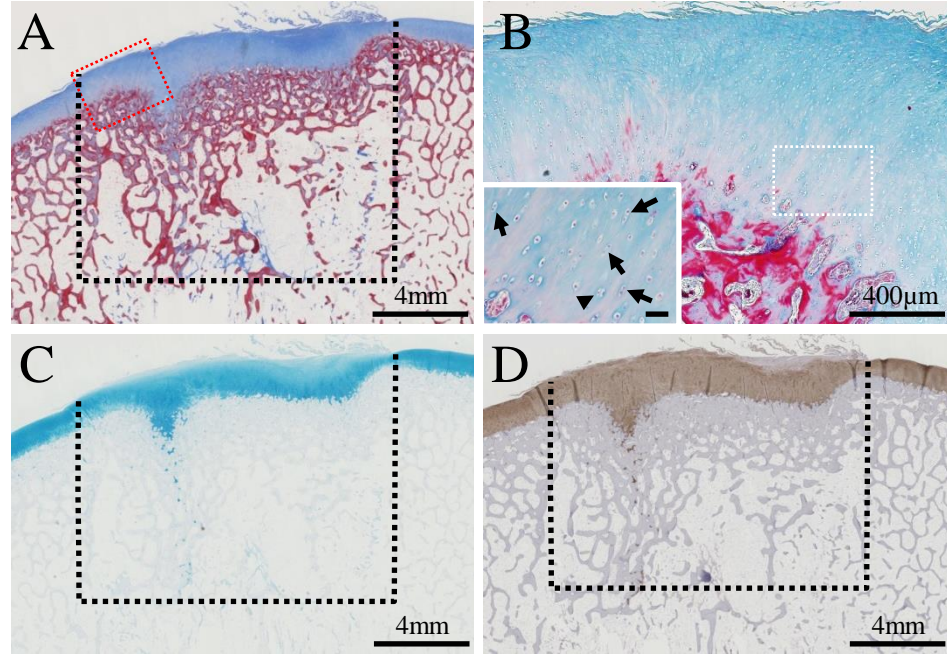
Implanted defect

Histopathology of osteochondral defects of animal No.3

At the implanted site, the restored subchondral bone was covered by mixture of hyaline/fibrocartilage, in which the clusters (arrowhead) and columnar clusters (arrow) of the cells were seen (A, B, C, D). In the control site, the surface was irregular, and the large fibrous tissue was presented in the subchondral (area no bone in bottom half of the defect (E, F, G, H). Black dotted lines indicate the areas of osteochondral defects immediately after the surgery. The images B and F are high power fields of red dotted square in the images A and E, respectively. The small images in the sections B and F were high power fields of white dotted squares in the respective images. The bars in the small images indicate 50 μm .
