# Supplementary Figure 1. EPI distortion due to the DBS electrode and Extension connector

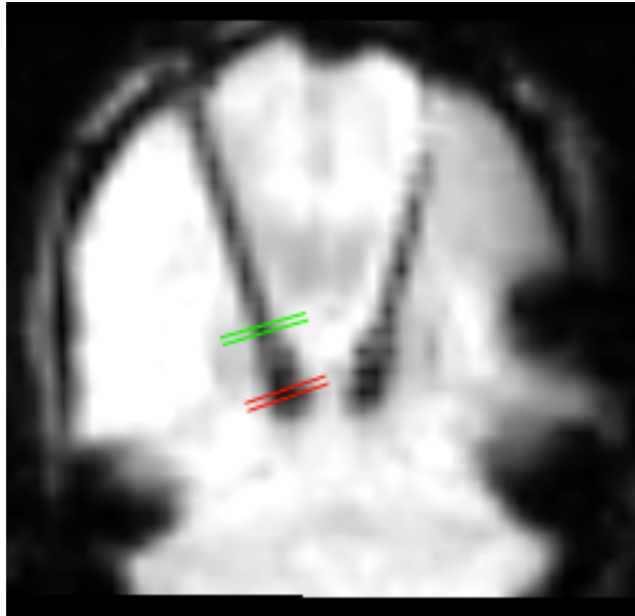
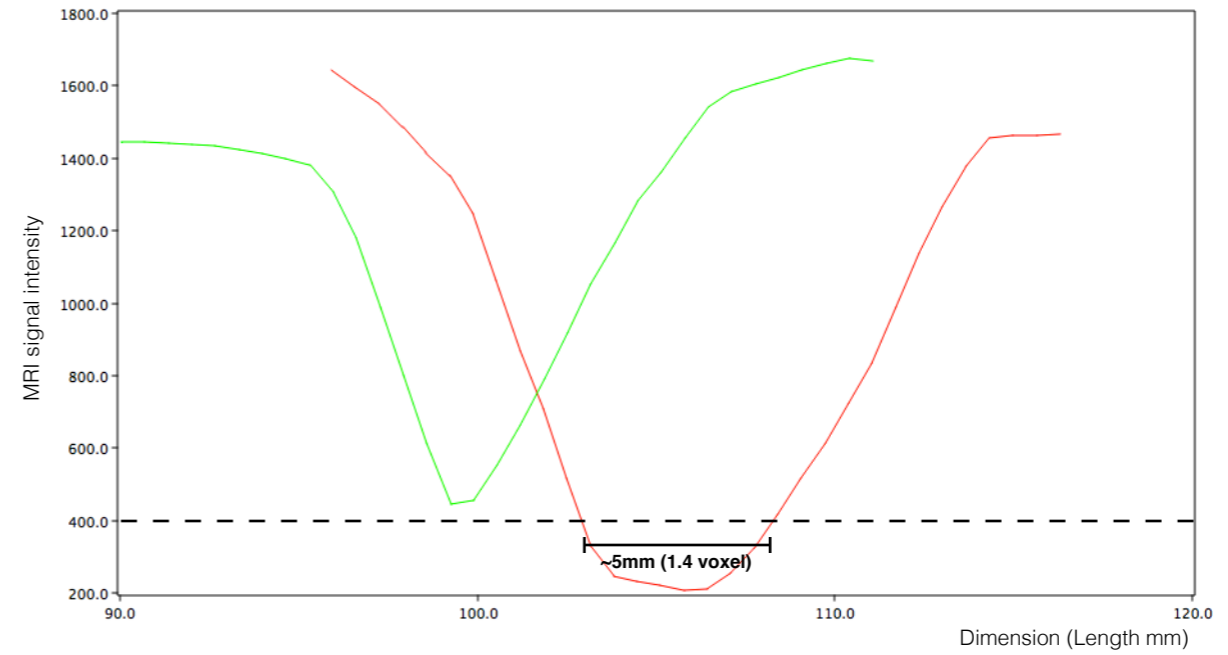
(A) EPI distortion of the DBS electrode

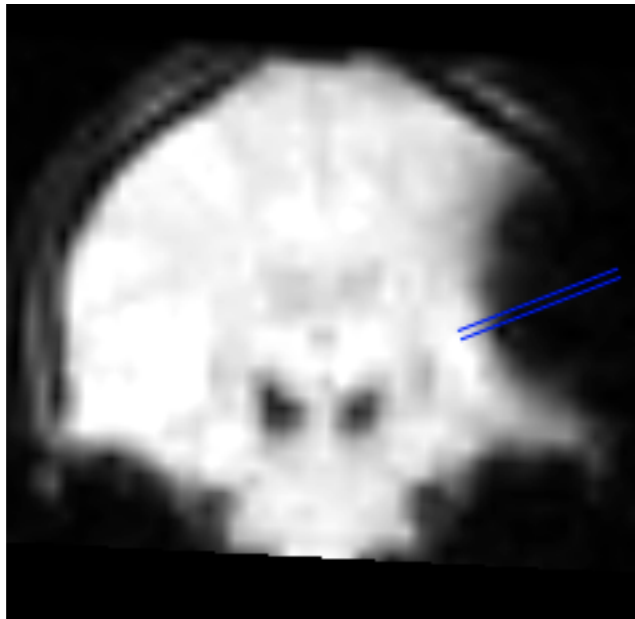
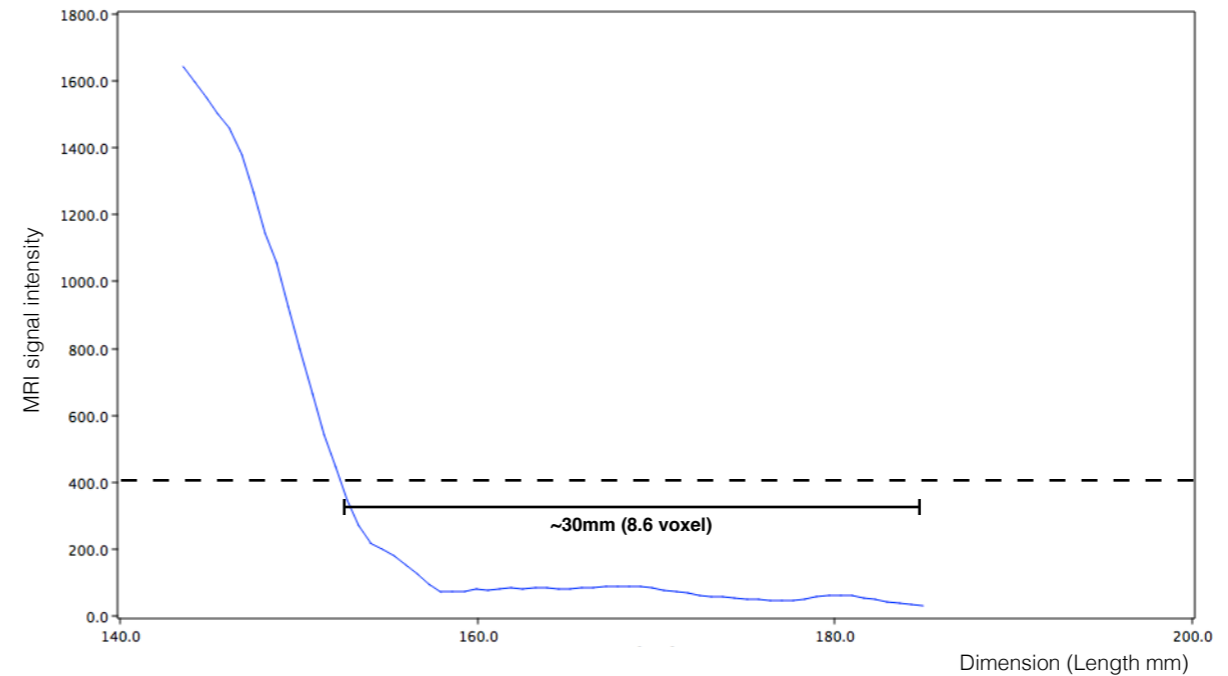
(B) EPI distortion of the Extension connector
