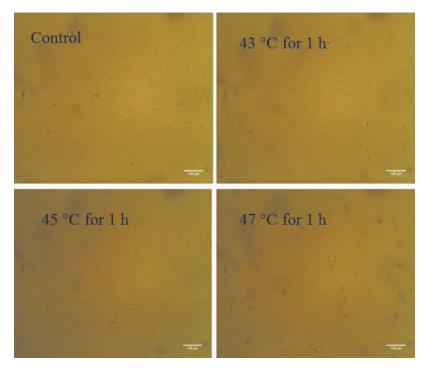
$\textbf{SUPPLEMENTARY FIG. S2.} \quad \text{Morphology of ASCs when exposed to different temperatures.} \ \text{Temperatures} > 45^{\circ}\text{C result in abnormal morphological changes in ASCs.}$
