Supplementary Figure 1: Typical MRI, micro-CT and histology images at week 1 after implantation of a bone defect filled with a Matrix-HA-Fuco. The lower raw shows the biomaterial-filled defect area in blue on each modality.

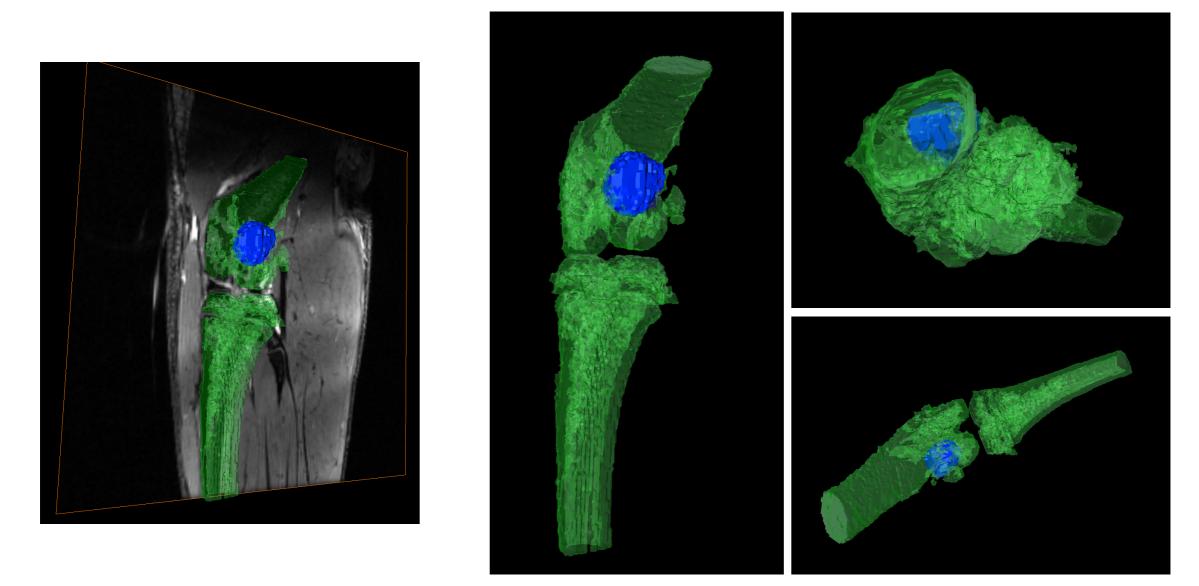
Supplementary Figure 2: 3D MRI representation of a rat knee with a femoral defect filled with a Matrix-HA-Fuco biomaterial, 1 week after implantation. On the left, extracted plan from a 3D MRI WS-bSSFP image and 3D superimposed representation of the femoral and tibial bones (green) and the biomaterial (blue). On the right, 3D representations shown along 3 orientations.
