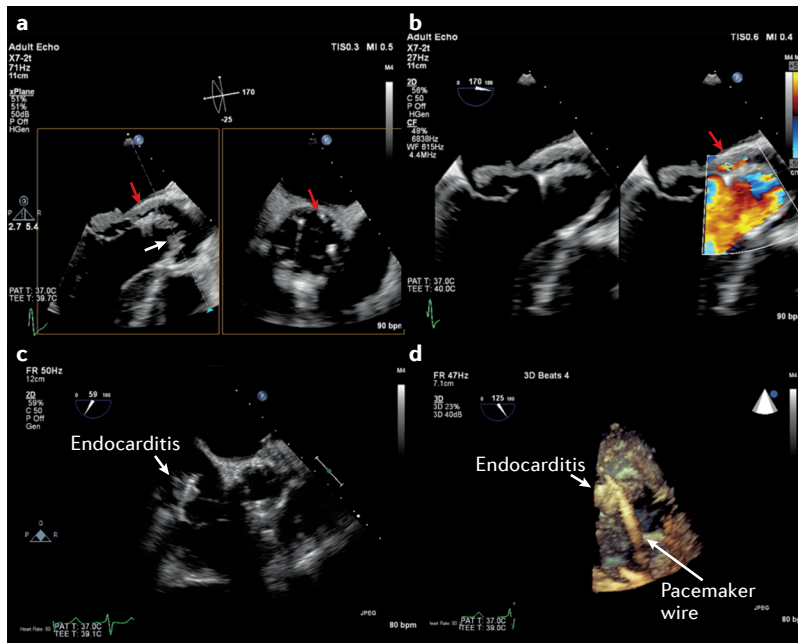
Supplementary figure 2 | **Echocardiographic features of infective endocarditis demonstrated using transoesophageal echocardiography. a,b** | Aortic prosthetic endocarditis showing leaflet thickening (white arrow) and root abscess (red arrows). Lower panels: device-related endocarditis, with vegetations (endocarditis) associated with an atrial pacing wire. Midoesophageal right ventricular inflow–outflow view on **c** | 2D and **d** | 3D imaging.
