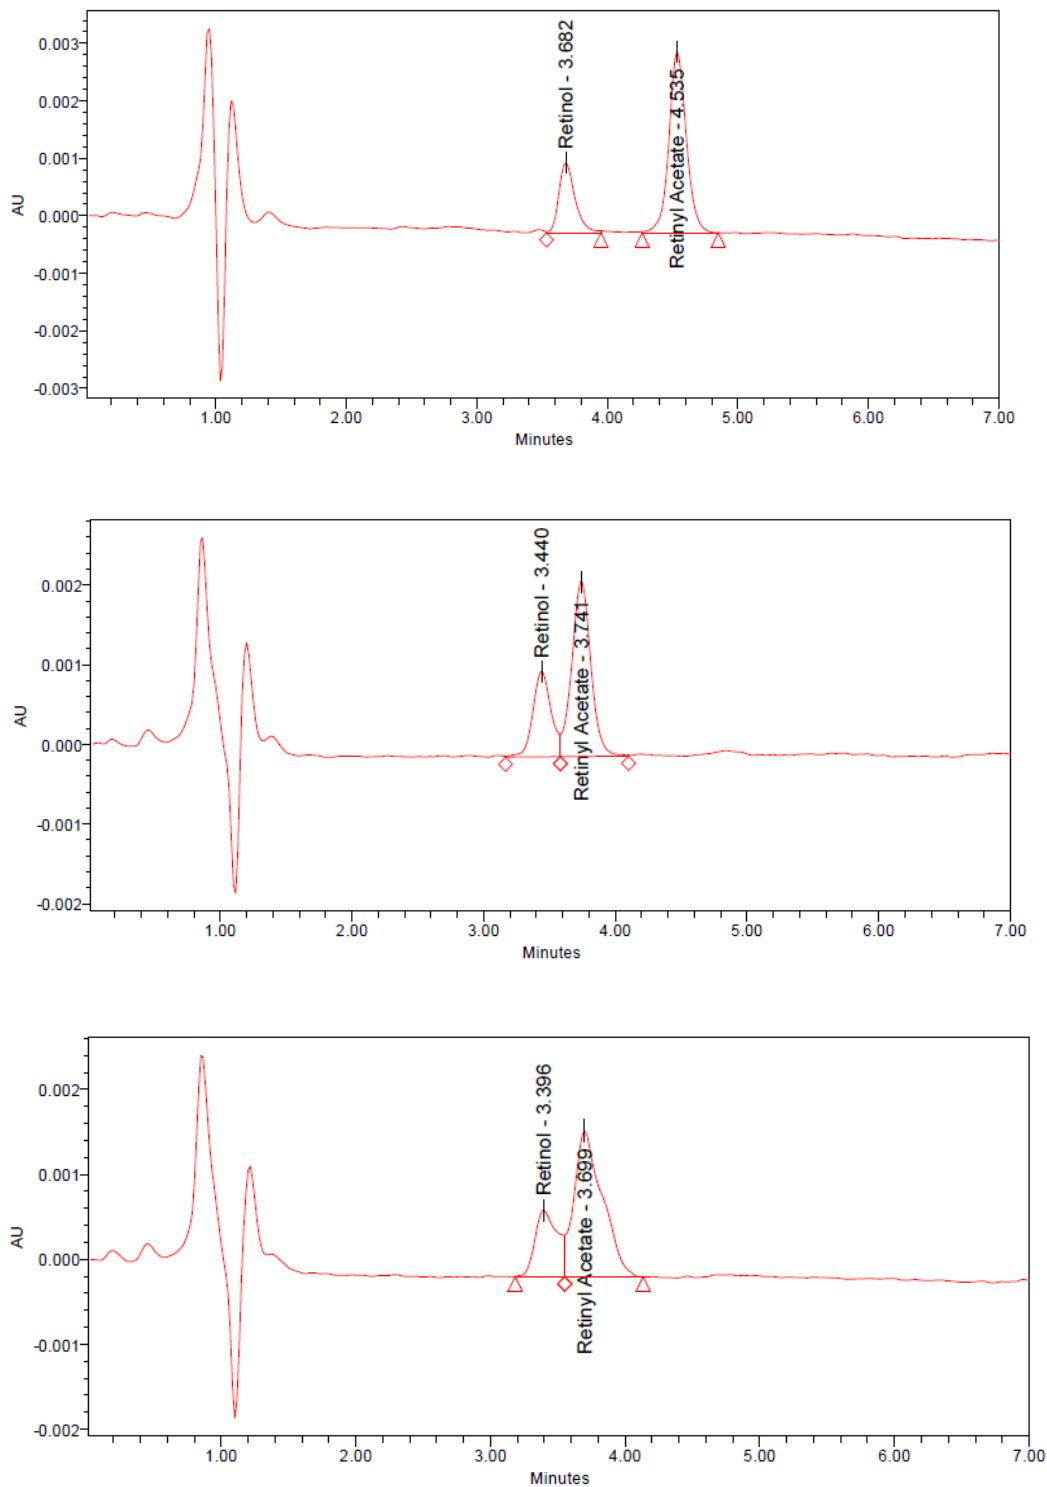
SUPPLEMENTAL FIGURE 2: Column replacement is suggested when peak separation or peak quality declines. Chromatograms on a C12 column for the same serum sample (~65 µg/dL) showing acceptable peak separation (top), declining peak separation (middle), and both poor peak quality and poor separation (bottom).
