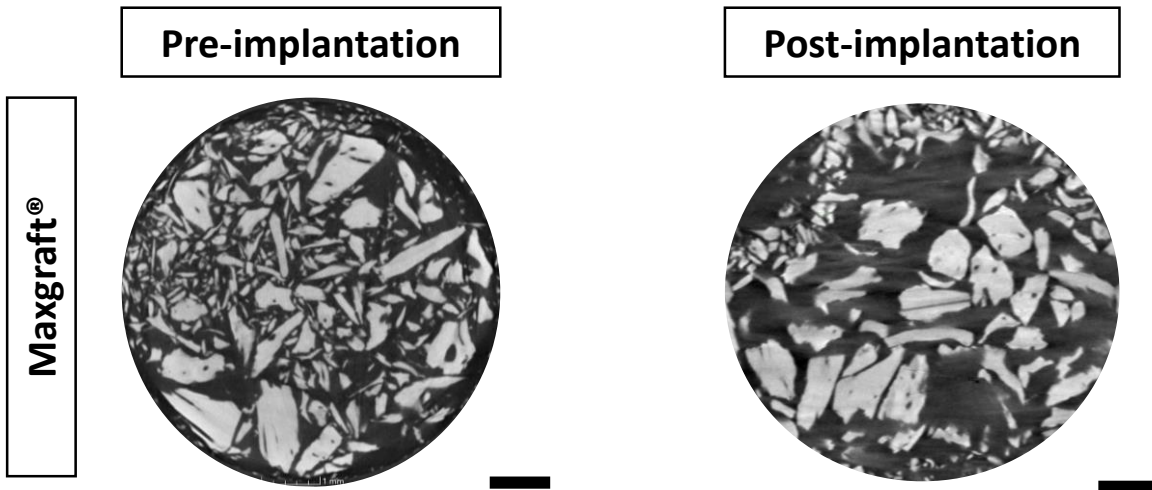
Figure S1: Implanted material Maxgraft®. Representative uCT picture of the Maxgraft® granules pre- and post- implantation. (scale bar = 1mm).
