Supplementary information, Fig. S1| CryoEM micrographs of EBV virion.

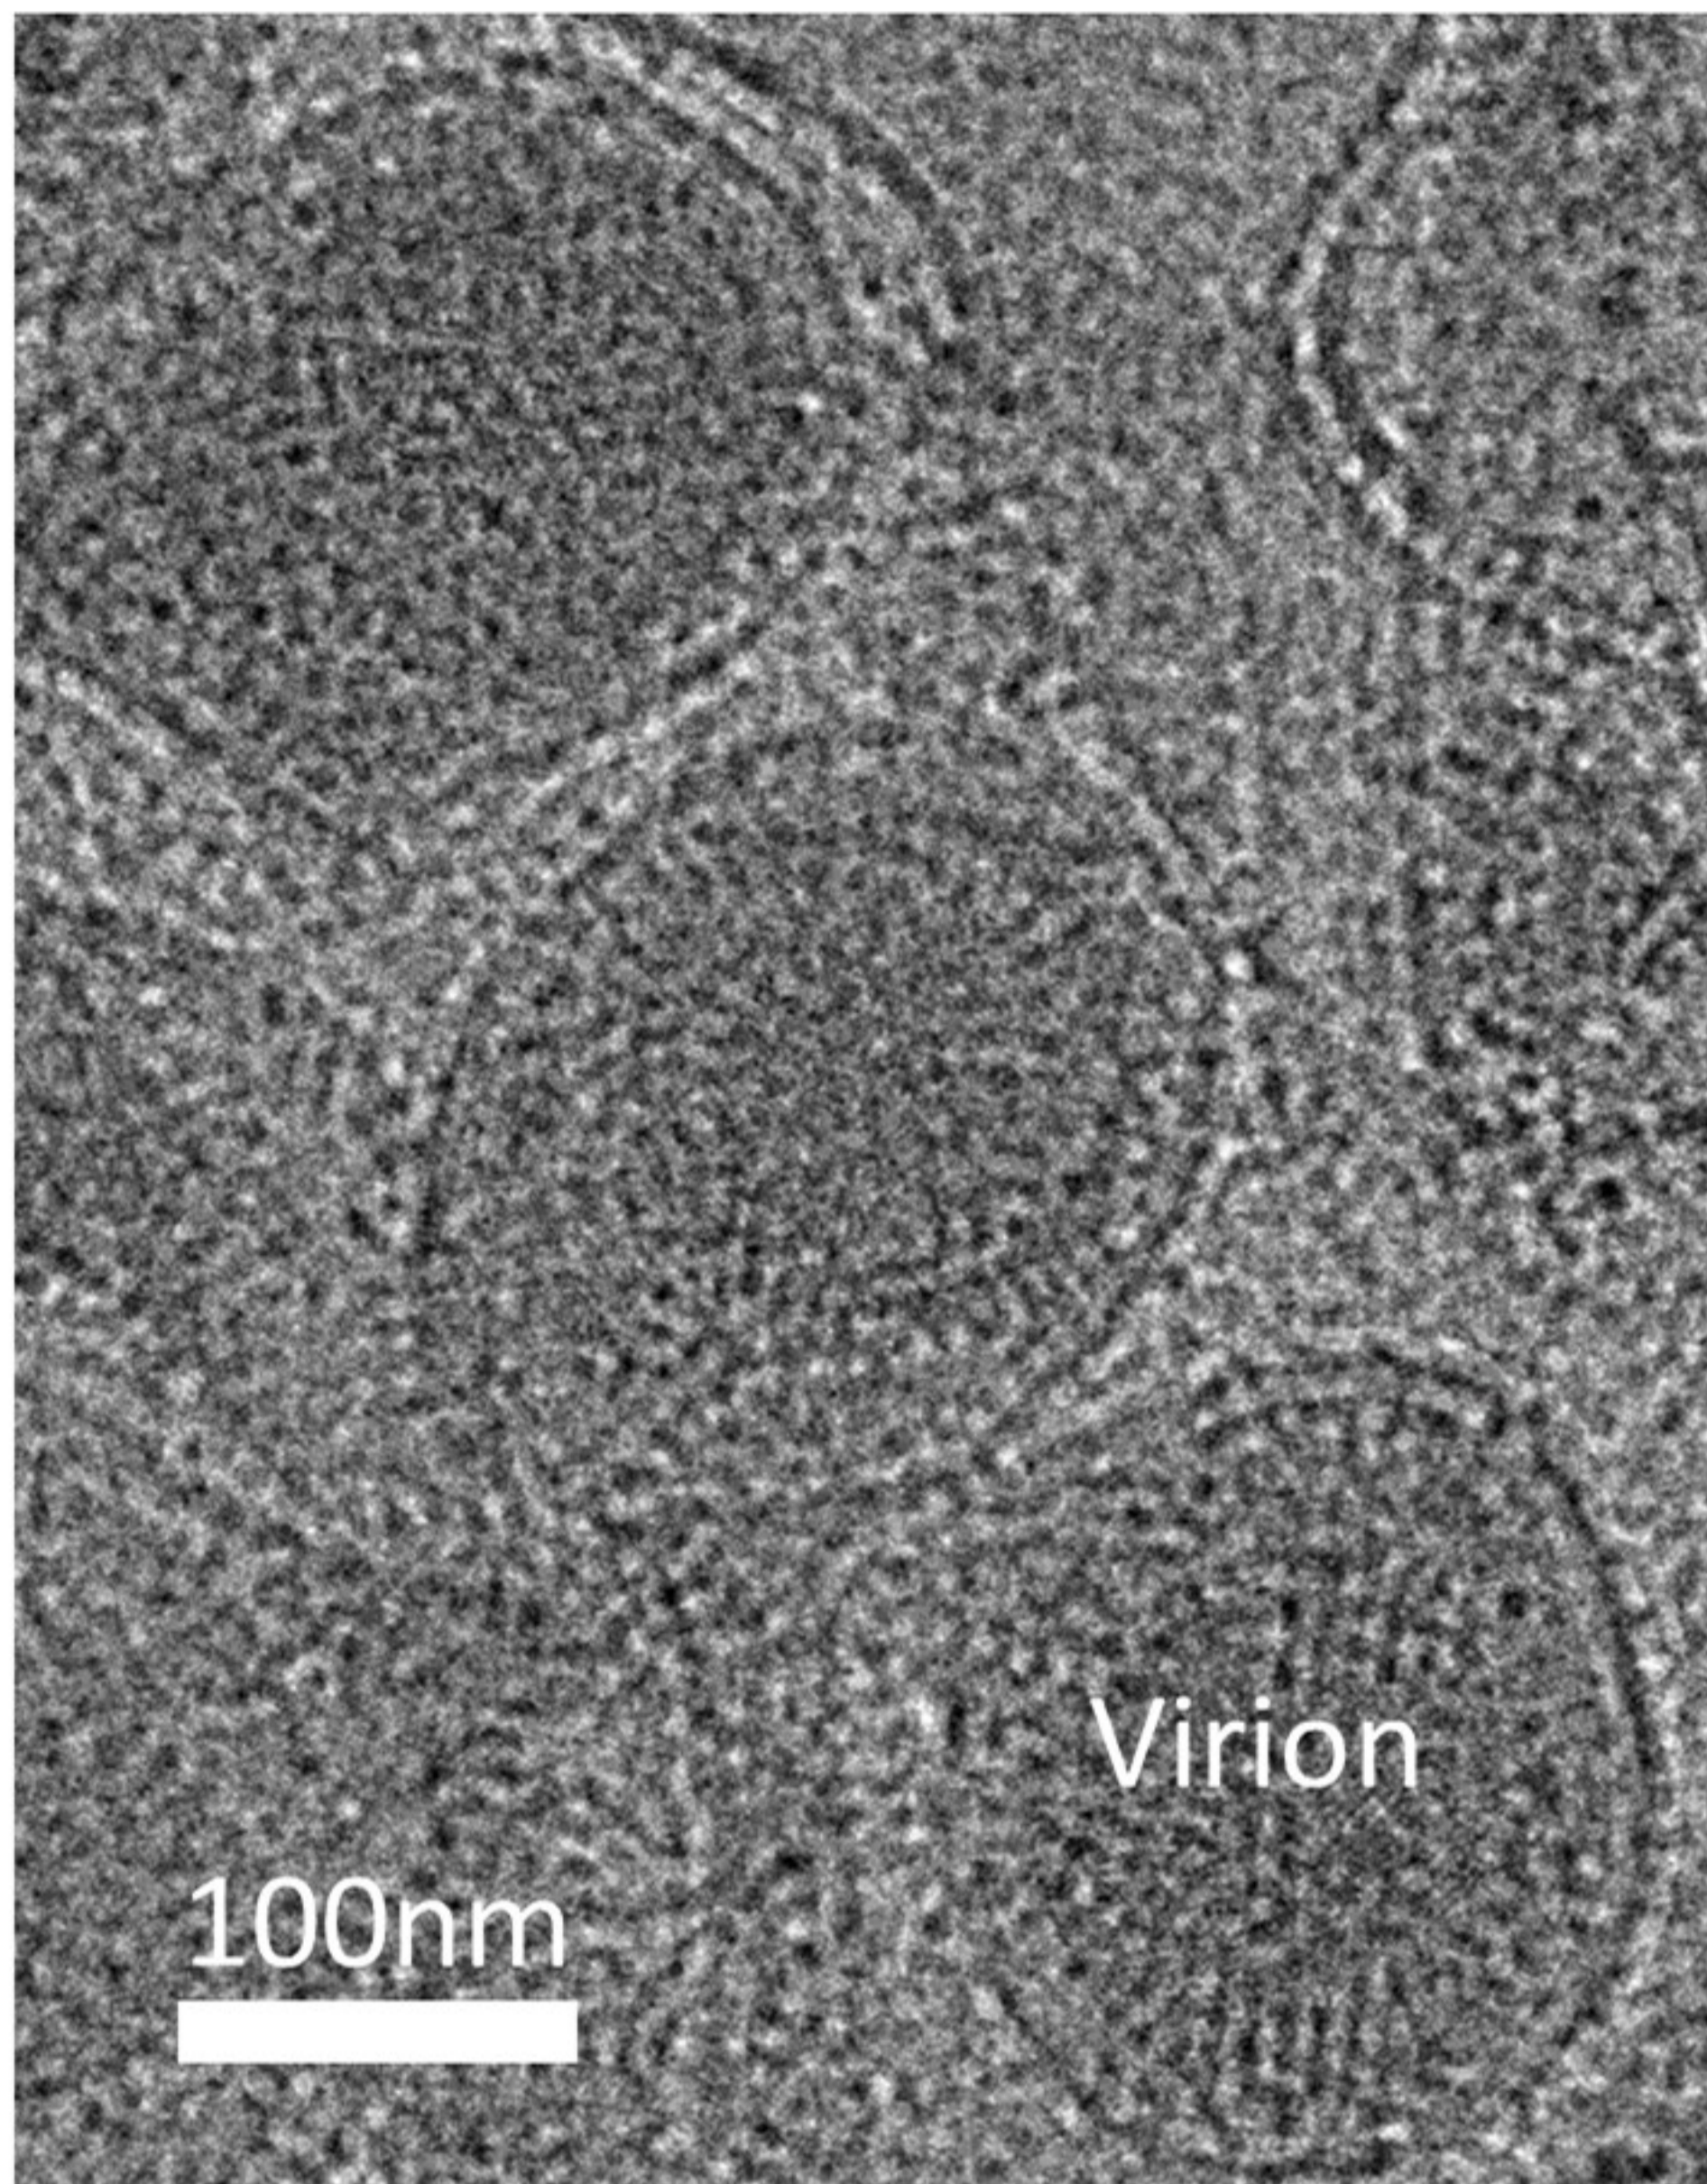
Before detergent treated

a A representative image recorded with a 200 kV Talos Arctica microscope, showing intact EBV virions before the detergent treatment.

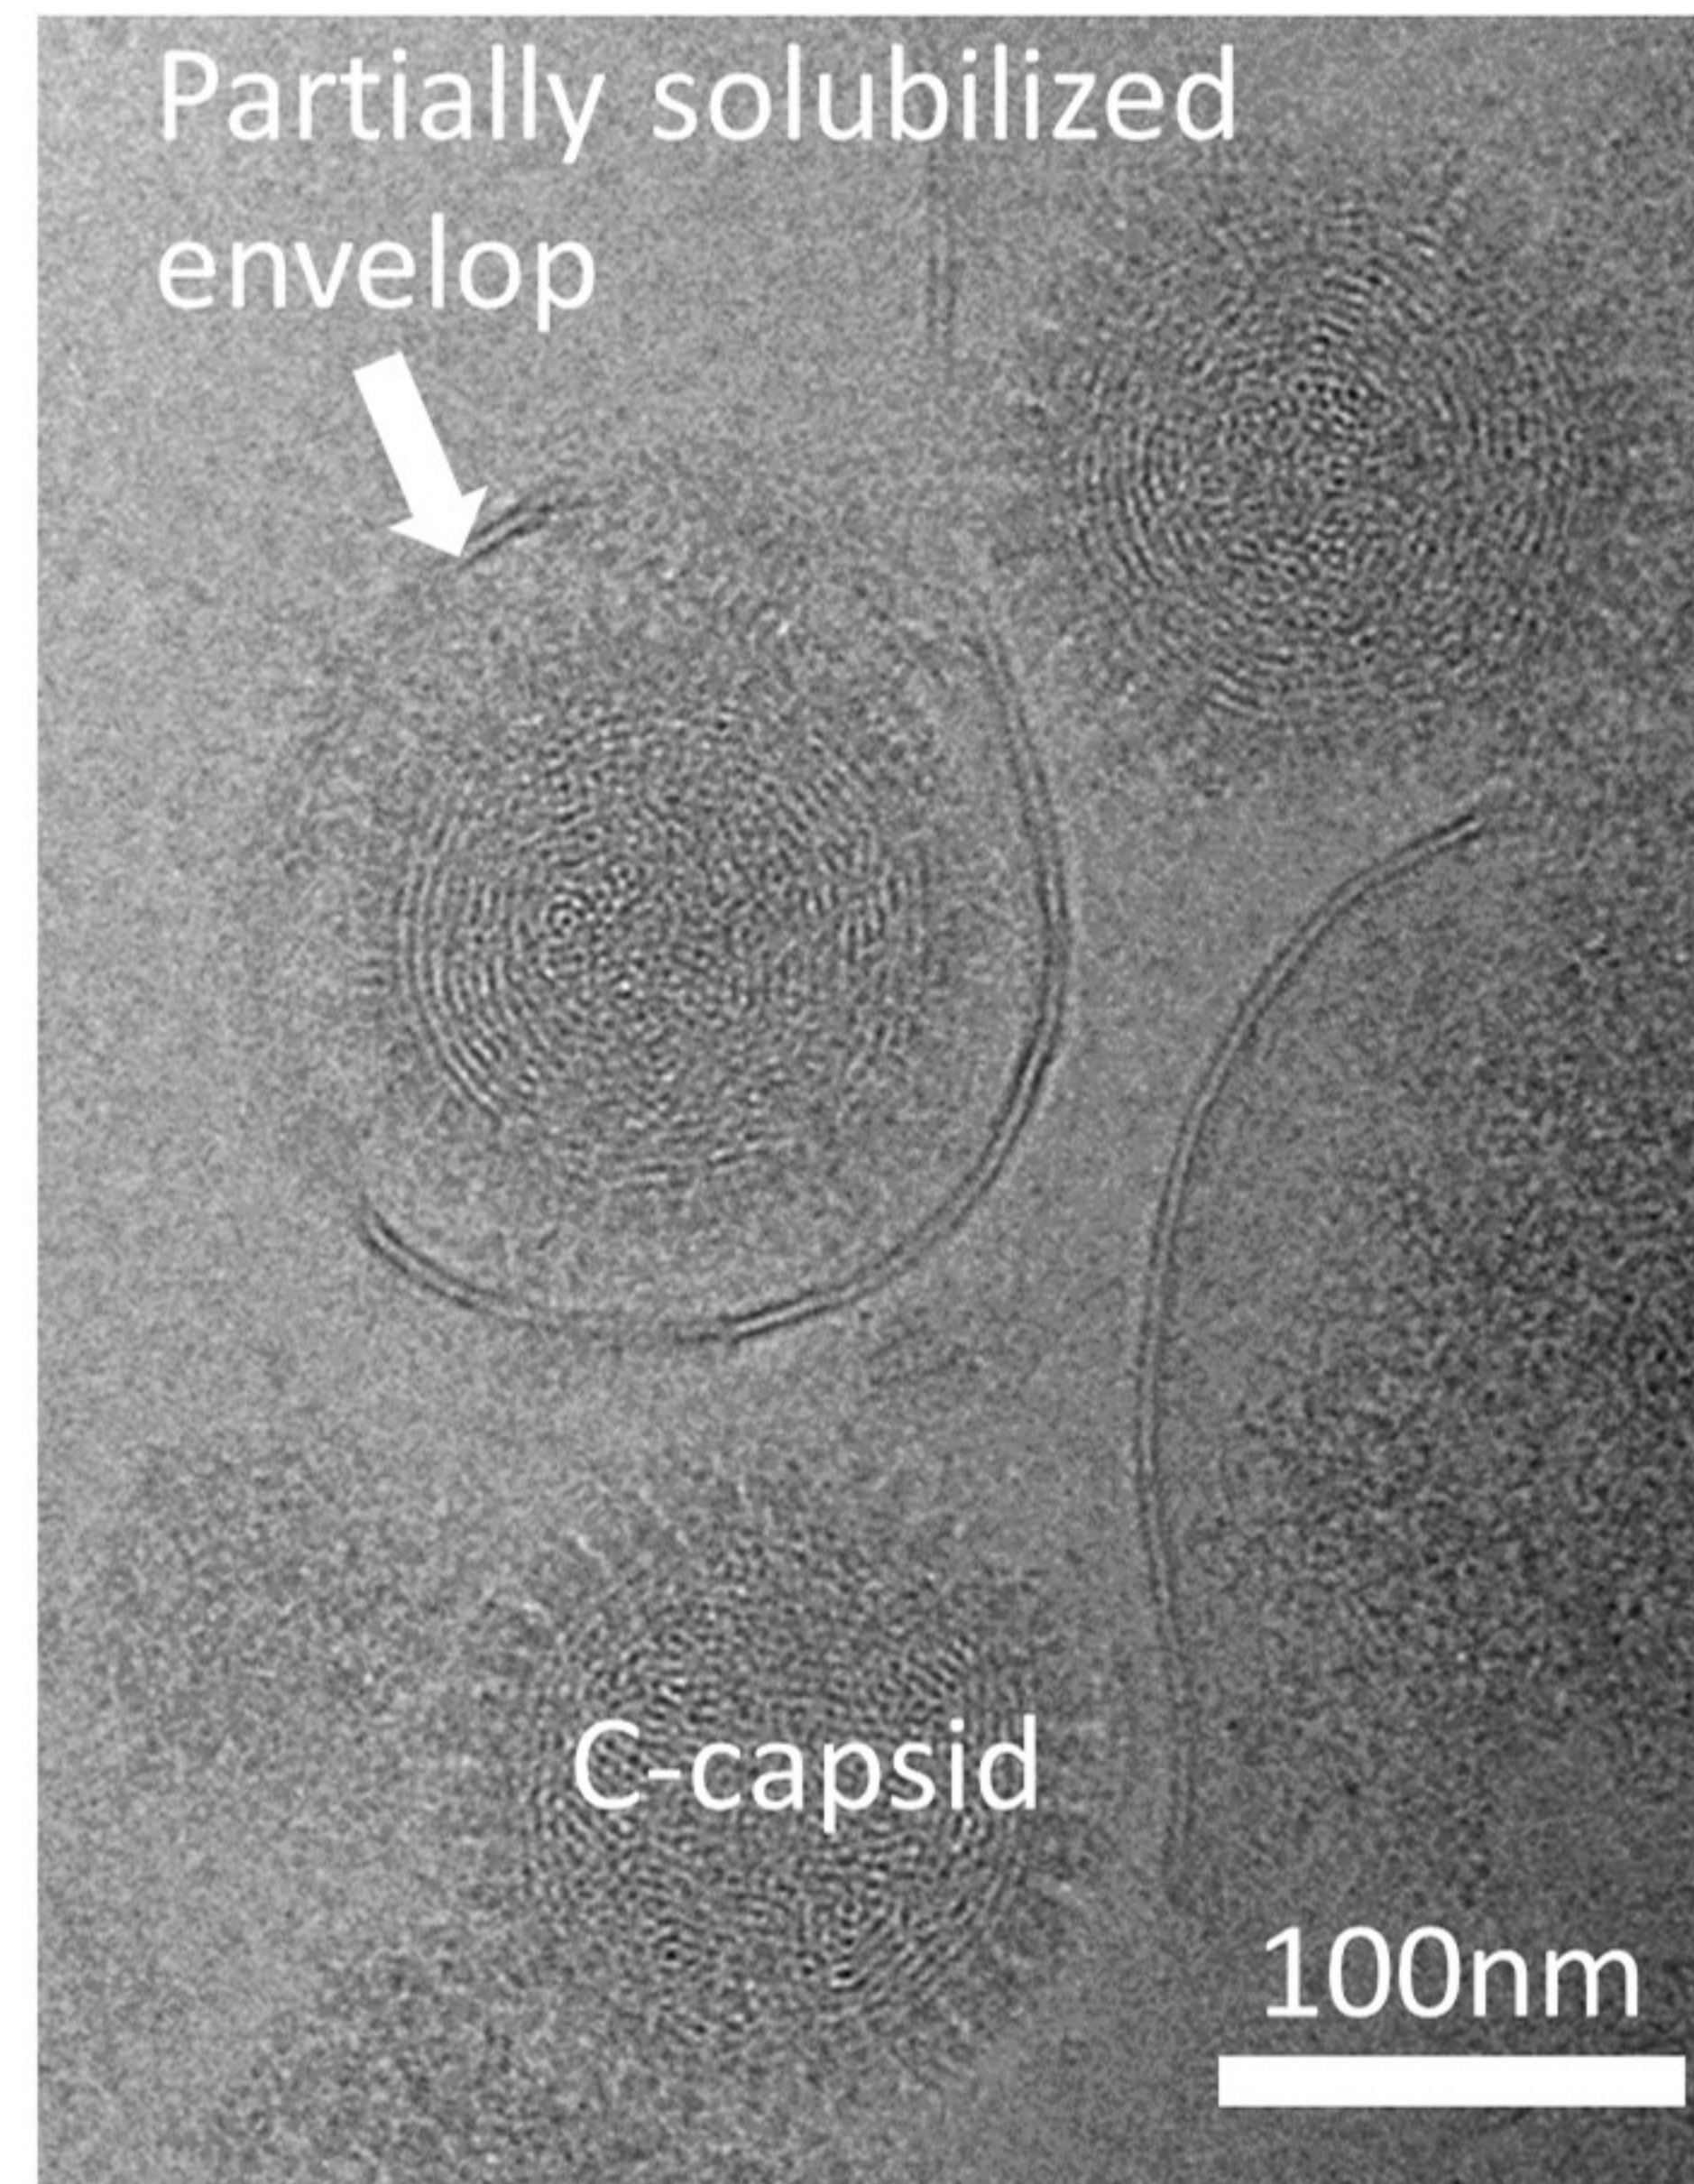
Treated with 0.8% Tween-100

b A representative image recorded with 300 kV Titan Krios microscope, showing that the viral envelopes were removed or partially solubilized by detergent treatment.
