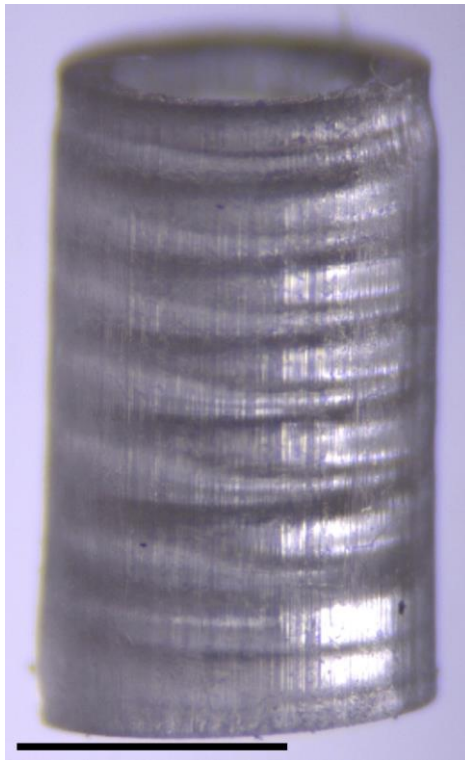
Figure S1. Optical microscopy image of a PCLMA tube produced via microstereolithography with non-optimal curing conditions. Lateral ridges can be seen due to overcuring of the material as a result of high laser power and the higher viscosity of room temperature resin. Scale bar: 1 mm.
