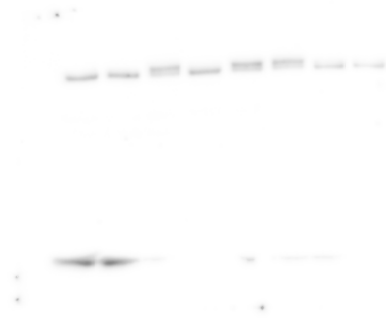
Replicate 3 – chemiluminescence image:

For this replicate, the actin loading control appears inconsistent due to a user error (gel overrun)
