Nondestructive Testing of the Miter Gates Using Various Measurement Methods

Mikolaj Binczyk [†] [ID]**, Przemyslaw Kalitowski** [†] [ID]**, Jakub Szulwic** [ID] **and Pawel Tysiac** *[ID]

Faculty of Civil and Environmental Engineering, Gdansk University of Technology, 80-233 Gdańsk, Poland;
mikbincz@pg.edu.pl (M.B.); przkalit@pg.edu.pl (P.K.); szulwic@pg.edu.pl (J.S.)
* Correspondence: pawel.tysiac@pg.edu.pl
† These authors contributed to the work equally and should be regarded as co-first authors.

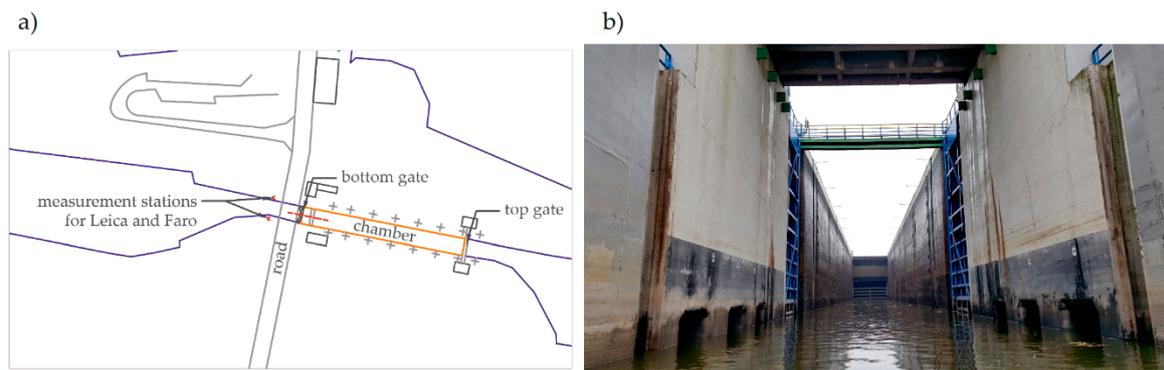
Figure 1. (**a**) Diagram of the lock in the Wloclawek river barrage; (**b**) View of the lock from the bottom side.

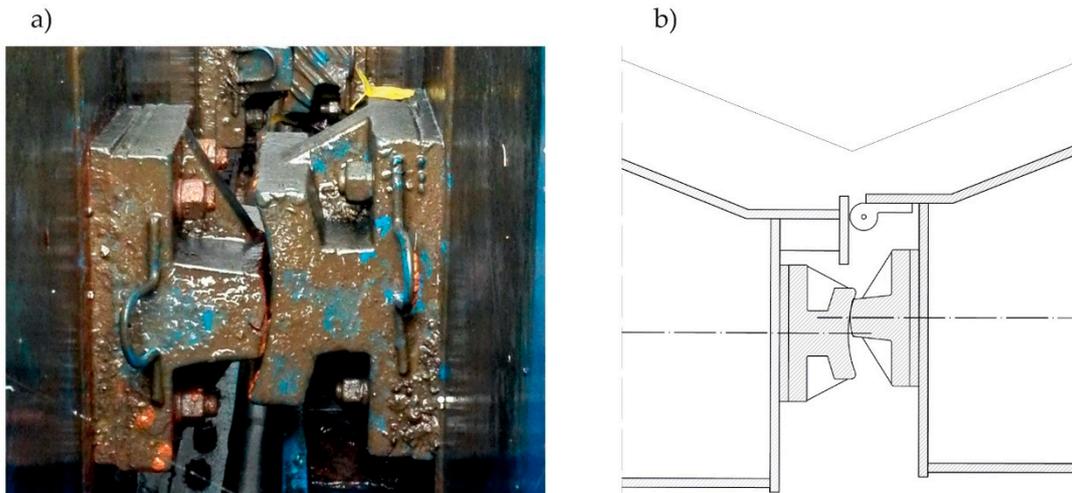
When totally emptied, the structure of the lock chamber underwent inspection based on visual examination, including photo records. The examination indicated misaligned miter bearings. Figure 3a shows a misaligned bearing that was observed. Figure 3b presents a scheme of this phenomenon.

Figure 3. Observed misalignment of miter bearings. (**a**) Real view; (**b**) Scheme of the top view.

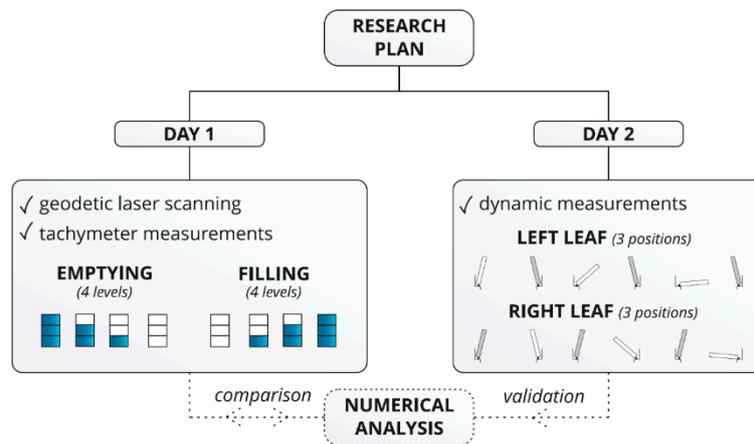
Figure 4. Diagram of tests regarding the lock in the Wloclawek river barrage.

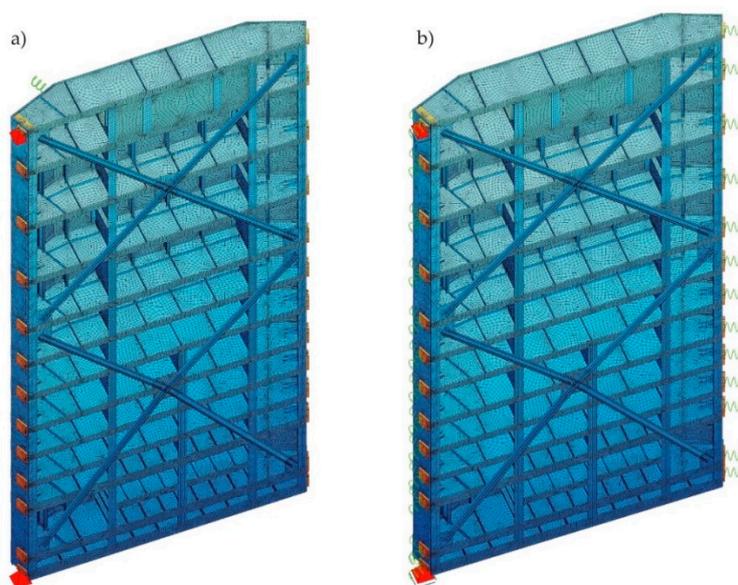
Figure 5. Visualization of the numerical models with different boundary conditions. (**a**) "Opened model"; (**b**) "Closed model".

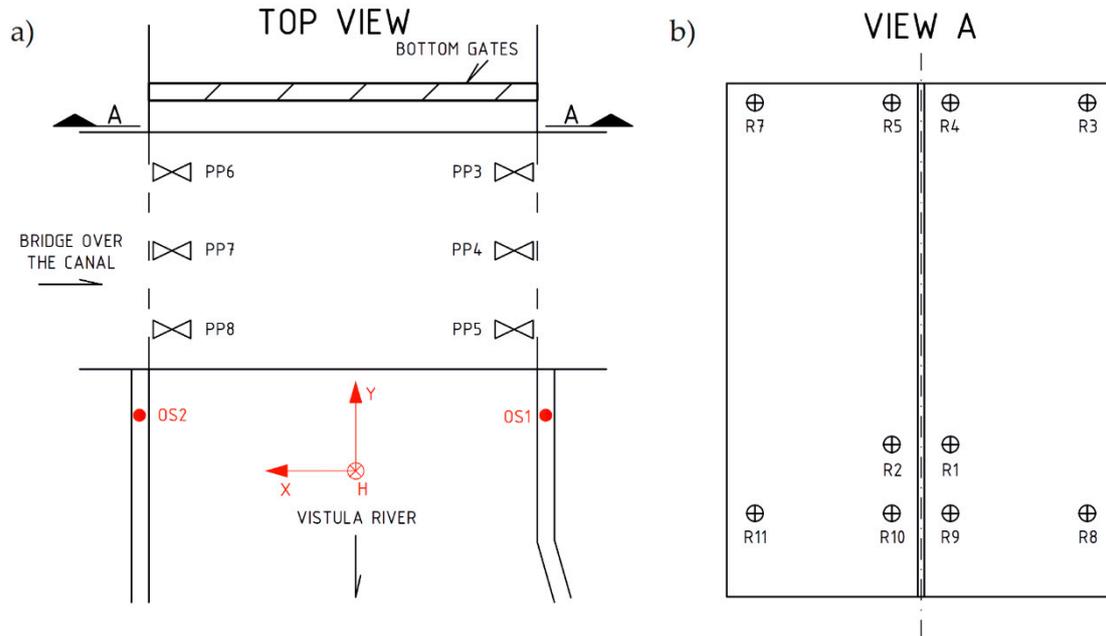
Surveying measurements were based on measurements performed with Leica TS30 (Leica Geosystems AG, Heerbrugg, Switzerland) (with a precise mode about 0.6 mm + 1 ppm / typ. 7 s) at data recording precision of 0.1 mm. Figure 6 specifies the locations of control points (from PP3 to PP8), measurement positions (OS1 and OS2), and measuring points (from R1 to R10).

Figure 6. Sketch regarding a location of gates displacement measuring points. (**a**) Sketch regarding the location of control points and measurement positions, top view; (**b**) View from bottom water.

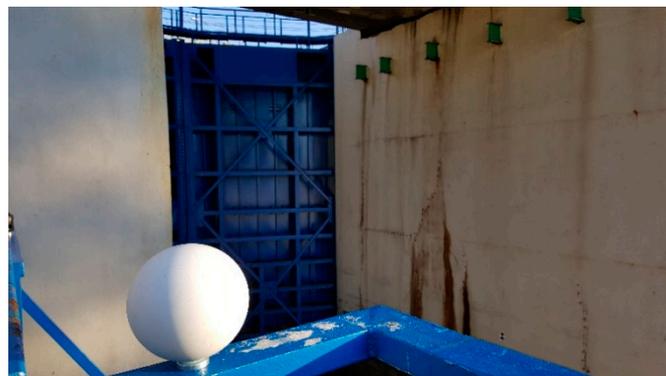
Figure 7. Representation of the surveying point during the tests.

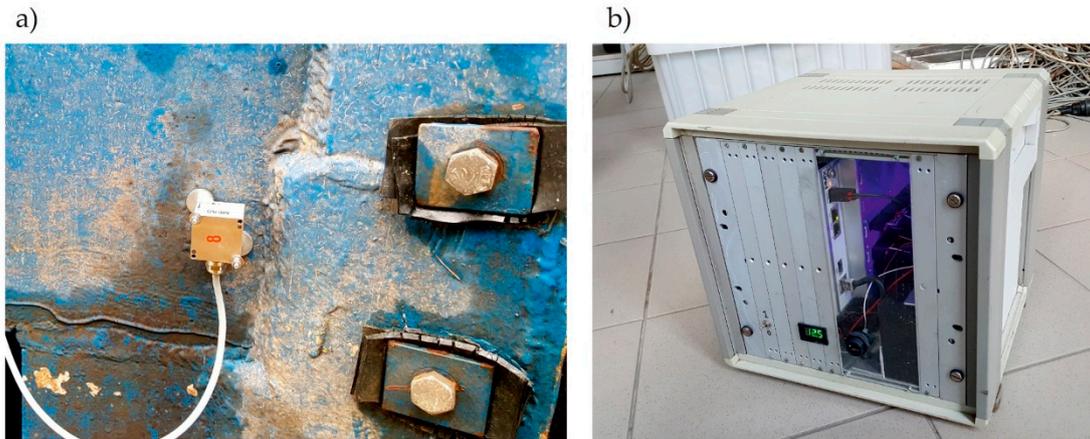
Figure 9. (**a**) Used tri-axis accelerometer TE 4332M3-002; (**b**) The individually improved HBM PMX Amplifier.

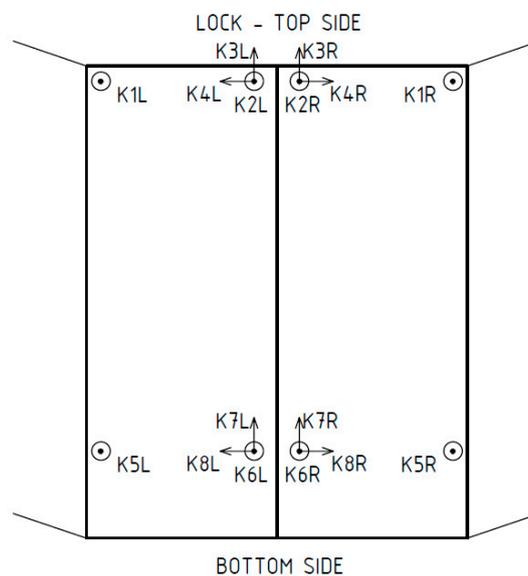
Figure 10. Location of the control points on the gates and the direction of the acceleration measurements.

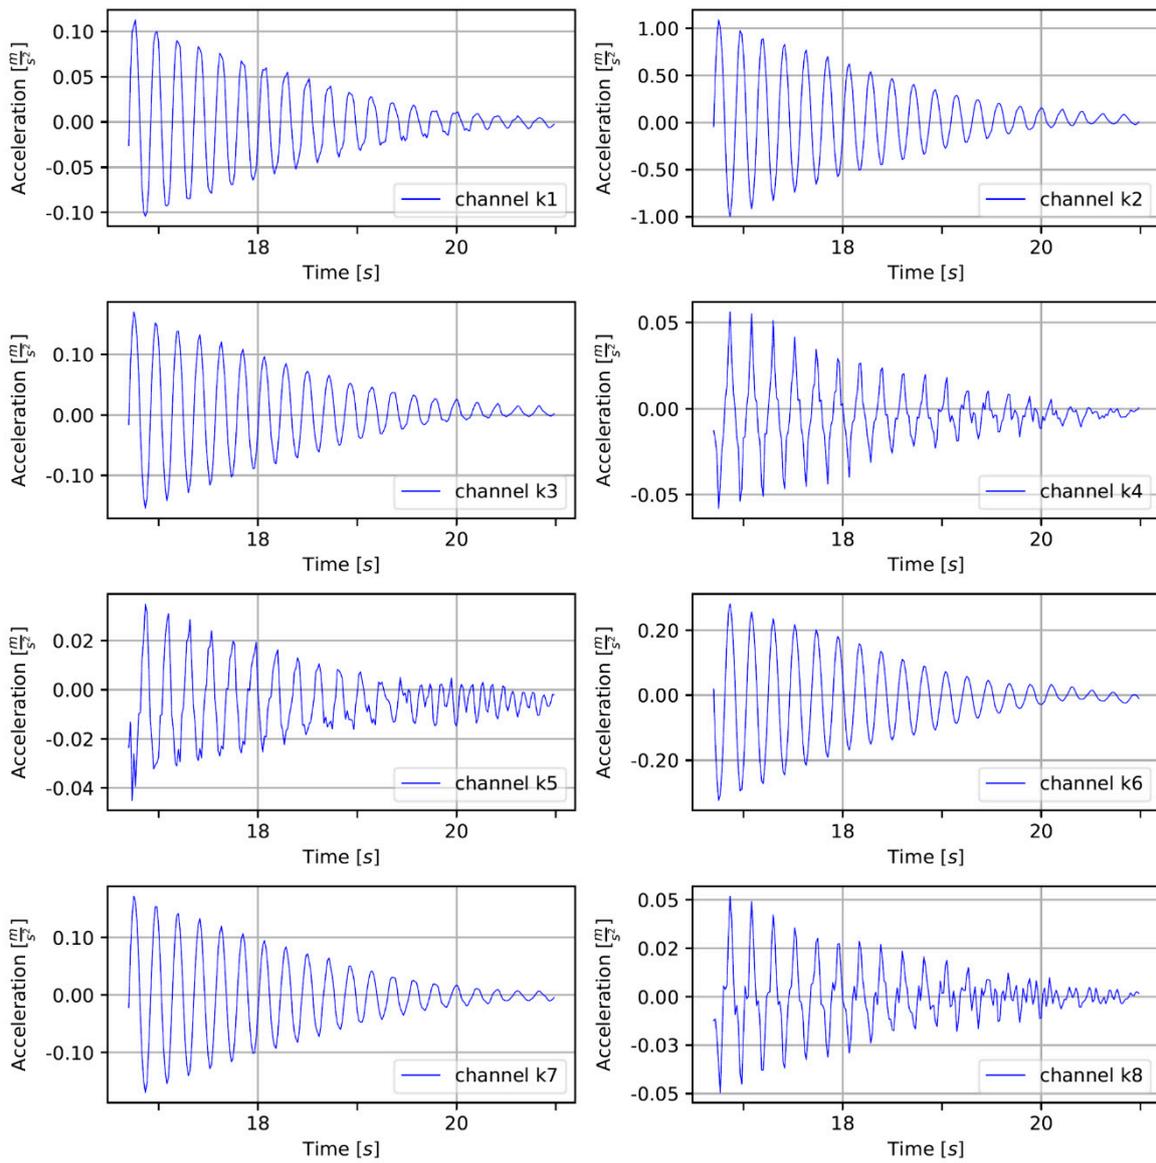
Figure 11. Acceleration measurements at points K1L to K8L during natural vibrations of the left gates' leaf.

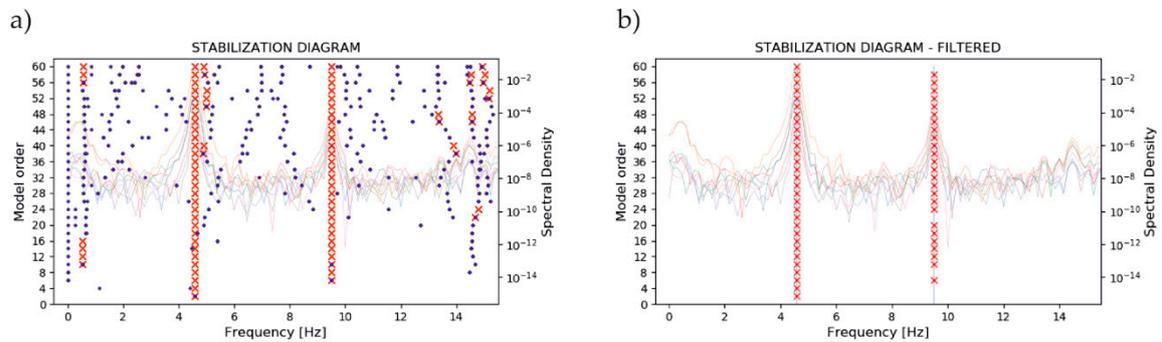
Figure 12. Stabilization diagram created for the gates' left leaf. (**a**) Classic version; (**b**) Filtered version.

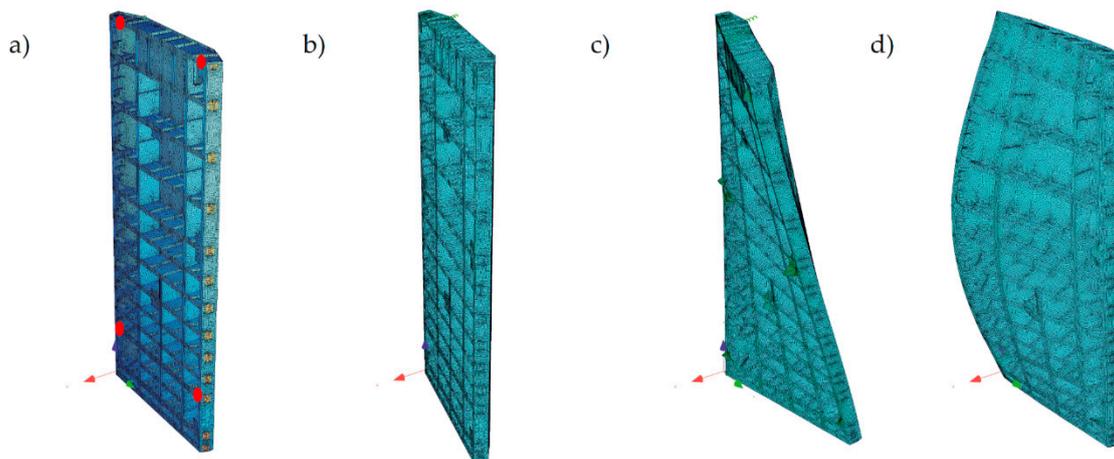
The "opened model" was used for the purpose of modal analysis. The model was validated by adding non-structural masses to the top deck and the miter bearings. First, three eigenfrequencies and eigenforms were determined (Figure 13) and both, identified in the tests and determined in the FEM analysis, were similar. The ratio between that identified in the test frequency and that from the FEM model was in the range of 99–102% for the second mode and in range of 98–101% for the third mode. Those which were identified in the field test eigenforms for the direction perpendicular to the gates' surface are presented in Figure 14. All eigenform coordinates were normalized. The linear connection between points was applied only for the visualization of mutual distances. For each leaf position and for each mod, the eigenforms were compared (Figure 15). All measuring points (K1 to K8) were included in the chart. Additionally, the normalized displacements of nodes were read from the numerical model for the second and the third mod. Appropriate nodes were chosen according to the location of measuring channels K1, K2, K5, and K6. The obtained frequencies and eigenforms for each mod were similar. Differences in frequencies and eigenforms, dependent on position, indicate that there were factors that slightly influence modal parameters. We discuss this phenomenon later. Although, from the aggregation of forms, it can be concluded that in all of the selected positions, the structure works in the same manner. Also, the displacements identified in channels related directly to potential bearings' movement (K4 and K8) did not reveal any disturbing values. The above results indicate that the assumed stiffness and elements' mass were established properly. The numerical model represents the real structure with a sufficient degree of precision. Therefore, there is the possibility of a comparison of calculated and measured at real structure displacements.

Figure 13. Frequency and eigenforms of the gates' leaf according to the "opened model". (**a**) Original geometry; (**b**) First eigenform, f = 0.51 Hz; (**c**) Second eigenform, f = 4.62 Hz; (**d**) Third eigenform, f = 9.46 Hz.

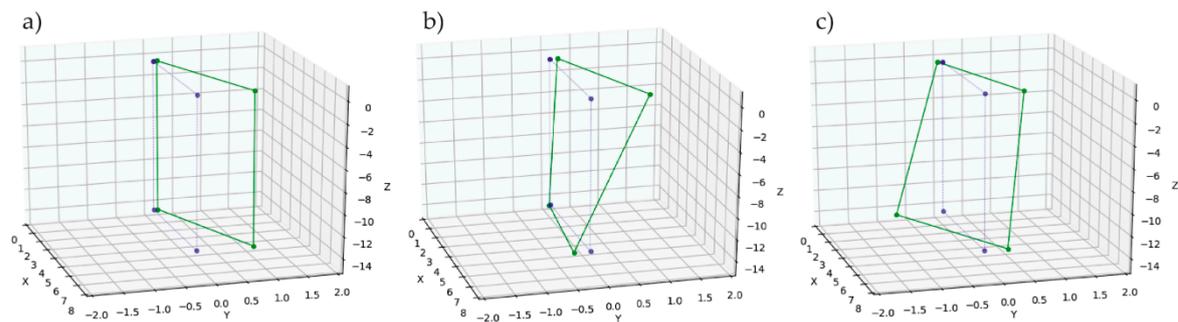
Figure 14. Identified in the eigensystem realization algorithm (ERA) eigenforms. (**a**) 1st; (**b**) 2nd; (**c**) 3rd. Blue points indicate the original positions of sensors. Green marked points displaced according to identified eigenform shape.

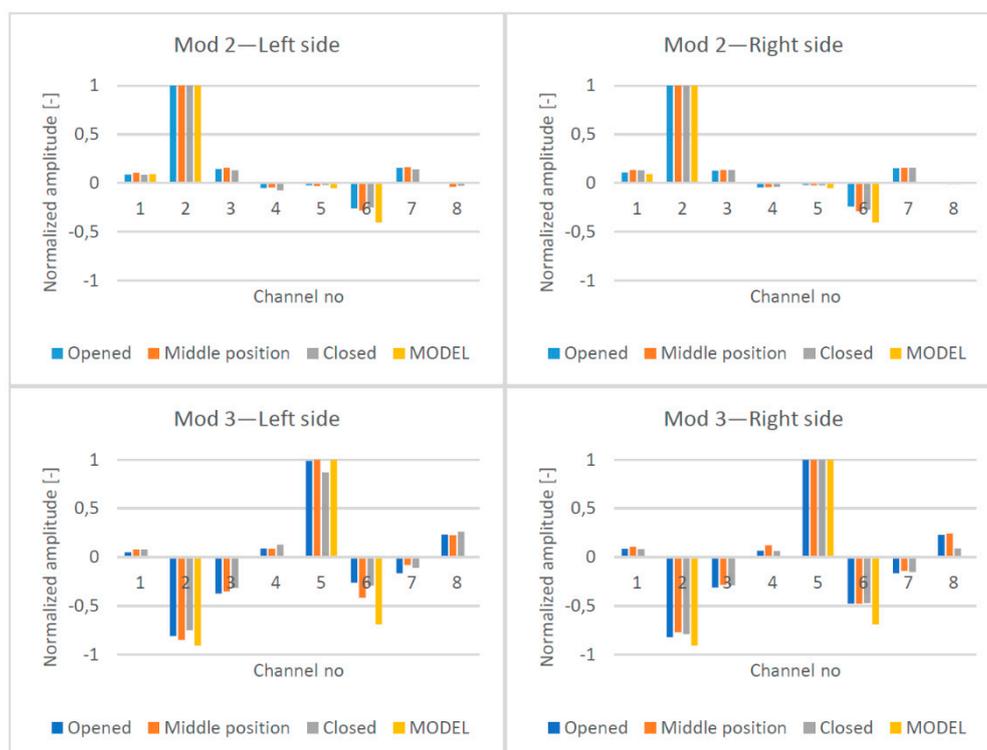
Figure 15. Comparison of the normalized eigenforms identified in three different positions of the gate's leaves for the two identified mods. Yellow bars represent corresponding results from the numerical model.

Dynamic measurements in different positions of the gates' leaves do not indicate any relevant displacements of the support bearings. A small difference between the identified, normalized modal displacements can be a consequence of adherence of the gasket to concrete elements. Differences occur, especially in the case of point K6, which is located near the bottom part of the gates, where the gasket is mounted. In addition to this, eigenfrequencies and eigenforms confirm matching between real structure and the numerical model.

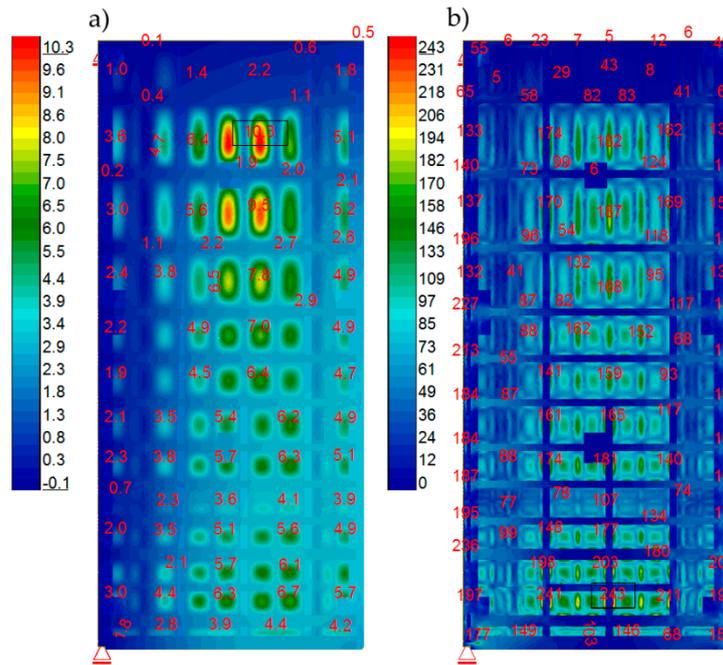
Figure 16. Calculation results regarding load A. (**a**) Displacements [mm] at water thrust direction; (**b**) Maximum von Mises stresses [MPa].

During lock filling and emptying, the gates' operation followed under stress and the numerical analysis did not indicate any excessive stress.

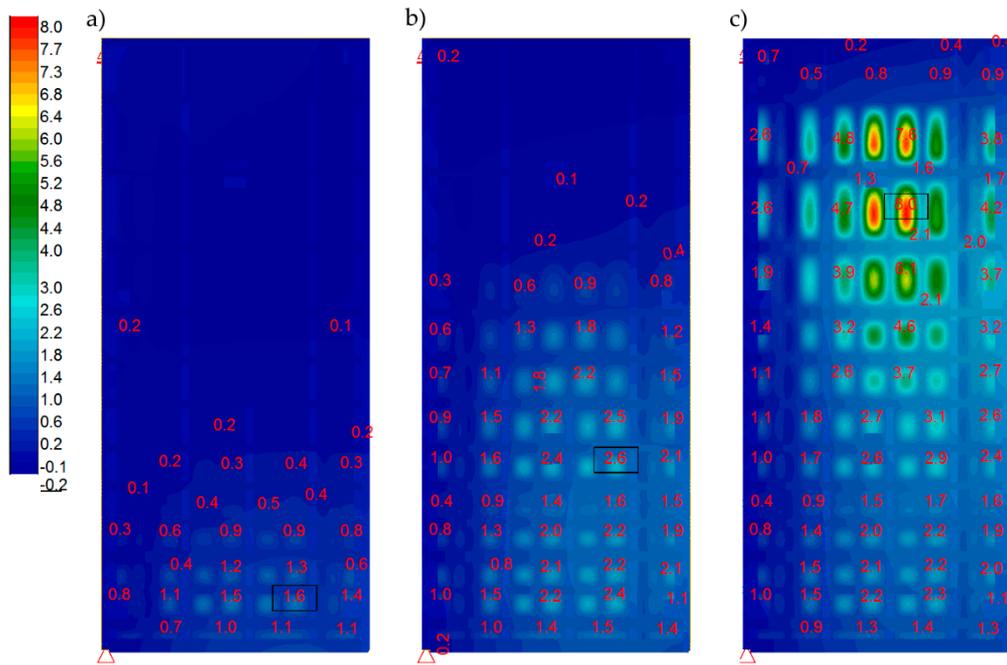
Figure 17. Calculated displacements [mm] at water thrust direction for respective loads. (**a**) B1; (**b**) B2; (**c**) B3.

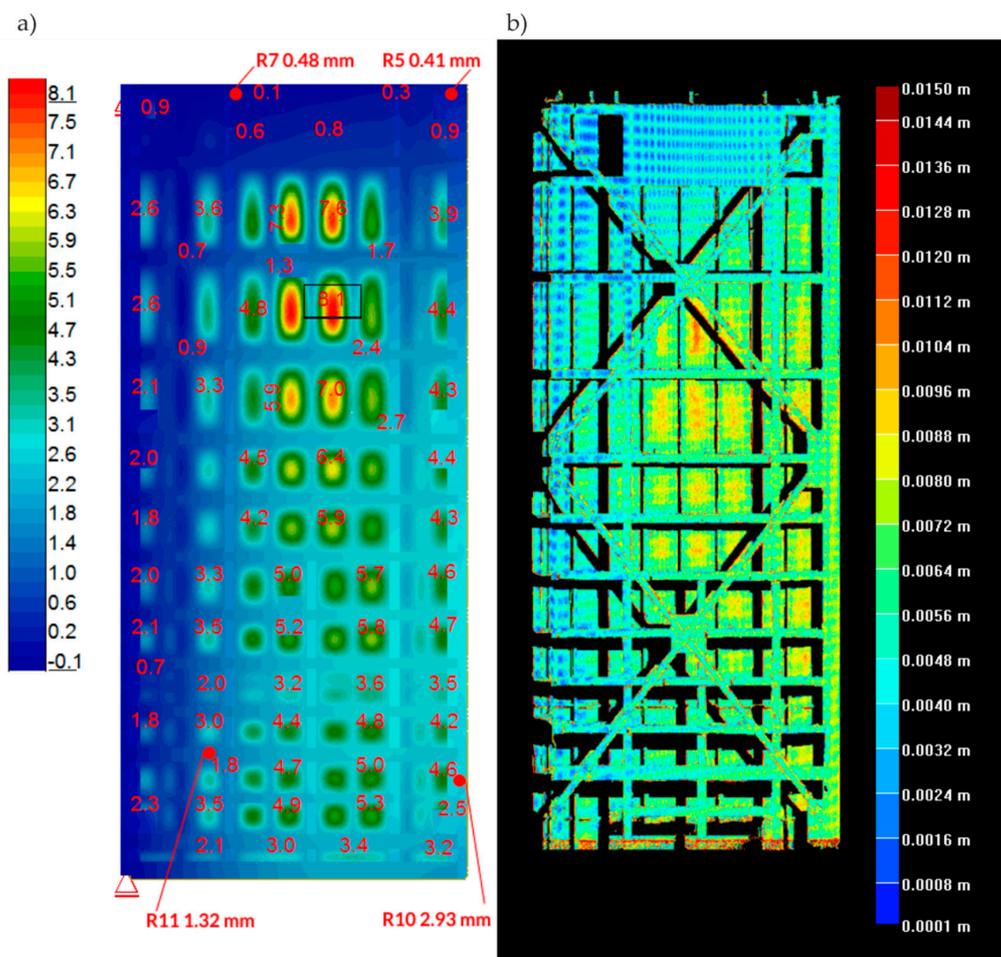
Figure 18. Comparative analysis regarding displacements at Y direction from. (**a**) Numerical model (mm); and (**b**) Laser scanning (m), top water increases from the 1/3 to the 3/3 level.

The comparative analysis was performed regarding measurements and calculations of structure displacement resulted from water level change from 1/3 to 3/3. Horizontal displacements, at a direction parallel to the gates' surface obtained based on the numerical model and the measurements with the tachymeter, were similar. Insignificant variance resulting from gates additional displacements resulted from pressure and gasket deformation at the initial phase during lock filling, which is a natural effect. Thanks to the miter gasket's deformation the sealing of gates was provided. The numerical model did not include this phenomenon; only points close to the miter axis indicate an anomaly. Displacements measured with tachymeter in points R5 and R4 (miter top corner) are significantly different than those obtained with the numerical model. However, the remaining results indicate that structure operation was consistent with the numerical model (design input). Therefore, we could exclude any significant damage to the main structural elements.

The displacements indicated by laser scanning were bigger than the results obtained using two other methods. The work provided an example regarding measurement accuracy difference during the elaboration of differential maps [58]. Additionally, water level changed slightly in the lock during laser scanning that featured a measurement period significantly longer (about seven min) than the one with the tachymeter.

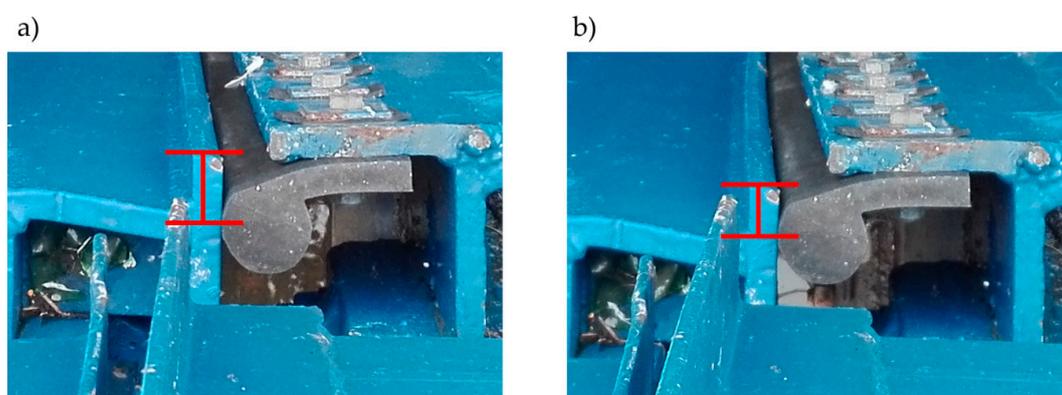
In summary, the visual examination and analysis regarding surveying measurements, vibration measurements, and laser scanning indicate that miter gates work properly, although all of the field tests were conducted without the occurrence of sudden movement. Thus, we concluded that only in the case of normal conditions does the operation of the gates work properly. All of the comprehensive measurements allow researchers to conclude that the rotating bearings work without redundant lose, and if sudden movement does not occur, the miter gates are characterized by elastic behavior. The differences between the measured and calculated displacements in the R5 and R4 points could indicate that boundary conditions close to these points can vary in structure and in the numerical model. During the visual examination, misaligned positions of the miter bearings were noticed. Unfortunately, no sudden movement was observed during the measurements. However, photographic documentation was taken before and after the example of sudden movement. Figure 19 shows the mutual position of the left and the right leaves after and before a sudden movement. The difference in the position of the leaves is marked with a red line. During a sudden movement of the miter gates, the miter bearings shifted. In [59] a similar problem was presented, which occurred in the case of the Red River Lock and Dam no 1. In [1], the authors also paid attention to the importance of adherence of the bearings for the appropriate distribution of loads. In our case, there is a possibility that the miter gates before filling are closed with misaligned miter bearings. It is hypothesized that, subsequently, the water level increases against the gates, and at some point, the pressure causes the leaves' self-adjustment. The gates final closing follows suddenly and results in a significant horizontal force transfer onto other adjacent structural elements, consequently, increasing vibrations.

Figure 19. The shift between the gate's leaves. (**a**) Position after sudden movement; (**b**) Position before sudden movement.
