Case Report

Experimental Analysis of a Failed Gamma Nail: A Case Report and Literature Review

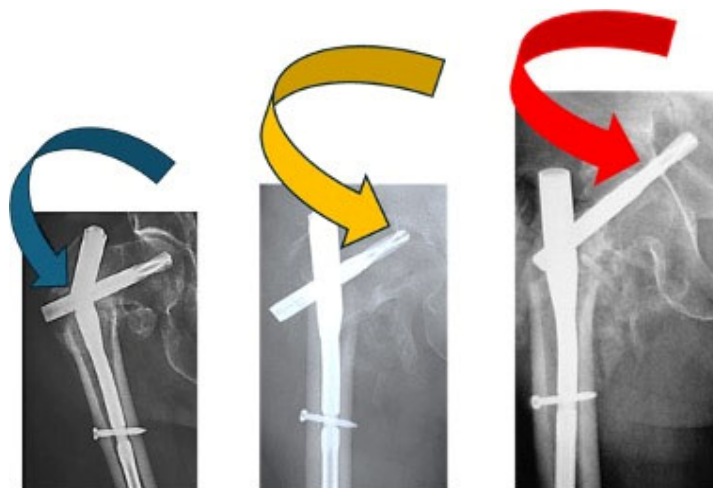
Figure 1. Different failure situations found for proximal femoral nail failure used in intertrochanteric fractures: main nail breakage (blue arrow), helical blade cutout (yellow arrow), and helical blade perforation (red arrow). Adapted from [36].
