Performance of a Ship-Based Cupronickel Alloy in Exposure Conditions of Arabian Seawater—A Comparative Study

Abstract: Cupronickel-based alloys are widely known for their excellent resistance against aqueous corrosion, however, they can be susceptible to corrosion at accelerated rates and premature failure when exposed to a polluted or brackish seawater medium, even for short-term exposure durations. This unfamiliar corrosion behavior may be a result of the formation of an unprotected corrosion film during the early exposure durations. The paper investigates the corrosion phenomenon in cupronickel 90/10 alloy, by exposing the coupons in two different seawater compositions in the Arabian Sea region. Corrosion losses were investigated on the experimental coupons in a submerged position, for a maximum exposure duration of 150 days, using the conventional weight loss method and a new dimensional metrology-based measurement technique. Additionally, in this research the tubes of a marine heat exchanger having similar material that failed prematurely during operation in the Arabian Sea were also investigated for corrosion losses, followed by the characterization of the corrosion deposits

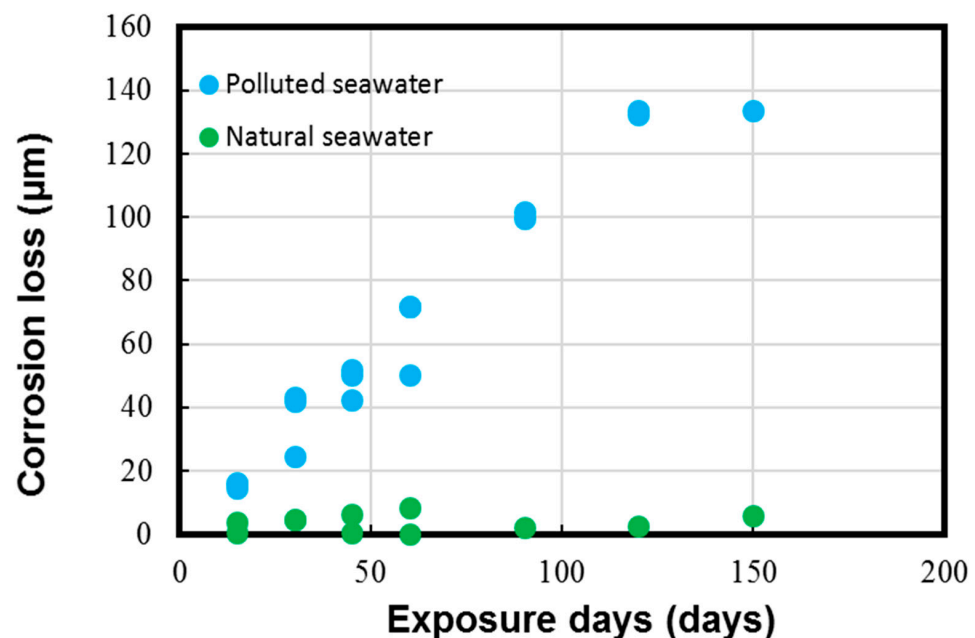
Figure 5. Corrosion loss parameter measured for Cu-Ni 90/10 alloy coupons. Reprinted with permission from [40].

The results in Figures 5 and 6 depict the corrosion rate parameter (ranging from 300 to 550 $\mu\text{m}/\text{y}$), which is significantly higher in the polluted seawater site and is rich in DINs and other influential corrosion factors, such as low pH levels and low DO content (as shown in Table 2). Likewise, the corrosion losses noted in the natural seawater site were quite nominal (ranging from 10 to 60 $\mu\text{m}/\text{y}$). These measured parameters in the natural

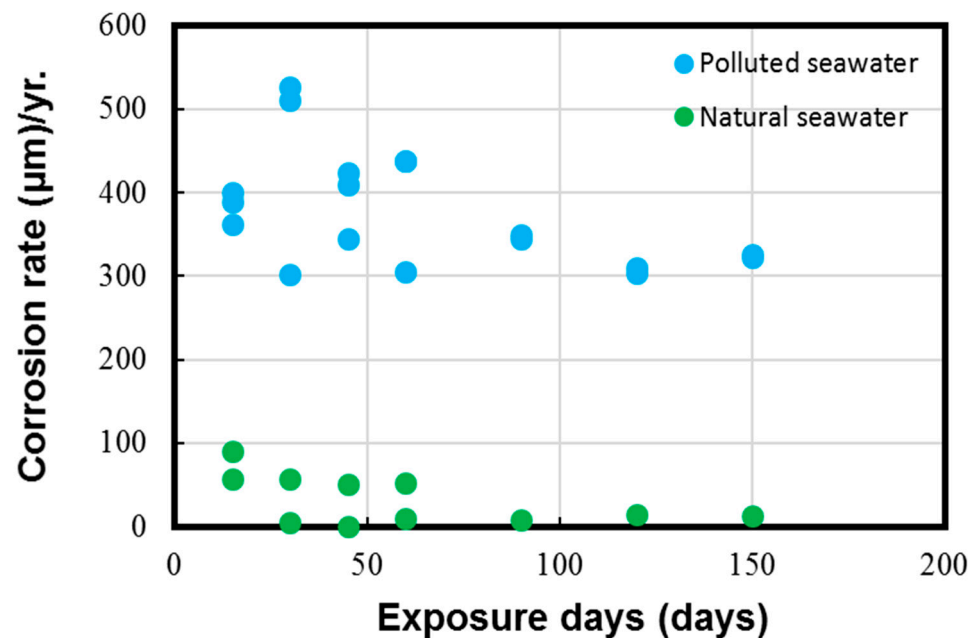
seawater were found to be similar to those previously reported in similar seawater sites, as reported in Figure 1 in Phull et al. [24], as well in other reviewed literature [8,13,41]. On the other hand, the corrosion losses in the polluted seawater site were extremely high and comparable to those reported previously in similar seawater compositions predominantly rich in pollutants [1,7,8,24].

Figure 6. Corrosion rate parameter measured for Cu-Ni 90/10 alloy coupons. Reprinted with permission from [40].

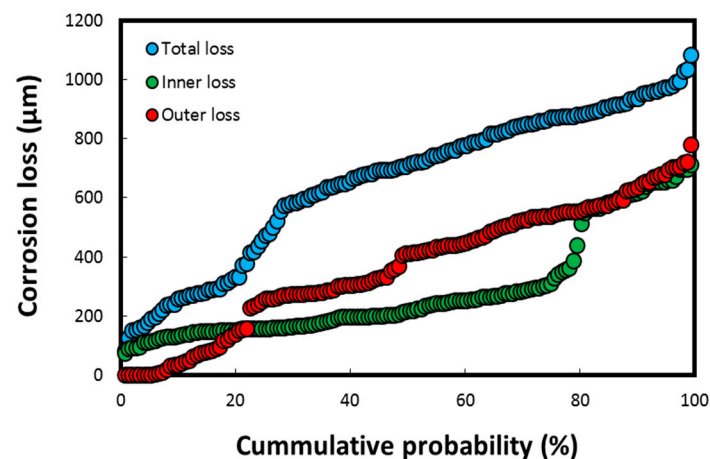
Figure 7. Cumulative probability (%) parameter for corrosion loss on heat exchanger tubes calculated using DM-image analyzer technique, both on seawater side (inside tube) and gas side (outside tube) of heat exchanger. Reprinted with permission from [40].

The thickness losses in Figure 7 were observed mostly on the tubes exposed to the polluted harbor seawater, which subsequently led to the perforation/failure of five tubes (total tube thickness of 1.2 mm). These values are significantly higher for a corrosion-resistant material such as Cu-Ni 90/10, in which the mean corrosion loss is reported

to be well below $50 \mu\text{m}/\text{y}$ (the typical range in clean natural seawater is $2\text{--}12 \mu\text{m}/\text{y}$ at a flow velocity below 3 m/s) in natural seawater exposure conditions [4,8,24,42]. The cumulative corrosion depth data indicated in Figure 7 corresponds to the pitting data resulted in the loss of integrity of the heat exchanger tubes. Hence, these results imply that the overall corrosion rate on the seawater side of the tubes is approximately $100 \mu\text{m}/\text{y}$, which is again considerably higher for a corrosion-resistant material such as Cu-Ni 90/10 exposed to a natural seawater environment. However, it is not unusual in a harbor seawater environment flooded with untreated waste water and pollutants from multiple sources, including heavily polluted sewage effluents [7,8,15,24].

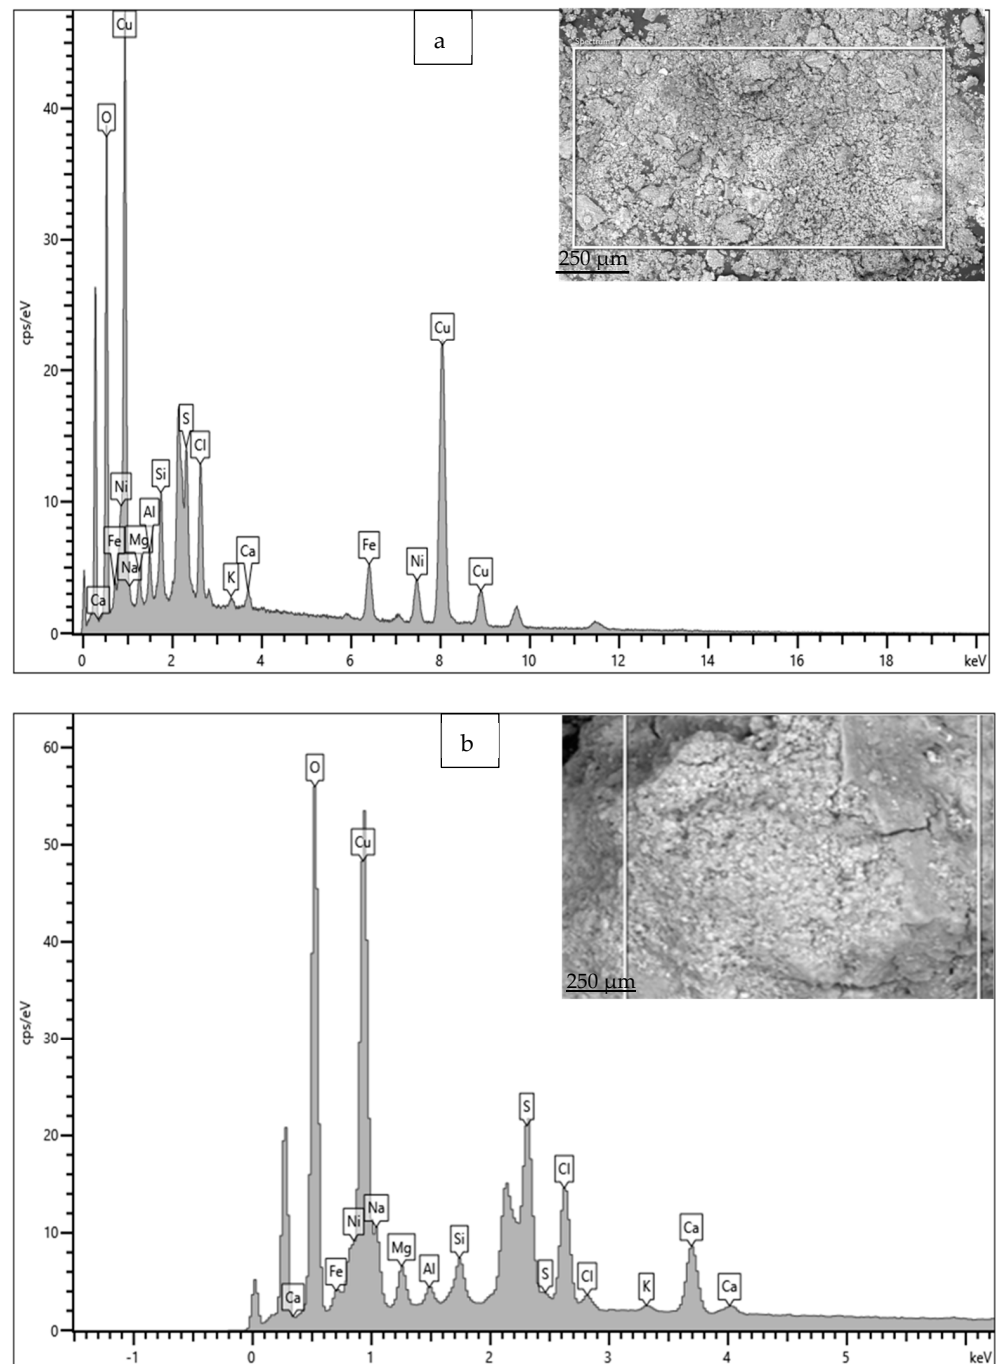
The EDS spectrum and elemental composition details are given in Figure 16 and Table 3. Apart from the elements in the material composition, the significant presence of S, Cl, Ca, Si and Mg in the rust is also observed. In particular, the presence of S and Cl is significantly high; these are widely recognized as causing rapid corrosion (localized) losses in Cu-Ni alloys, because S and Cl may result in the formation of various corrosive compounds (sulfides, complex chlorides, etc.), which have detrimental effects on the corrosion resistance of Cu-Ni alloy structures [2,14]. The presence of Fe in the corrosion products is significant (up to 4.5–5.8 wt. %), despite its low presence in the material composition (up to 1 wt. %).

Figure 16. (a,b) EDS results for corrosion products deposited on heat exchanger tubes exposed mainly to the polluted seawater conditions of the Arabian Sea.

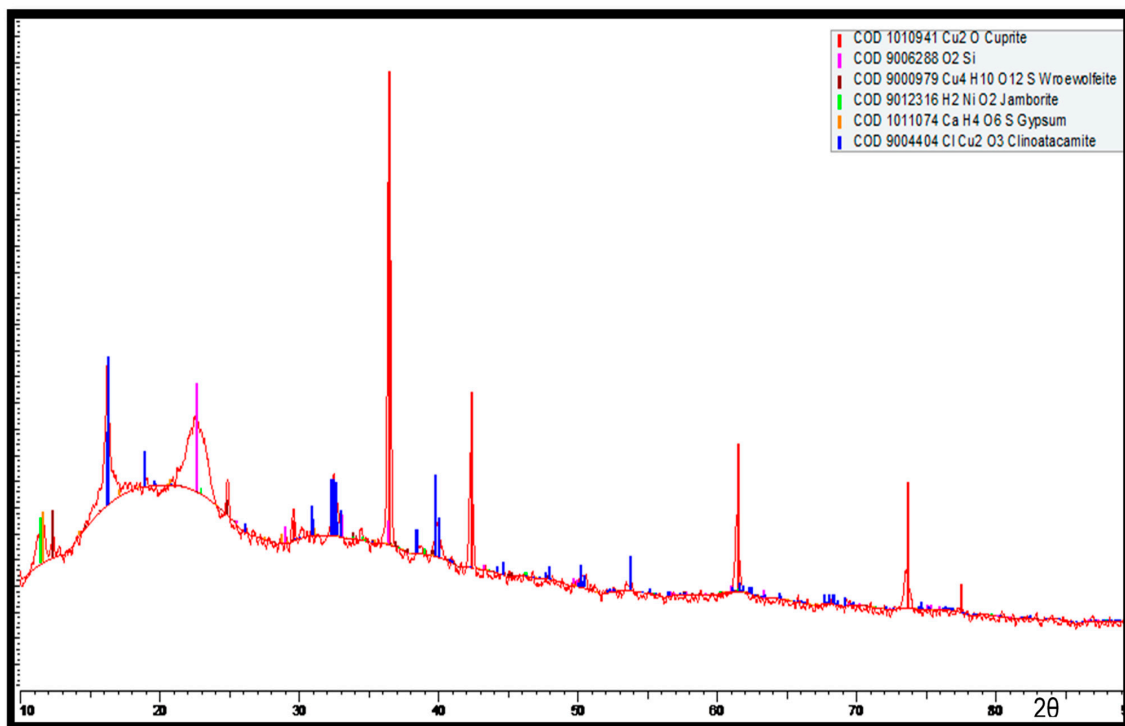
The XRD results for the corrosion products accumulated on the Cu-Ni 90/10 tubes at the outermost layers (multi-colored) are shown in Figure 18. Here, major peaks are identified for the cuprite, clinoatacamite and SiO_2 compounds. Lower levels of jamborite nickel oxide/hydroxide, gypsum and paratacamite are also observed.

Figure 18. XRD analysis of the multi-colored corrosion products deposited at the outermost corrosion layers on heat exchanger tubes exposed to the polluted seawater site in the Arabian Sea.

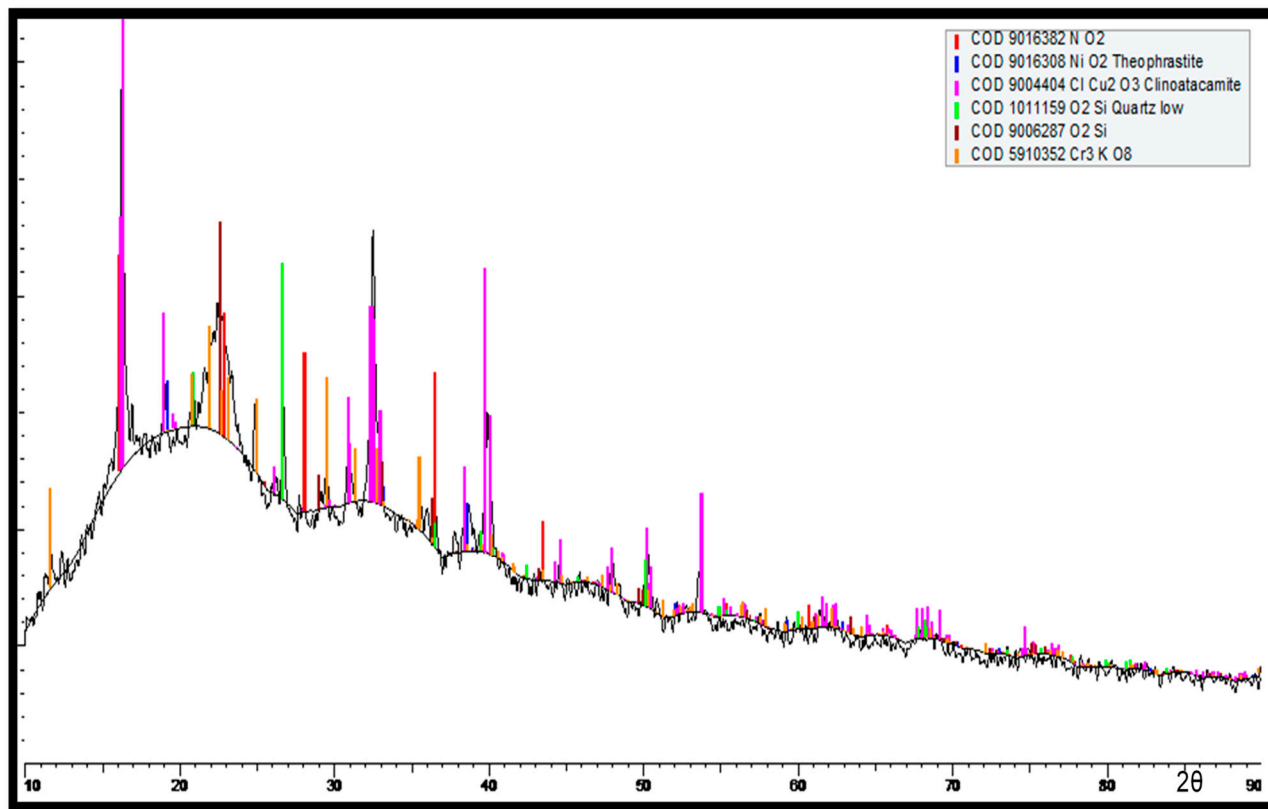
For the innermost corrosion layers (reddish) observed on the tubes exposed to the polluted seawater of the Arabian Sea, the XRD spectrum is shown in Figure 19. Clinoatacamite and quartz (SiO_2) appeared as major compounds. Lower levels of paratacamite, aluminum, cuprite, tenorite and theophrastite (NiO_2) were also observed.

Figure 19. XRD analysis of corrosion products (reddish products next to metal surfaces) deposited next to the surfaces of Cu-Ni 90/10 alloy tubes.

In Figure 19, high cuprite content can be observed on the outermost corrosion layers (seawater sides of the tube), whereas clinoatacamite was found in abundance in the innermost corrosion layers. In the presence of high salinity (Cl^- ions) exposure, the cuprite layers transform into various polymorphs (e.g., botallackite and atacamite) of copper chlorides, which are subsequently transformed into clinoatacamite, being the most stable phase.

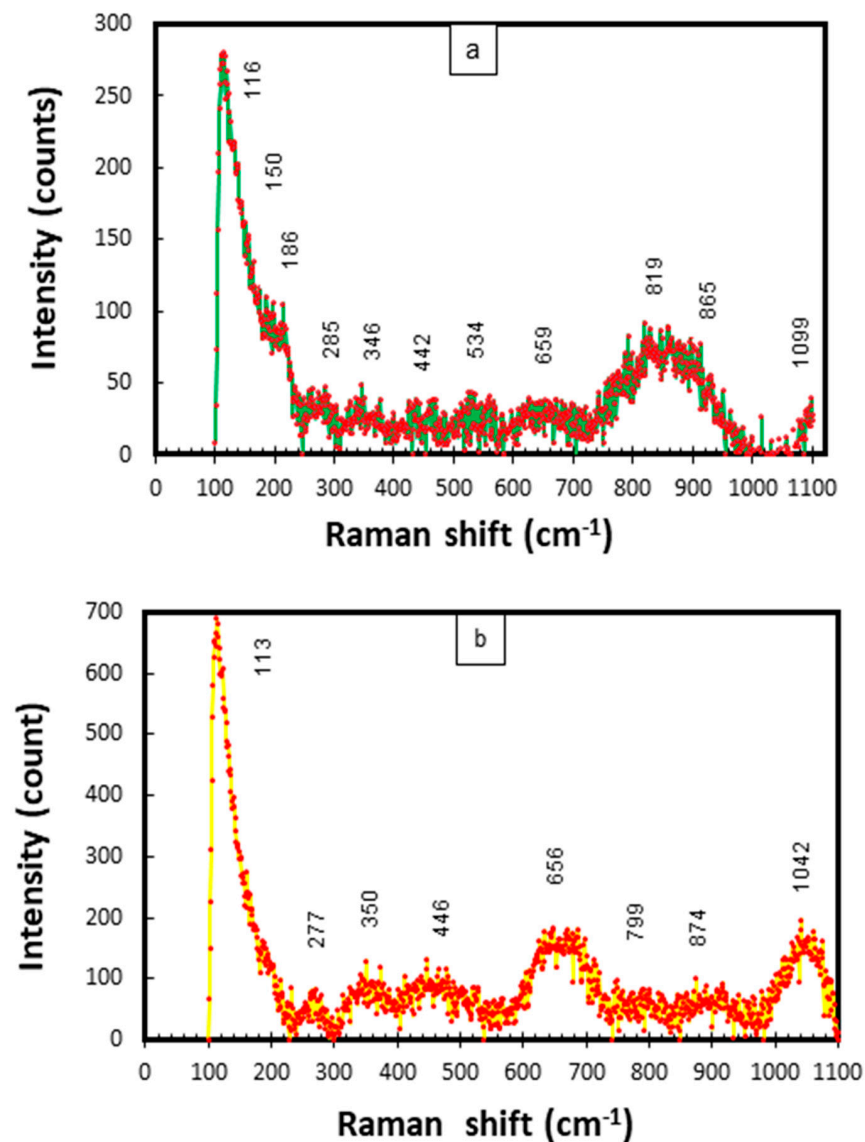
In Figure 20a,b strong characteristic bands of Cu_2O and NiO can be observed at 150, 446 and 526 cm^{-1} . The peaks at 534, 1042 and 1099 cm^{-1} may also represent NiO . The bands at $113\text{--}116\text{ cm}^{-1}$ may be attributed to aragonite. The peaks at 278, 285, 344 cm^{-1} and 351 cm^{-1} have also been linked to CuO [46]. Moreover, the peaks at 819, 865, 874, 1044 and 1099 cm^{-1} can be attributed to $\text{Cu}(\text{OH})_2$, $\text{Cu}_2(\text{OH})_3\text{Cl}$ and $\text{CuCl}/\text{CuCl}_2$, respectively. In the published literature, strong peaks at 890, 942 and up to 1100 cm^{-1} have been attributed to the clinoatacamite and paratacamite compounds, respectively [31]. The presence of both of the above compounds has also been verified by the XRD results. A strong peak in the band of $346\text{--}350\text{ cm}^{-1}$ may be attributed to iron sulfide (FeS). Peaks at 460 and 527 cm^{-1} have been recognized for jaborite in a previous research study [47].

Figure 20. (a,b) Raman scattering plots for corrosion products collected from CuNi–90/10 alloy tubes exposed to polluted seawater conditions in the Arabian Sea.
