COMPARISON OF REAL WORLD SIDE IMPACT / ROLLOVER
COLLISIONS WITH AND WITHOUT THORAX AIRBAG / HEAD
PROTECTION SYSTEM:
A FIRST FIELD EXPERIENCE STUDY

Peter Baur
Department of Engineering
BMW of North America, Inc.
Montvale, New Jersey

Wolfgang Lange
Georg Messner
Stefan Rauscher
Department of Vehicle Safety, Regulations and Certifications
BMW Group
Munich, Germany

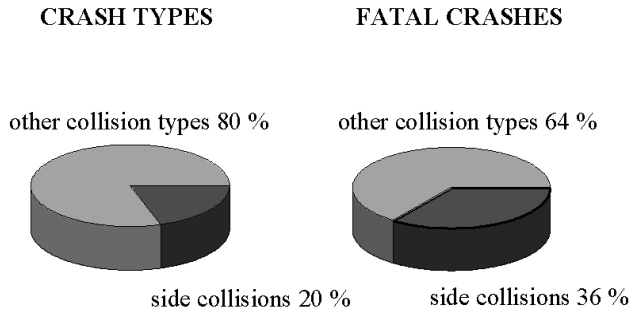
Fig. 1 – Side impact frequency and fatality representation of BMW vehicles (Source: BMW Accident Analysis)

SIDE COLLISIONS/FATALITIES – Of all severe collisions (BMW Accident Analysis – in depth accident investigation in Bavaria with severely injured occupants in current BMW models), side collisions in Germany occur with a frequency of app. 20%. This generally concurs with the US data where the frequency is reported to be 21% [NHTSA, 1999]. However, when focusing solely on fatalities, side collisions (without protection system) are disproportionately represented with 36% of fatal injuries (Fig. 1).

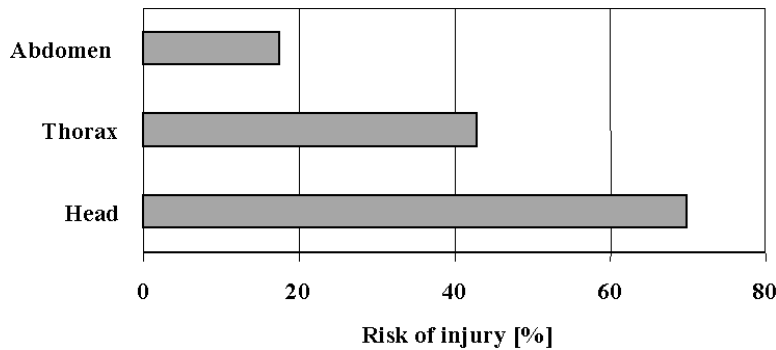
Fig. 2 – Distribution of injuries from side collisions by body region (Source: BMW Accident Analysis)

FREQUENCY OF INJURY IN SIDE COLLISIONS - The risk of severe injury for the occupants in a side collision is, according to data collected by BMW Accident Analysis, significantly higher than in frontal collisions. The distribution of injuries by body region is shown in Fig. 2. The head and thorax are particularly susceptible to injury during side collisions.

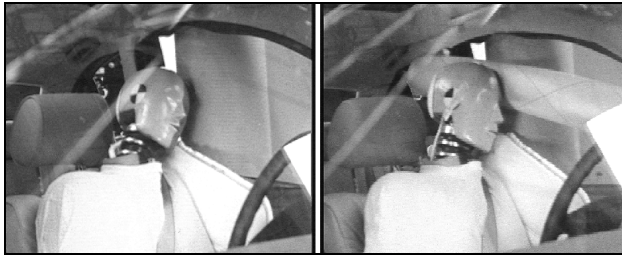
Fig. 5 – Dummy kinematics with and without HPS

The test comparisons clearly indicate the effectiveness of HPS with regard to neck kinematics and head contact (Fig. 5). The different load values of the head and neck (Fig. 6) support the value of the system.

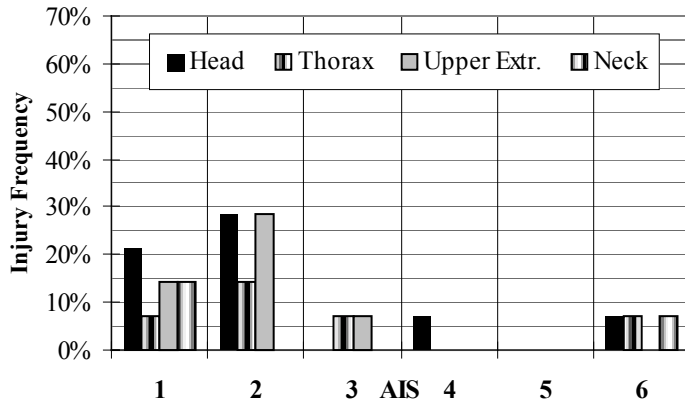
Fig. 18 - Injury frequency in side collisions without HPS/TA
(Source: BMW Accident Analysis)

Fig. 18 and 19 show the percentage of injuries to different body regions, comparing side collisions with and without HPS/TA. Principally, there is an increase in AIS 1 injuries (head by 29%, thorax by 3%, neck by 6%), with the exception of upper extremities, which were reduced by 4%. There were no AIS 2+ injuries anymore.

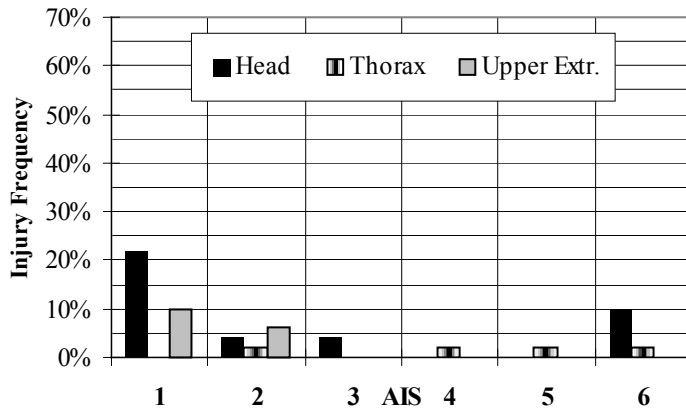
Fig. 20 - Injury frequency in rollovers without HPS/TA
(Source: BMW Accident Analysis)

Fig. 20 and 21 show the percentage of injuries to different body regions, comparing rollovers with and without HPS/TA. AIS 1 injuries increased (head by 45%, thorax by 8%, upper extremities by

7%) where there were no serious injuries (AIS 2+), with the exception of one AIS 2 head injury.

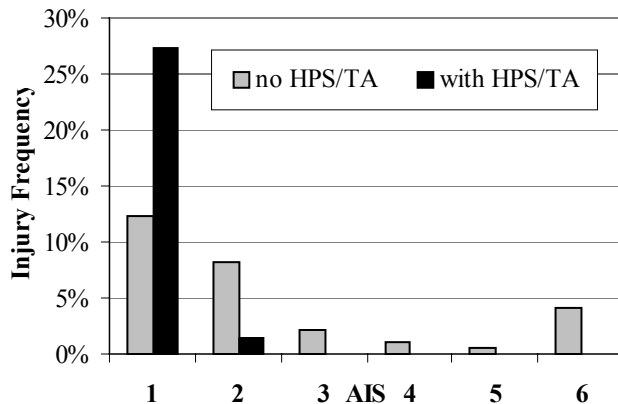
Fig. 22 - Frequency of all injuries (head, thorax, upper extremities) in side collisions and rollovers (Source: BMW Accident Analysis)

Fig. 22 shows the benefit in its totality; while AIS 1 injuries increase, AIS 2+ injuries are reduced.

Although the scope of currently available data does not permit a statistically valid statement, it is presumed that this trend will continue. Otherwise, even in this limited quantity of cases, there would have been severe injuries (AIS 3+) expected, since the data used was based on observations of serious collisions only. It is interesting to observe that the HPS is responsible to a greater extent for the reduction of serious injuries than the TA.
