Semin Arthroplasty. 2013 December 1; 24(4): 246–254. doi:10.1053/j.sart.2014.01.002.

Does Taper Angle Clearance Influence Fretting and Corrosion Damage at the Head-Stem Interface? A Matched Cohort Retrieval Study

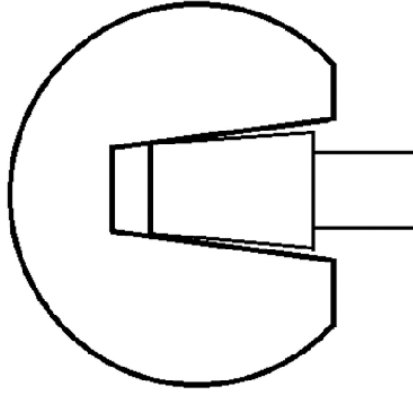
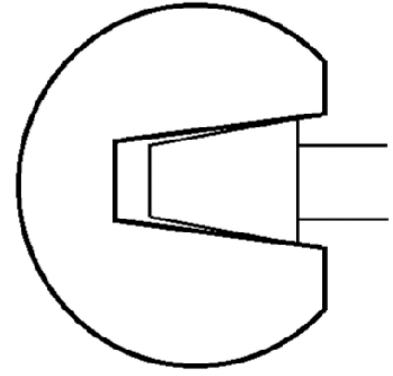
a) Proximal Contact

[taper angle > trunnion angle

Clearance (taper angle – trunnion angle) > 0]

b) Distal Contact

[taper angle < trunnion angle

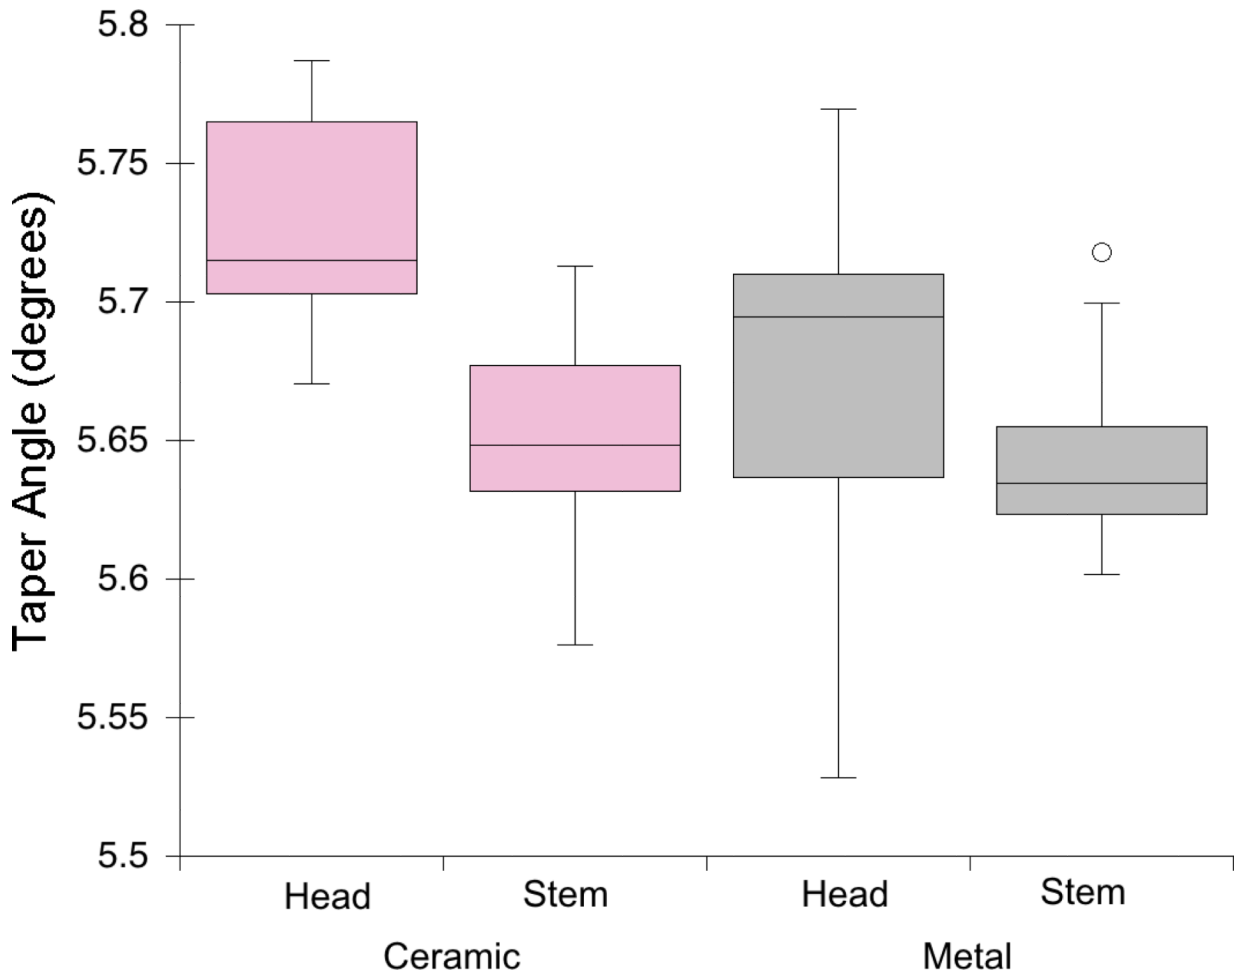
Taper angle measurements for ceramic and metal heads resulted in no overlap between the taper and trunnion angles in the ceramic cohort, while there was overlap in the metal cohort (Figure 5). Hence, calculation of taper angle clearance revealed a difference between the ceramic and metal cohorts. The ceramic cohort had exclusively positive taper angle clearance, geometrically indicating proximal contact (Figure 1). The metal taper cohort had both positive ($n=35$) (proximal) and negative ($n=15$) (distal) taper angle clearance (Figure 6). Proximal contact in the ceramic cohort was further verified visually by evidence of metal transfer at the proximal end of the head taper (Figure 7). For metal head-stem pairs, it was possible to confirm proximal or distal contact by inspecting the surface topography of measured profiles when there was observable material loss, as determined by a skilled operator who could identify deviations in topography in profiles. Profiles of metal heads showed one of the following wear conditions: a pristine surface with no detectable material loss ($n=32$), region with material loss indicating proximal contact ($n=3$), distal contact ($n=9$), or proximal and distal contact simultaneously ($n=6$) (Figure 4).

Figure 5. Taper angle measurements for the ceramic and metal head-stem pairs. There is no overlap in the taper and trunnion angle measurements for the ceramic cohort, while there is overlap in the metal cohort.

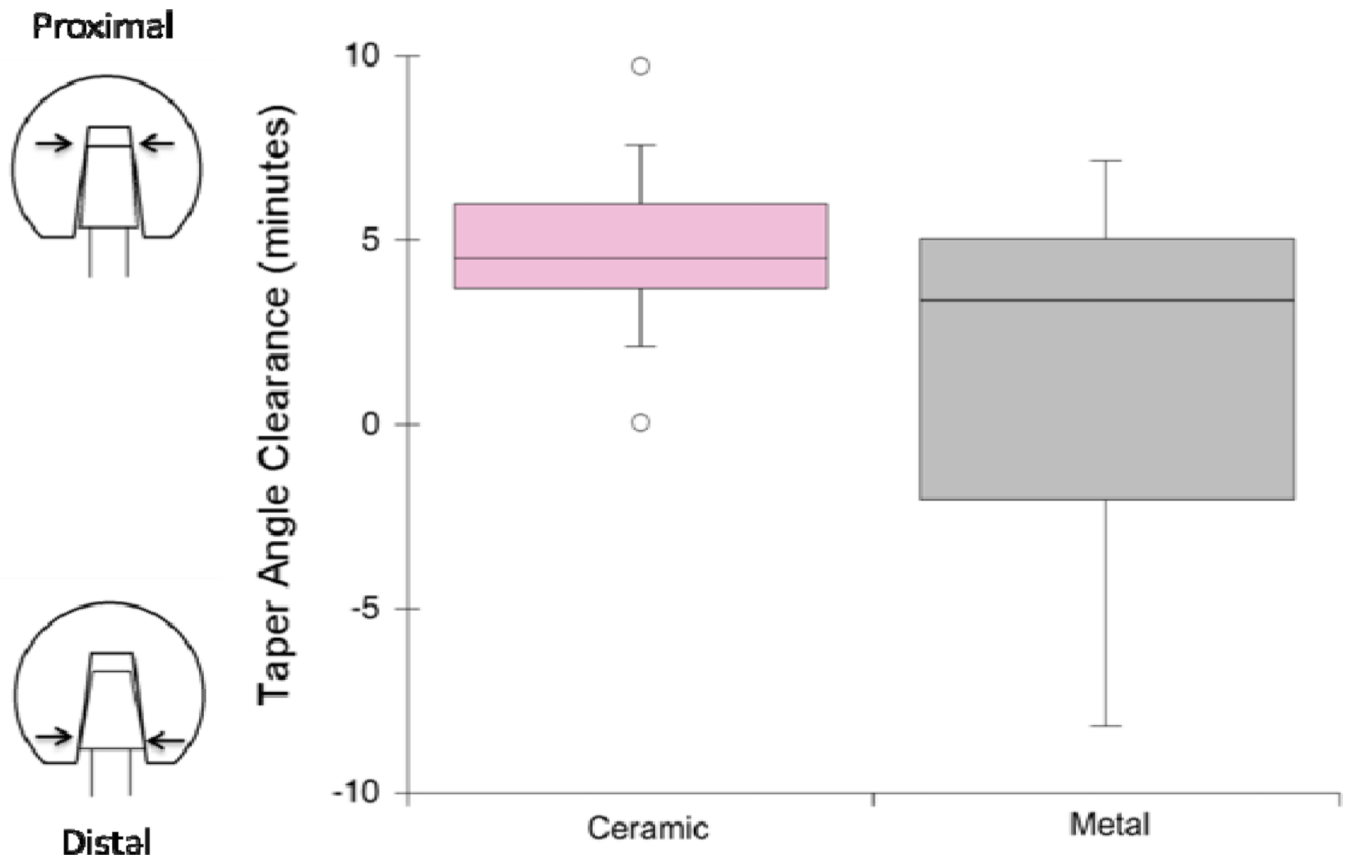
Figure 6. Taper angle clearance distribution for the ceramic and metal cohorts. The taper angle clearance for the ceramic cohort is always greater than zero (indicating proximal contact), while the metal cohort has clearance values that are greater and smaller than zero (indicating a mixture of proximal and distal contact)

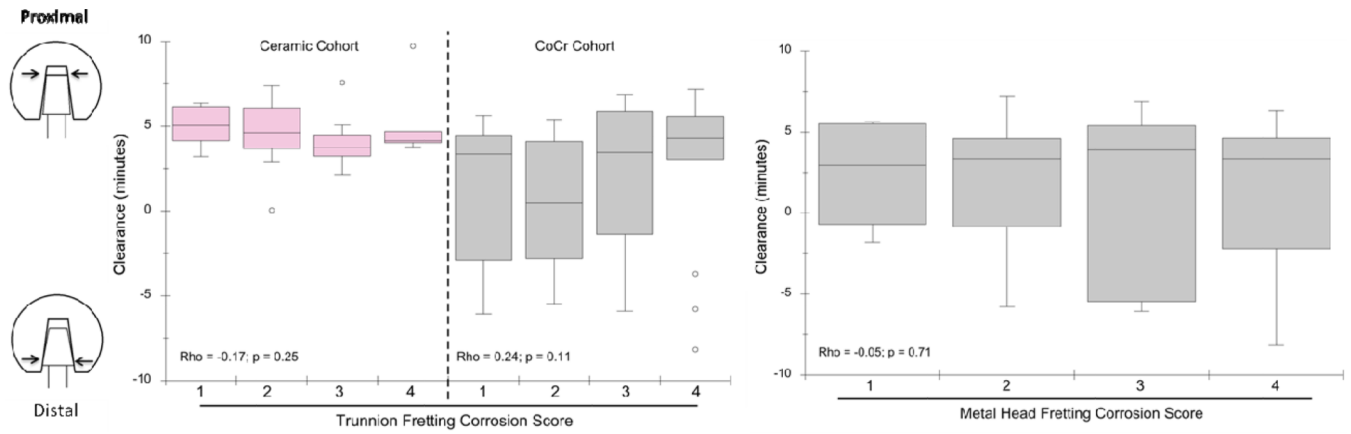
There was no significant correlation observed between taper angle clearance and visual fretting-corrosion scores for trunnions in the ceramic cohort ($\rho = -0.17$), trunnions in the metal cohort ($\rho = 0.24$) nor the femoral head tapers in the metal cohort ($\rho = -0.05$) (Figure 8). Additionally, visual fretting-corrosion scores in the metal cohort were similar between components with distal contact (negative taper angle clearance) and components with proximal contact (positive taper angle clearance) ($p = 0.43$ and 0.56 for taper and trunnion scores, respectively; Wilcoxon Test).

Figure 8. Distribution of measured ceramic and metal cohorts according to a) trunnion fretting corrosion score, and metal cohort according to b) metal head fretting corrosion score.
