Cite this article: Ornthammarath T. 2019 Seismic damage to ancient monuments in Chiang Saen (Northern Thailand): implication for historical earthquakes in Golden Triangle area. *Phil. Trans. R. Soc. A* **377**: 20180255. <http://dx.doi.org/10.1098/rsta.2018.0255>

Seismic damage to ancient monuments in Chiang Saen (Northern Thailand): implication for historical earthquakes in Golden Triangle area

Teraphan Ornthammarath

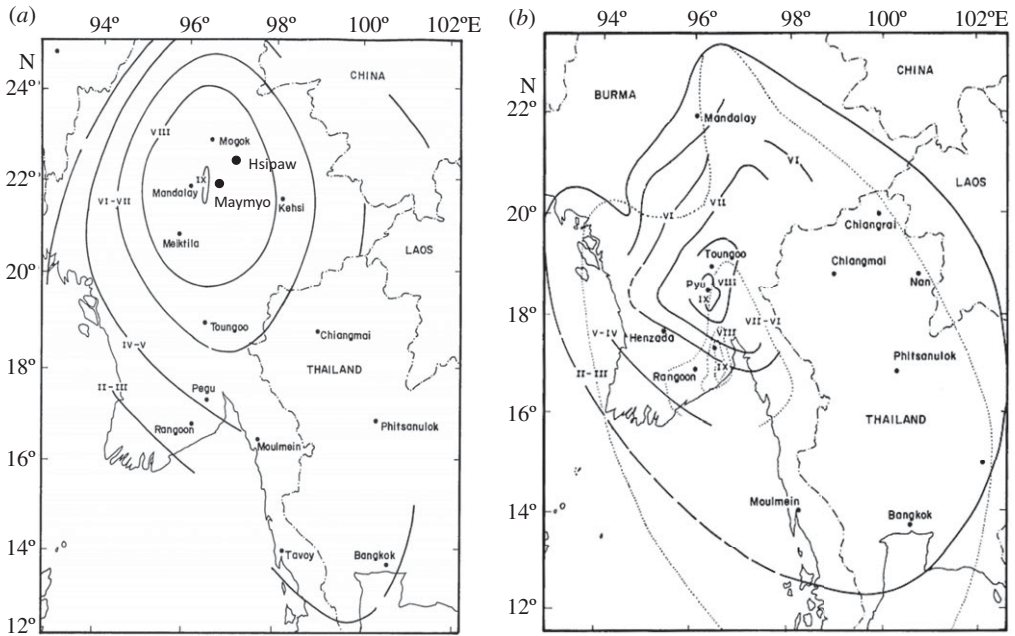
Based on the past damage to similar structures in Myanmar, it is unlikely that ancient monuments in Chiang Saen should survive any ground shaking greater than MMI and greater than or equal to VII without damage or collapse. The weight of the superstructure would easily bring down the entire Chedi Pasak and other previously described monuments. Had collapse occurred, it should be observed through different architectural forms for several structures in Chiang Saen; however, the fourteenth century original summit in Chedi Pasak is still preserved as well as other structures in the present day [26]. It is also worth mentioning that several stone inscriptions and the remains of damaged stupas indicate the total structural collapse since the thirteenth century due to earthquakes from other parts of Lan Na kingdom, in the present day Northern Thailand [10,13,33] (figure 8 and 9).

Figure 8. Rossi–Forel’s (RF) isoseismal map for (a) the Mw 7.8, 23 May 1912 Shan earthquake, Myanmar [29] and (b) the Mw 7.5, 4 December 1930 Pyu earthquake, Myanmar [31]. Reported damage to towns in tables 5 and 6 is shown according to the observed damage from past studies.

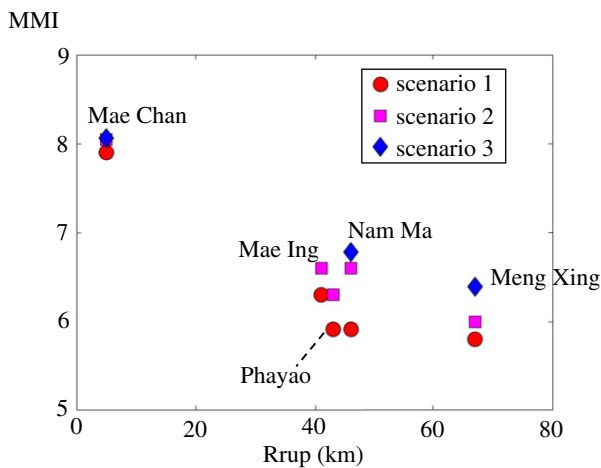
Figure 10. Estimated intensity using macroseismic intensity prediction equation for active crustal region developed by Allen *et al.* [34] based on five major active faults located in and around Chiang Saen with different earthquake scenarios as reported in table. (Online version in colour.)

Based on scenario 1, a simple-segment rupture, the estimated intensity for considered faults excluding the Mae Chan fault could vary between V and VI (figure 10), which is similar to the observed shaking intensity from recent earthquakes causing minimum to moderate damage to Chiang Saen's ancient monuments. For multiple-segment ruptures, scenario 2 and 3, larger intensity could be expected, and the range of estimated intensity apart from the Mae Chan fault might vary from VI to VII (figure 10). Heavy damage to ancient monuments in Chiang Saen should be expected if an earthquake of magnitude 7.8 should occur similar to the 23 May
