## Case report

# Inferior vena cava filter fracture and migration to the pulmonary artery

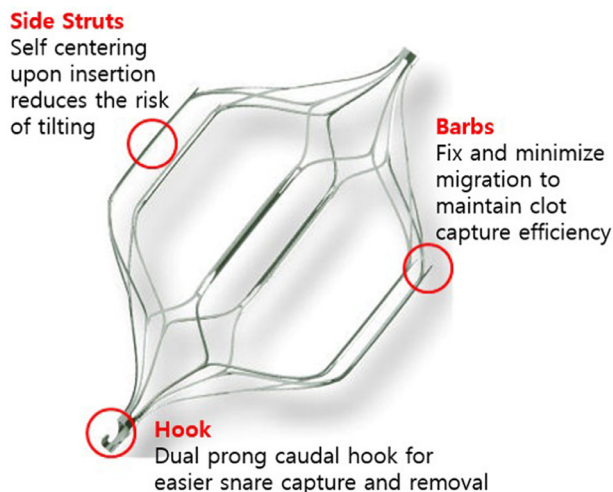
ing a normal structure of the OptEase IVC filter for reference (Fig. 4).

**Fig. 4 – Side view of the OptEase filter demonstrating a symmetrical double-basket design, which consist with the six straight struts engaged the proximal and distal baskets and anchoring barbs at the upper pole of each of the six straight struts.**
