The 30 October 2020 Aegean Sea Tsunami: Post-Event Field Survey Along Turkish Coast

Abstract—On 30 October 2020, a strong normal-faulting earthquake struck Samos Island in Greece and İzmir Province in Turkey, both in the eastern Aegean Sea. The earthquake generated a tsunami that hit the coasts of Samos Island, Greece and İzmir, Turkey. National teams performed two post-tsunami field surveys on 31 October to 1 November 2020, and 4–6 November 2020, along the Turkish coastline; while the former was a quick survey on the days following the tsunami, the latter involved more detailed measurement and investigation focusing on a ~ 110 -km-long coastline extending from Alaçatı (Çeşme District of İzmir) to Gümüldür (Menderes District of İzmir). The survey teams measured runup and tsunami heights, flow depths, and inundation distances at more than 120 points at eight different localities. The largest tsunami runup among the surveyed locations was measured as 3.8 m in Akarca at a distance of 91 m from the shoreline. The maximum tsunami height of 2.3 m (with a flow depth of 1.4 m) was observed at Kaleiçi region in Sığacık, where the most severe tsunami damage was observed. There, the maximum

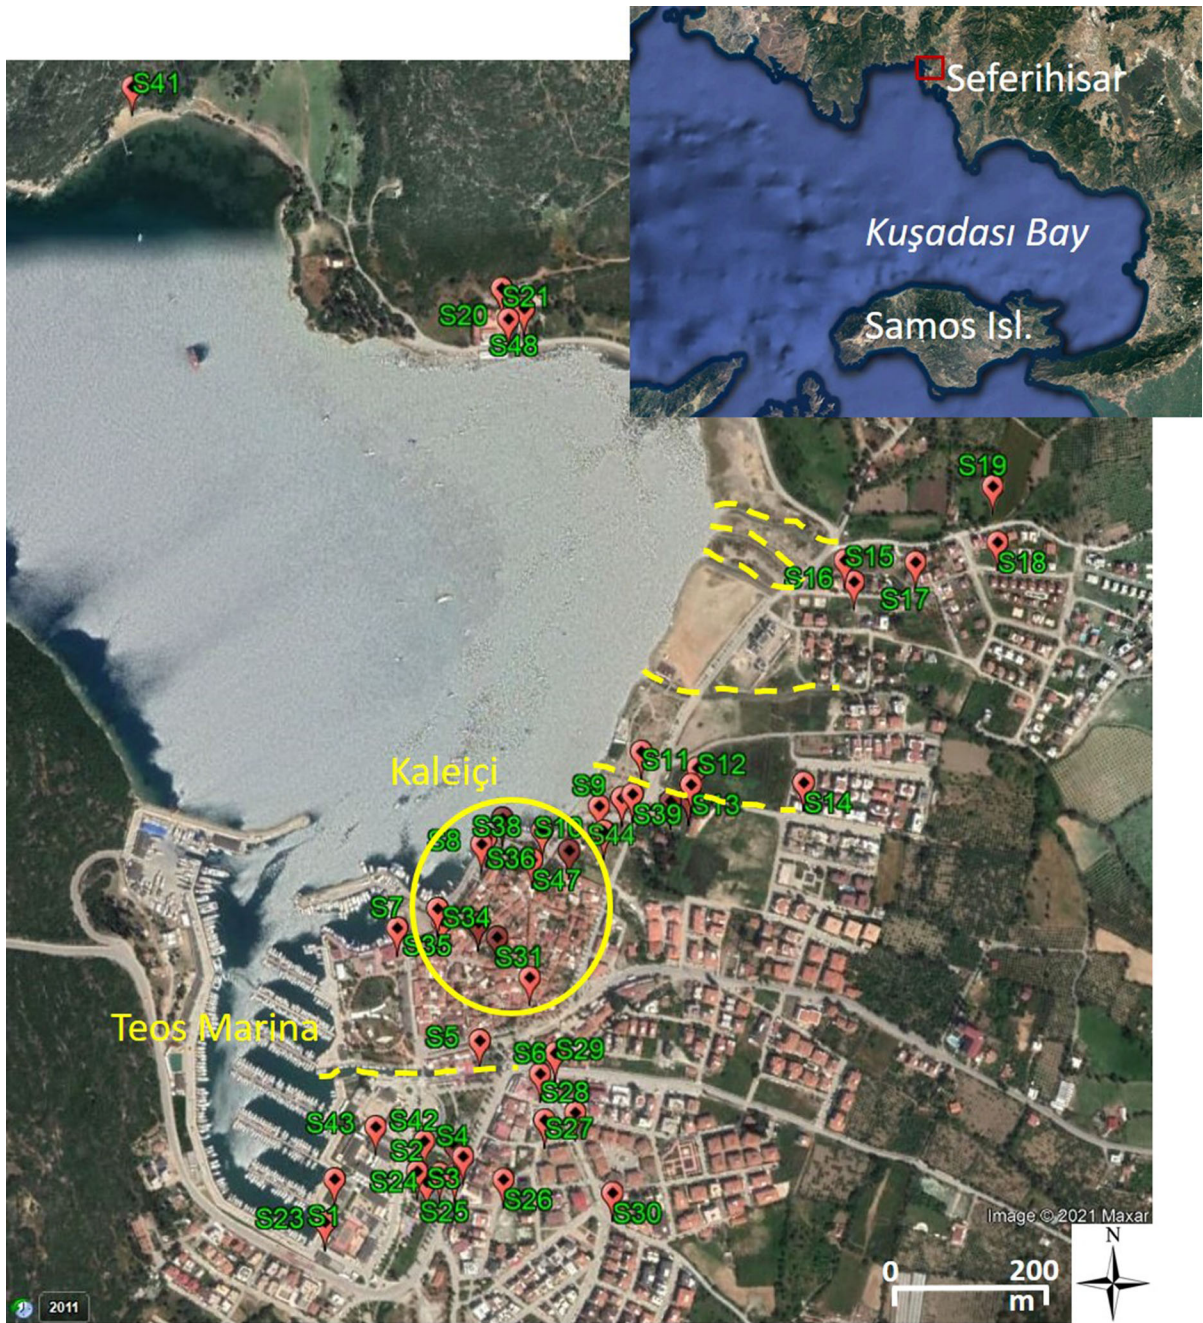
Figure 8

General view of the surveyed locations in Siğacık. Dashed yellow lines show the local river/riverbeds where the tsunami penetrated. Teos Marina and Kaleiçi regions experienced heavy damage. There was significant inundation in the most low-lying area (~ 410 m) due to an incoming wave through the bay (Table 2-S19) as well as through Teos Marina (Table 2-S30) (image is taken from Google Earth)

Siğacık, a low-lying bay-shaped area with several local streambeds, was the most impacted area of the tsunami-affected coastline (Fig. 8). The tsunami height measurements at surveyed locations in Siğacık range from 0.9 to 2.3 m (Fig. 9). We measured the maximum runup as 1.9 m (Table 2-S21). Further tsunami inundation and impact were observed in the low-lying areas surrounding the local streams of the bay (Figs. 8, 9). We observed significant inundation in the most low-lying area (Fig. 8). Here, we measured the inundation distance as ~ 410 m

(Table 2-S19). The tsunami also caused significant damage to properties and houses at that location, leaving injured locals who barely survived the tsunami (Fig. 10a–d).

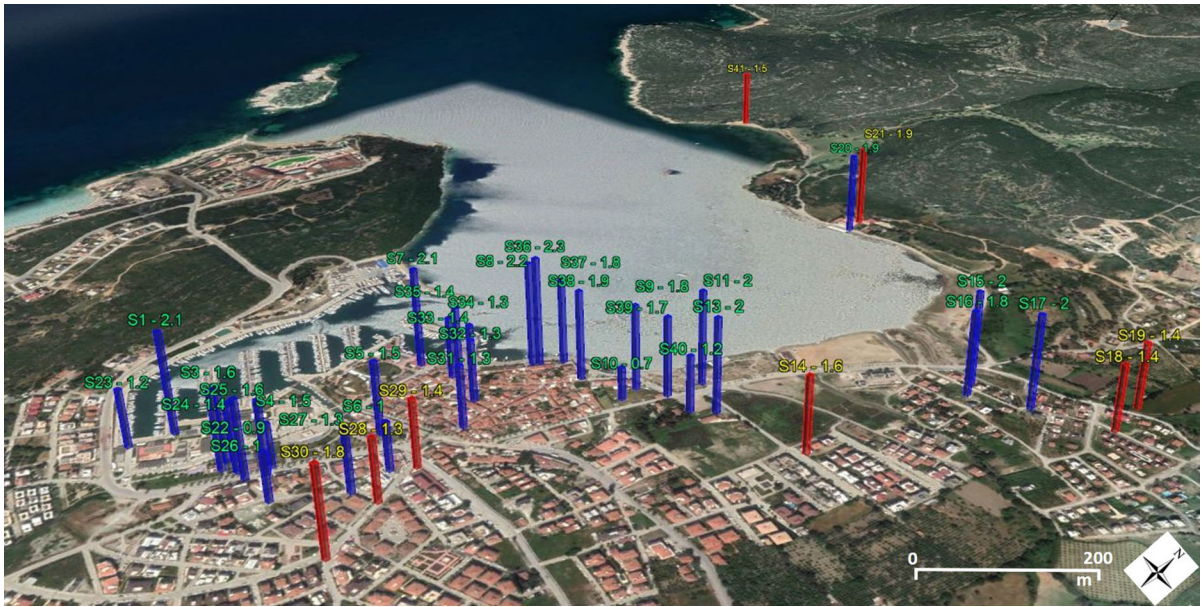
Figure 9

Distribution of the measured tsunami and runup heights along the surveyed coastline in Siğacık due to the 30 October 2020 tsunami. The blue bars represent the tsunami height, and the red ones represent the runup. The labels are given as survey point ID–measured value (m)

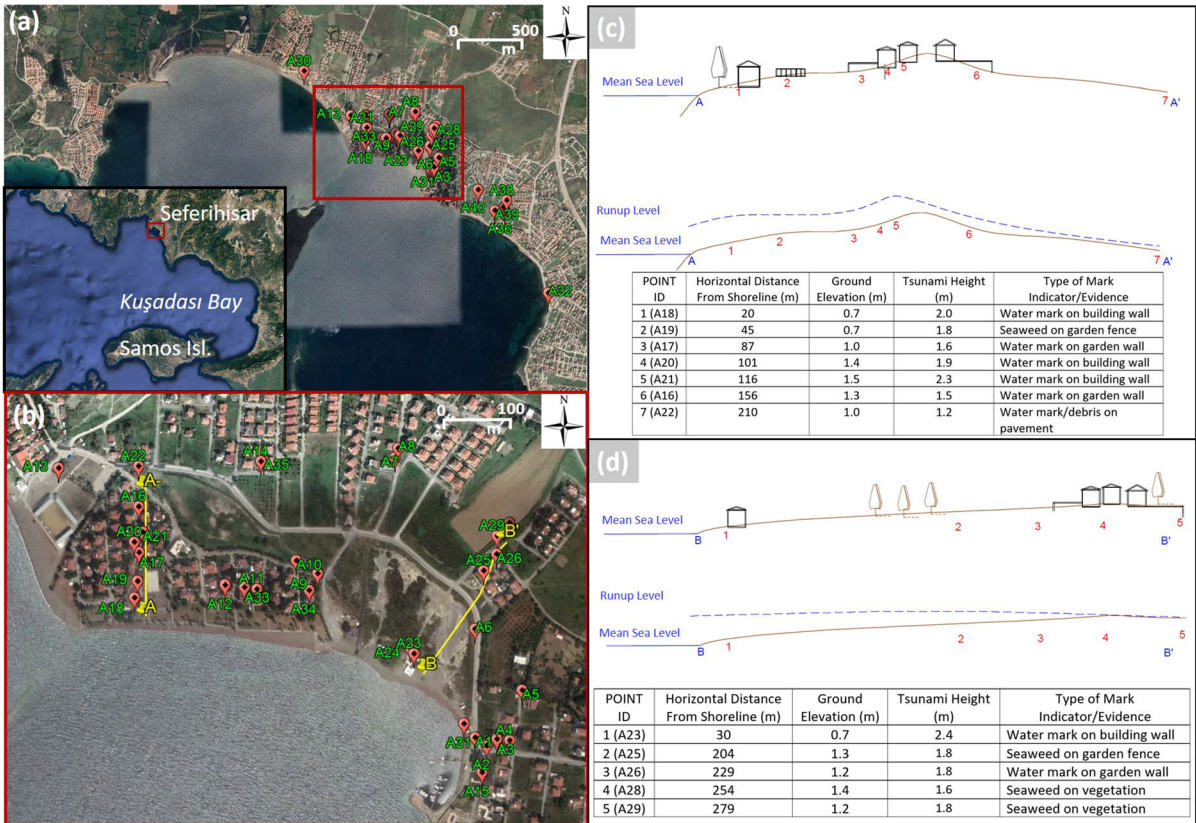
Figure 13

The Akarca coast has three bays, with a highly localized tsunami impact in the central one and a significant reduction in the northwest and southeast directions (Fig. 13a, Table 2-A30, A32, A36–A40). We collected a significant number of measurements in the central part of Akarca and gathered information from eyewitnesses. The maximum inundation distance in Akarca was measured as ~ 290 m (Fig. 13b, Table 2-A8). We present two different cross-sectional profiles of tsunami height measurements in Fig. 13c–d. The tsunami height and runup distributions along the surveyed coastline are also given in Fig. 14. The maximum runup among all surveyed locations was measured as 3.8 m (Fig. 15a, Table 2-A5) and observed at a distance of 91 m from the shore.

a General and **b** closer view of the surveyed locations in Akarca. The red rectangle shows the central bay of Akarca, where the tsunami impact was highly localized. **c, d** Cross profiles of measured tsunami inundation heights in Akarca at A–A' and B–B', respectively (image is taken from Google Earth)

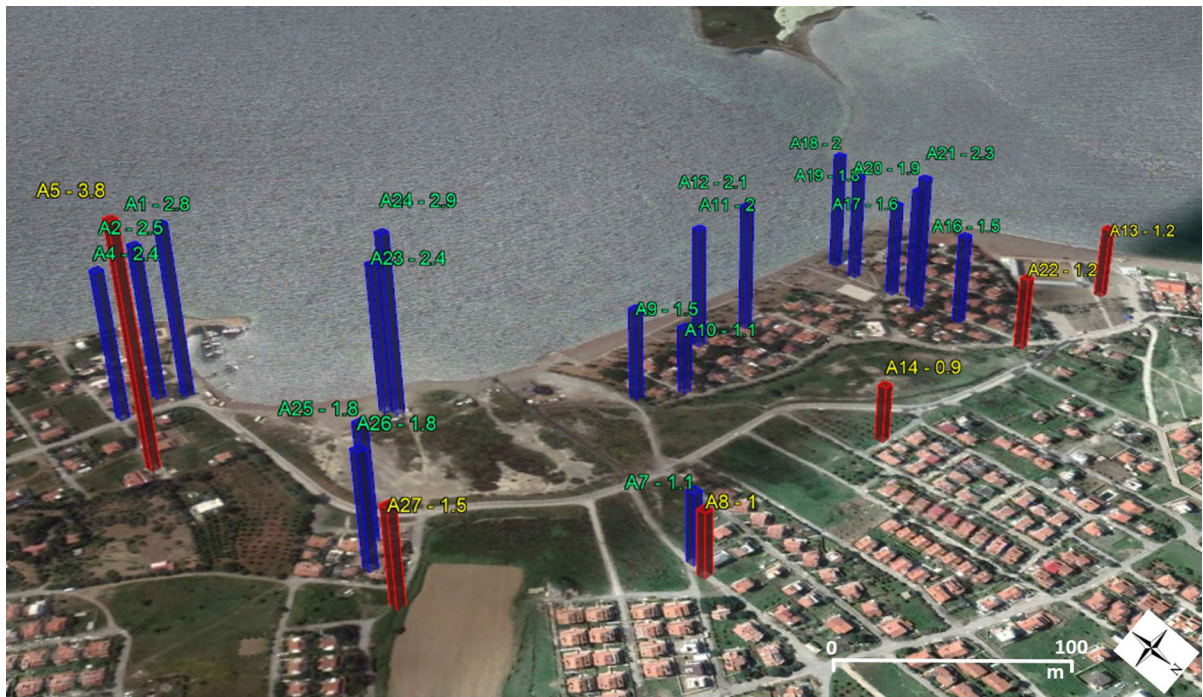
Figure 14

Distribution of the measured tsunami and runup heights along the surveyed coastline in Akarca. The blue bars represent the tsunami height, and the red ones represent the runup. The labels are given in a point ID–measured value format
