Brief Report

A Brief Report on the Collapse of Self-Built Houses on 29 April 2022, in Changsha, China

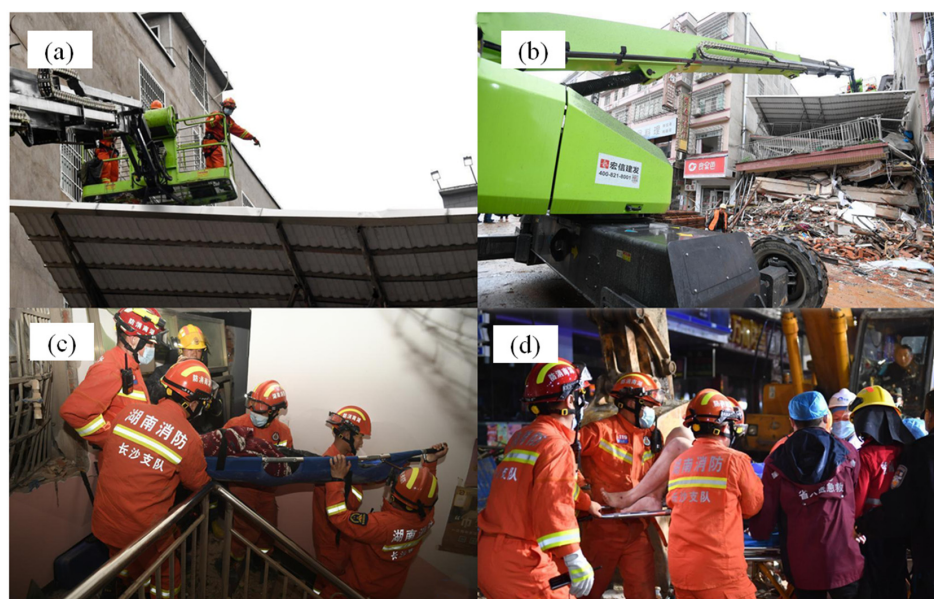
After the accident, the relevant departments quickly started the emergency plan and set up the scene dispatch and disposal command center. They urgently performed on-site rescue, with an emergency dispatch of more than 700 fire rescue personnel, armed police, social emergency forces officers, and soldiers, as well as mobilizing fire trucks, large cranes, power generators, MIMO radar life detectors, and other rescue equipment totaling more than 120 units, to undertake an on-site search and rescue. The relevant progress is shown in Figure 4a,b.

Figure 4. (a,b) Rescuers perform rescue operations; (c,d) Rescue work by relevant personnel.

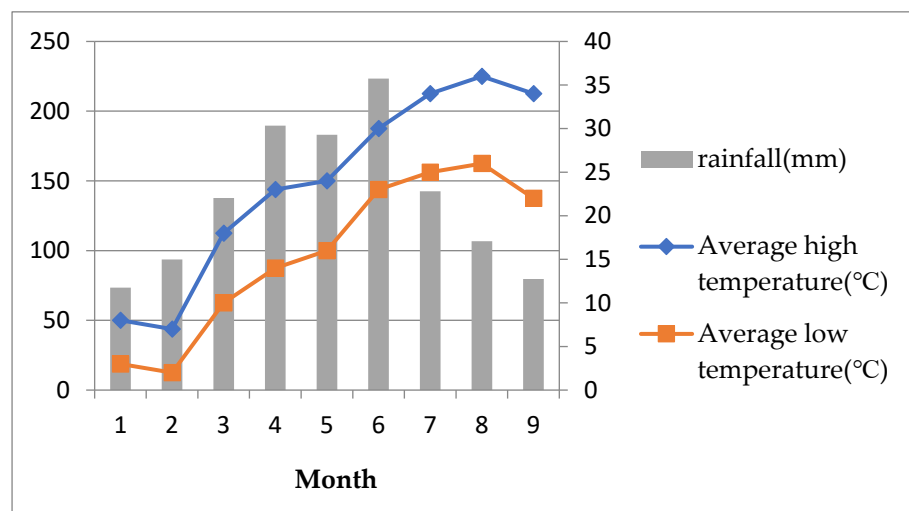
Changsha Wangcheng District has medium geological and environmental conditions which are mainly slate, mudstone, sandstone, conglomerate, shale, and granite, with high lithology. Its resistance to weathering is poor. The buried depth of groundwater is generally $15\text{ m} \leq 30\text{--}50\text{ m}$, with poor water richness, such as bedrock fracture water and abundant karst water, without adverse geological effects. Changsha has a subtropical monsoonal humid climate. The temperature rises significantly from late April throughout the year and the average monthly temperature can exceed $25\text{ }^\circ\text{C}$. At the same time, rainfall also increases significantly, and Changsha has entered the rainy season with a monthly average rainfall greater than 150 mm (see Figure 8). However, the incident occurred in a rainy area in the south–central part of Wangcheng District. The increase in rainfall resulted in continuous softening of the foundation soil, increased pore water pressure, increased compressibility, and a significant decrease in shear strength and bearing capacity. The uneven loading caused significant differential settlement of the foundation, exceeding the requirements of the relevant codes and subsequent collapse.

Figure 8. Rainfall, average high temperature, and average low temperature in Changsha.
