Review Article

Magnetic Resonance Imaging in patients with ICDs and Pacemakers

Prashant Nair MD, DM , Ariel Roguin MD, PhD

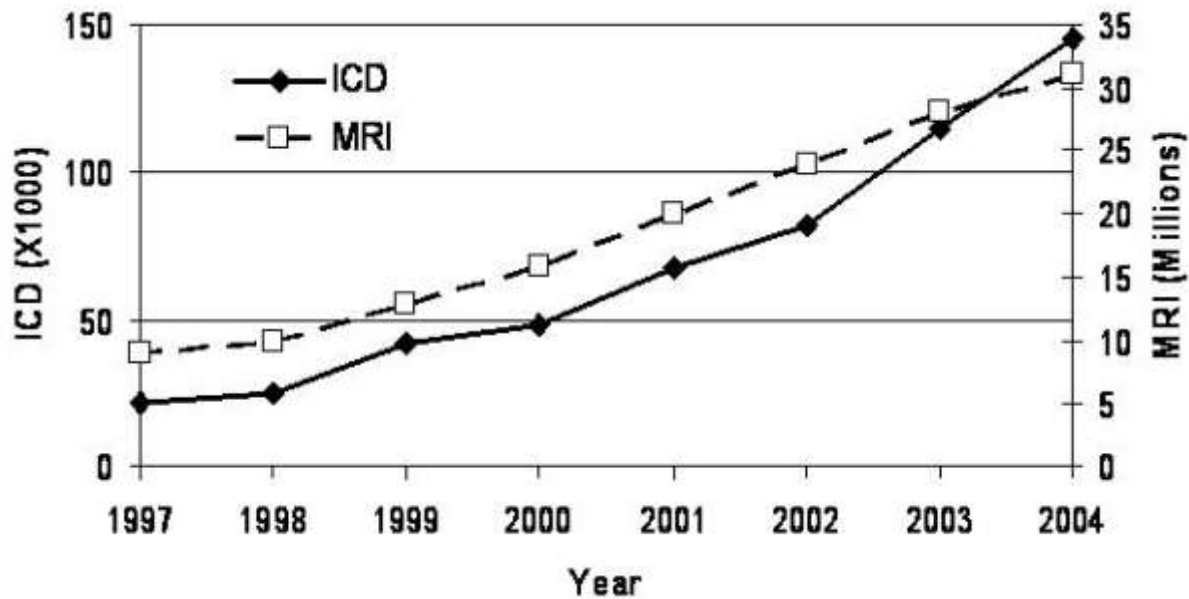
Figure 1: Number of annual MR scans and of newly implanted ICDs in the USA.

Parallel to the growth and evolution of the MR field, is the burgeoning number of patients benefiting from implantable cardiac systems including pacemakers and implantable cardioverter-defibrillators (ICDs) (**Figure 1**). With new indications for heart failure, innovative device features and expanded medical coverage; this trend is likely to continue its trajectory. The combination of these two growing phenomena results in an estimated 50-75% probability of a patient being indicated for an MR study over the lifetime of their device creating an estimated 200,000 device patients who were denied the MR scan and more in the future^{7,8}.
