Bioinspired self-healing of advanced composite structures using hollow glass fibres

R. S. Trask, G. J. Williams and I. P. Bond*

*Department of Aerospace Engineering, University of Bristol, Queen's Building,
University Walk, Bristol BS8 1TR, UK*

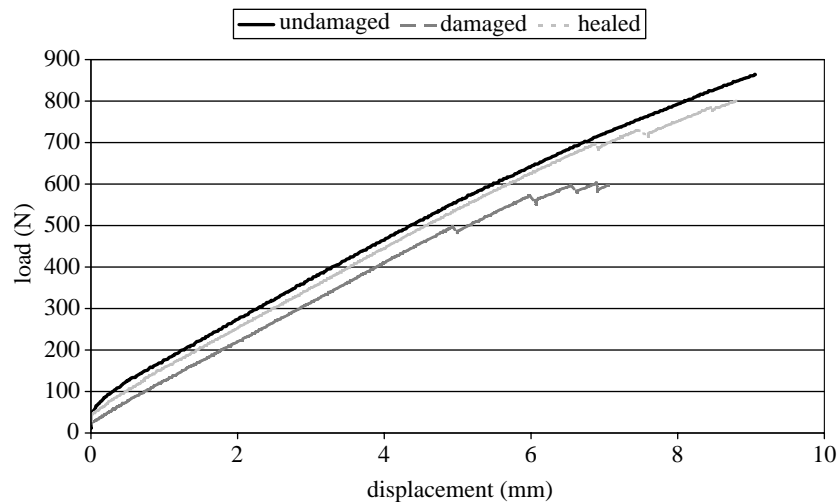
Figure 4. Comparative load–displacement curves under four-point bend for undamaged, damaged and healed for 70 μm spaced HGF.

Figure 4 shows typical load–displacement curves from the flexural testing. The relative placement of the undamaged, damaged and healed traces for 70 μm HGF spacing gives a clear representation of the effects of damage and healing events on the flexural performance for CFRP with embedded HGF.

Figure 4 shows that a damaged specimen containing HGF under load experiences a number of intermittent decreases in load as failure is approached. This is probably attributable to the propagation of matrix cracks and delaminations up to a critical level at which they affect the load-bearing performance of the

laminates. Conversely, the healed specimen appears to suppress these damage sites, inhibiting crack propagation and thereby delaying the failure of the laminate to higher load levels. Figure 4 also highlights the effectiveness of self-healing as the load–displacement curve for the healed laminate lies close to the undamaged curve.

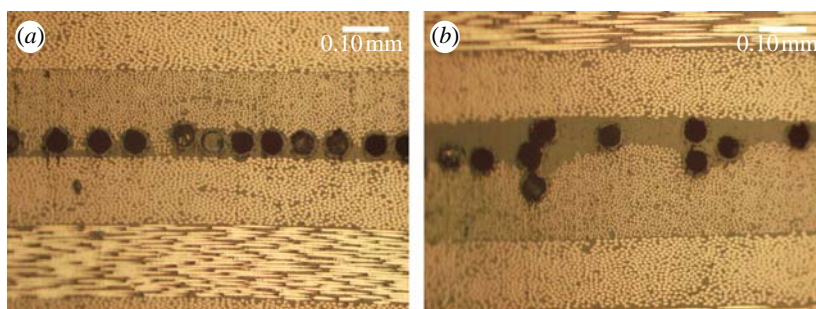
Figure 7. HGF spaced at $70\ \mu\text{m}$ showing (a) good embedment and (b) fibre clumping within host laminate.

Analysis of table 2 shows that the 70 μm fibre spacing resulted in the largest reduction in undamaged strength (8%). This can be attributed to a significant disruption in fibre architecture (figure 7). However, after a quasi-static impact at 2000 N peak load, this configuration exhibited a significant amount of damage tolerance compared with the 200 μm fibre spacing and control laminates. The large volume fraction of HGF also provides a considerable reservoir of healing agent as shown by a 97% recovery of undamaged strength (equivalent to 89% of the undamaged strength of the control laminate).

A fibre spacing of 70 μm (figure 7) highlighted several issues about the resulting quality of embedding HGF within a laminate. This small pitch spacing was selected to ensure that the HGF were in close proximity and thereby facilitate a high degree of healing efficiency. However, during preparation, HGF could be mislocated resulting in disruption to the host ply (figure 7*b*). This was attributed to fluctuations in the fibre pitch control at low HGF spacing combined with poor tackiness of the 914 epoxy resin at ambient temperature. This was seen to result in lengths of HGF detaching from and reattaching to the surface producing fibre clumping and resin-rich regions post-cure.

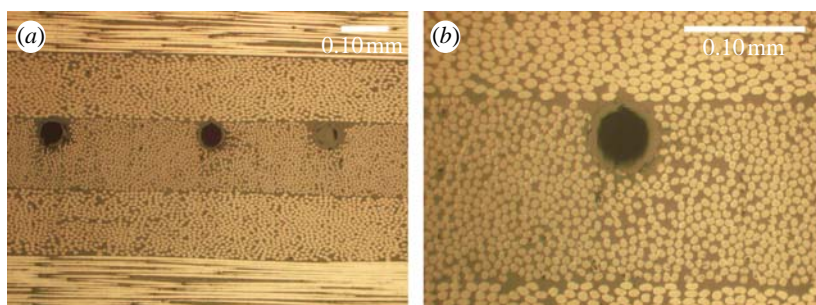
Figure 8. HGF spaced at $200\ \mu\text{m}$ showing (a) consistent spacing and (b) excellent embedment within host laminate.

The 200 μm HGF spacing specimens exhibit little reduction in undamaged strength (2%) attributable to the reduced disruption to the host laminate (figure 8). These specimens behaved similarly to the control laminate when damaged, presumably due to the limited amount of HGF available for crushing. However, healed samples achieved 82% of their undamaged strength (equivalent to 80% of the undamaged strength of the control laminate), despite the significantly lower volume of available healing resin.

A fibre spacing of 200 μm resulted in a much higher integrity laminate (figure 8). The resin-rich regions surrounding the HGF are minimized and there was no evidence of fibre clumping. The large spacing between fibres allowed the low tackiness of the 914 resin system to hold them in place, any that did detach were able to reattach without interfering with neighbouring fibres. The large spacing between the HGF permitted excellent consolidation during cure, further improving overall HGF embedment and reducing disruption to the laminate.
