Circulation. 2004 August 3; 110(5): 475–482. doi:10.1161/01.CIR.0000137121.28722.33.

Modern Pacemaker and Implantable Cardioverter/Defibrillator Systems Can Be Magnetic Resonance Imaging Safe:

In Vitro and In Vivo Assessment of Safety and Function at 1.5 T

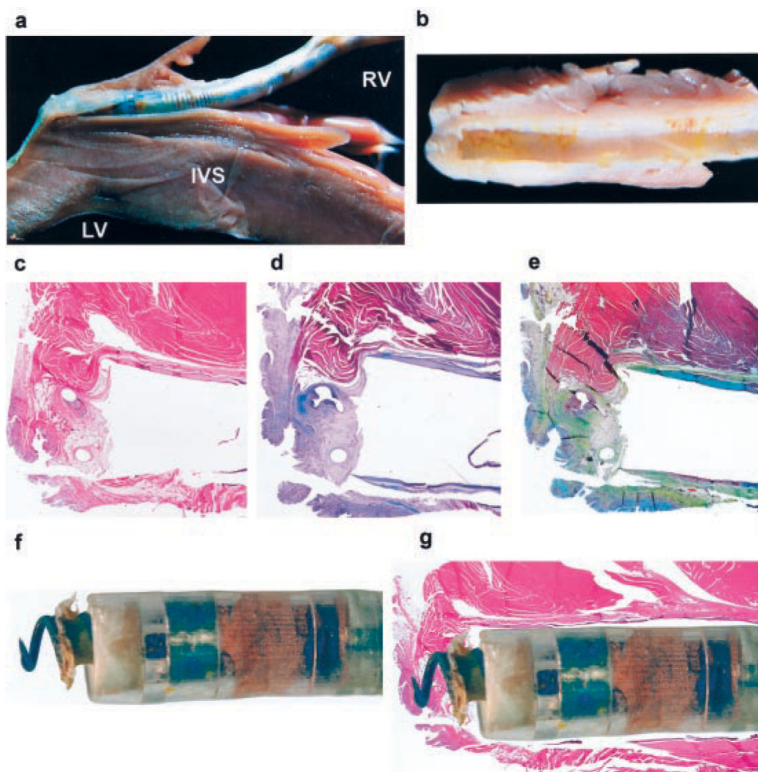
Figure 3.

Gross and microscopic examination of the heart. a, The heart is opened in a parasagittal fashion, parallel to the orientation of the lead. The lead is well anchored at apex of the right ventricle (RV). The RV free wall is seen above the lead. The trabeculation of the RV side of the septum is prominent below the lead. Note the absence of scar tissue in the muscular portion of the RV. LV indicates left ventricle; IVS, interventricular septum. b, The fibrous “cuff” that covers the lead near the apex is shown after removal of the lead. c, Low-magnification view of a histo-logical section showing the lead implantation site with the fibrous tissue surrounding the lead and the anchoring screw. The myocardium is unremarkable; note the absence of inflammatory infiltrates or scarring within the muscle parenchyma. The only fibrous tissue present is at the anchoring site where the anchoring screw has been deployed. Note the 2 circular orifices left during removal of the anchoring screw of the lead (hematoxylin-eosin stain). d, Masson trichrome stain for fibrous tissue (blue staining) confirms the fibrous nature of the cuff. However, there is no evidence of interstitial or replacement fibrosis in the myocardium (red staining). e, Movat pentachrome stain shows mild elastosis within the fibrous cuff but no fibrosis or elastosis in the myocardium. f, Close-up view of the lead showing the anchoring screw delivered and some dried tissue on it. g, Composite of light microscopy of the anchoring site with a superimposed image of the lead. Note matching of the gross image and absence of myocardial fibrosis in areas surrounding the location of electrodes in the lead.

In all 15 animals that were scanned after chronic implantation, histopathological analysis revealed no or very limited necrosis or fibrosis around the tip of the lead (Figure 3), which was not different from findings in control animals (n=3) not undergoing MR scans.

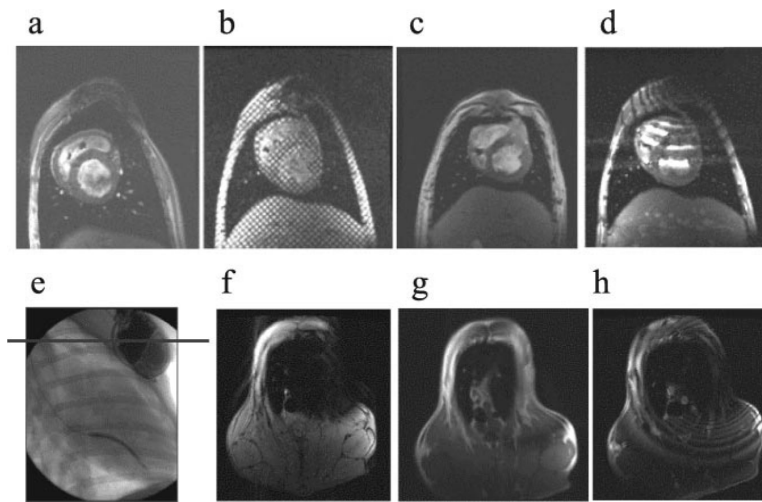
Figure 4. MRI at heart level with the use of different MR scanning sequences: FSPGR (a), tagging (b), FGRE (c), and FIESTA (d). Imaging at device level (e through h) shows different artifacts depending on scan sequence: angiography showing the level where the axial scan was done (e), FSPGR (f), FGRE (g), and FIESTA (h).

Artifacts due to the devices and leads were observed in some protocols and less in others. Most of the distortion was dependent on scan protocol and image plane: FSE and FIESTA sequences had significant distortion. Fast GRE (FGRE), tagging, and FSPGR sequences, however, yielded good images (Figure 4, a through d). Larger artifacts were observed in image planes roughly parallel to the planes defined by the device itself (Figure 4, e through h). Most distortion was at a distance of 10 to 15 cm around the device generator.
