*Heart Rhythm*. 2008 April ; 5(4): 545–550. doi:10.1016/j.hrthm.2008.02.033.

## Digital Music Players Cause Interference with Interrogation Telemetry for Pacemakers and Implantable Cardioverter-Defibrillators without Affecting Device Function

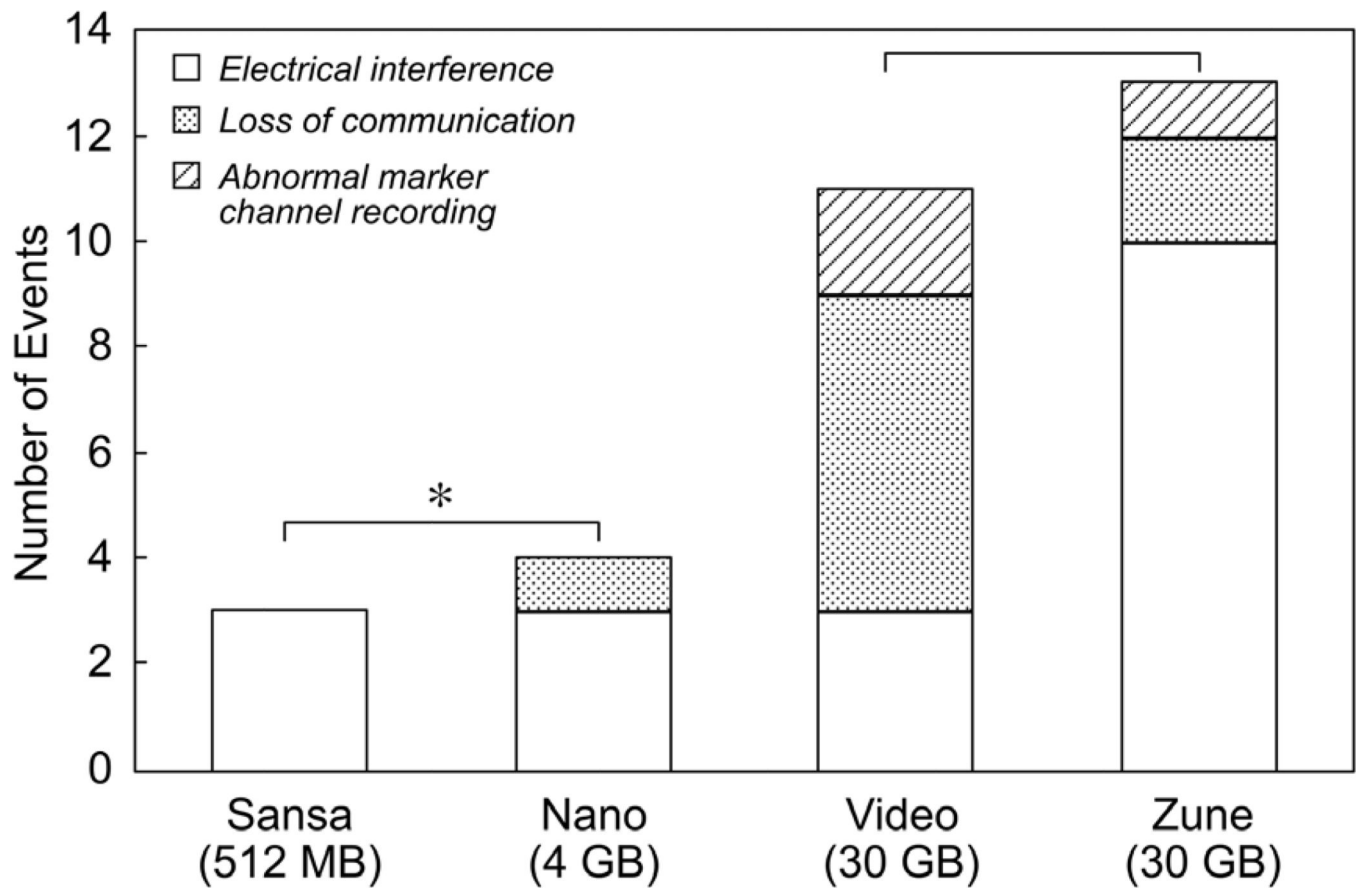
**Figure 1.** DMP interference, classified by type. \*More interference was noted with larger players (30 GB) than with smaller DMPs (4 GB) by chi-square analysis ( $p < 0.01$ ).

There was a high incidence of interference with telemetry programmer communication when the DMPs were placed directly against the patient ( $p < 0.01$ ). This interference was recorded in 29 of 204 total DMP tests (14%), accounting for 21 of 51 patients (41%). Among patients with interference, 11 had St. Jude Medical devices, 13 had Boston Scientific/Guidant devices, and 26 had Medtronic devices. These accounted for 21%, 26% and 53% of the devices, respectively. There was insufficient power to determine whether there was any difference in frequency between brands of programmer communication interference as a secondary outcome; however, larger DMPs (30 GB) had significantly more interference when compared to smaller DMPs (< 4 GB) (Figure 1). This may be due to the larger size of hard drive, larger batteries, or other factors that distinguish the larger memory devices from the smaller memory DMPs.

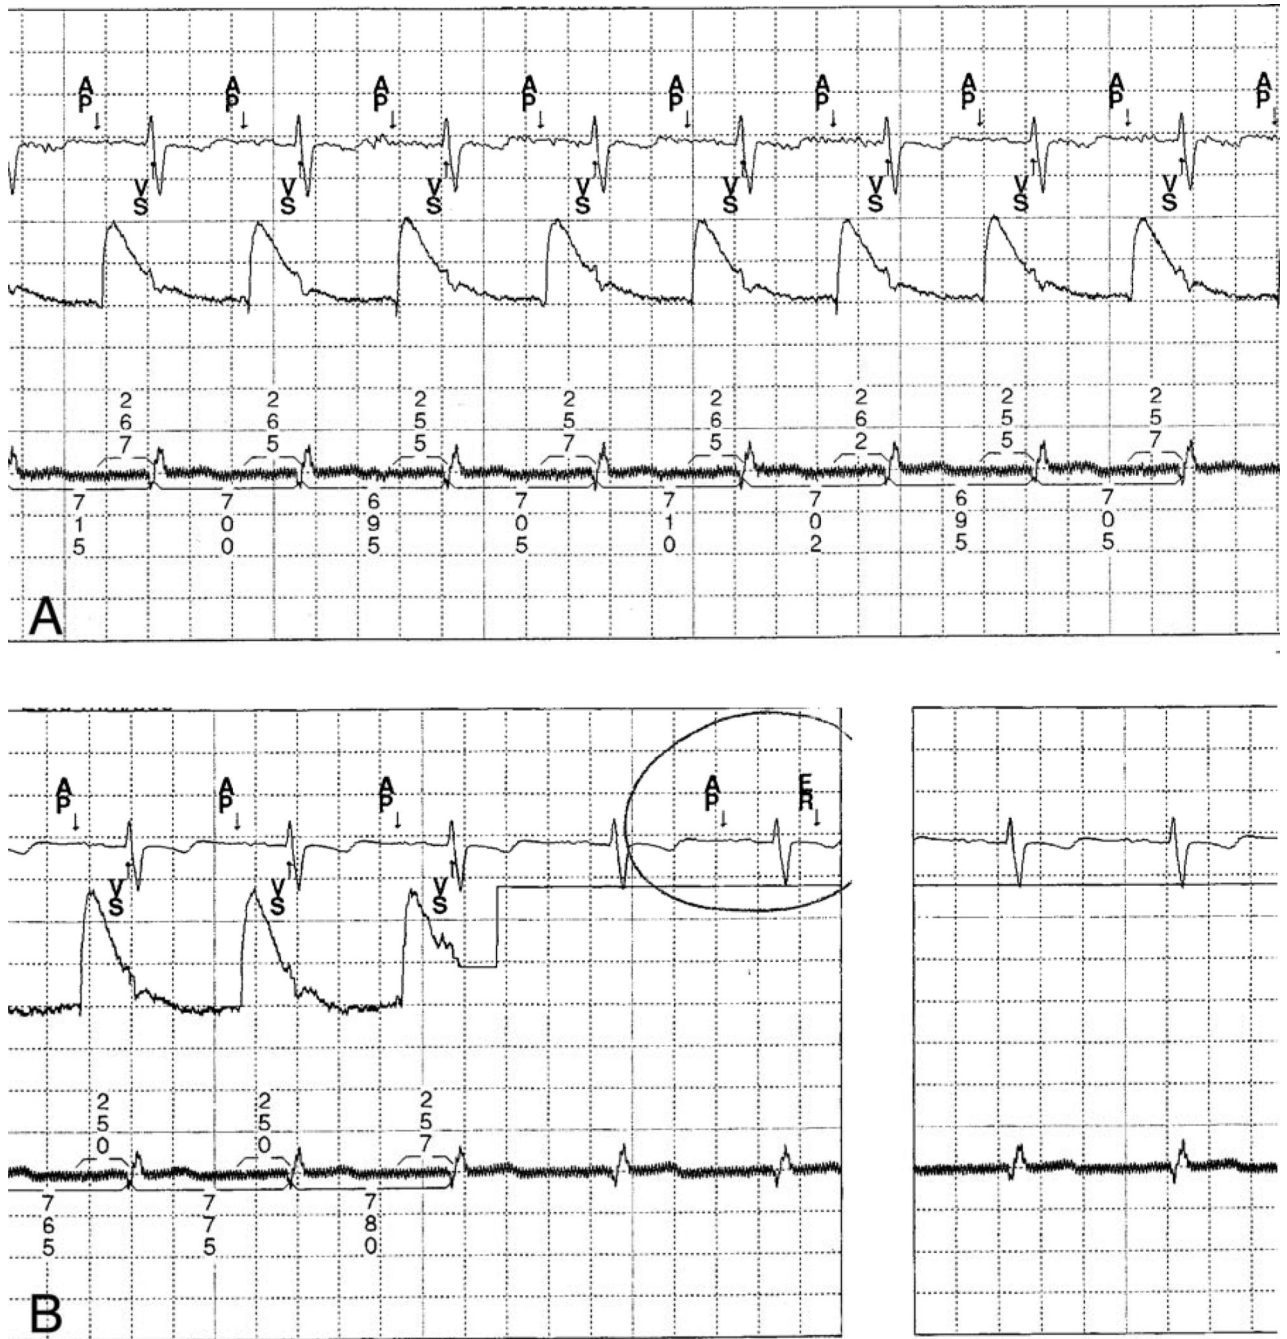
**Figure 4.**  
 A. Baseline rhythm strip showing surface electrocardiogram, atrial intracardiac electrogram, and ventricular intracardiac (top, middle, bottom), with atrial pacing (Ap) and ventricular sensing (Vs) noted in the marker channel, and intervals noted in milliseconds. B. Rhythm strip with placement of DMP causing electromagnetic interference (ER) with the atrial intracardiac channel and the marker channel, but no change in the ventricular channel and no

change in intervals on the surface ECG. There is no effect of the digital music player on the actual rhythm.
