*J Am Soc Echocardiogr.* 2016 May ; 29(5): 381–391. doi:10.1016/j.echo.2016.01.009.

## Fact or Artifact in Two-Dimensional Echocardiography: Avoiding Misdiagnosis and Missed Diagnosis

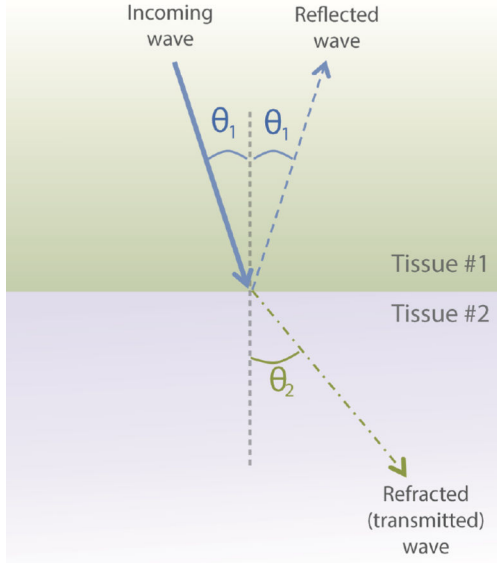
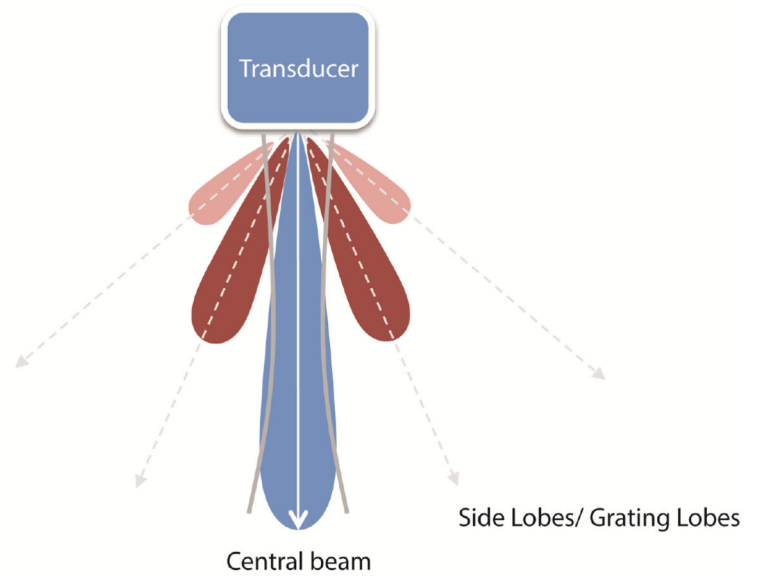
### Figure 1. Basic principles of ultrasound imaging

(1) Ultrasound waves obey the physical laws of reflection and refraction. The boundary of two tissues with different acoustic impedance acts as a specular reflector if significantly larger than the wavelength of the ultrasound waves. A portion of ultrasound wave energy will be reflected with reflection angle equal to the angle of incidence. Another portion will be transmitted with a reflection angle dependent on the magnitude of difference in acoustic impedance between both tissues.

(2) Ultrasound beam-forming is associated with small parts of ultrasound energy travelling off-axis in so-called side lobes or grating lobes.

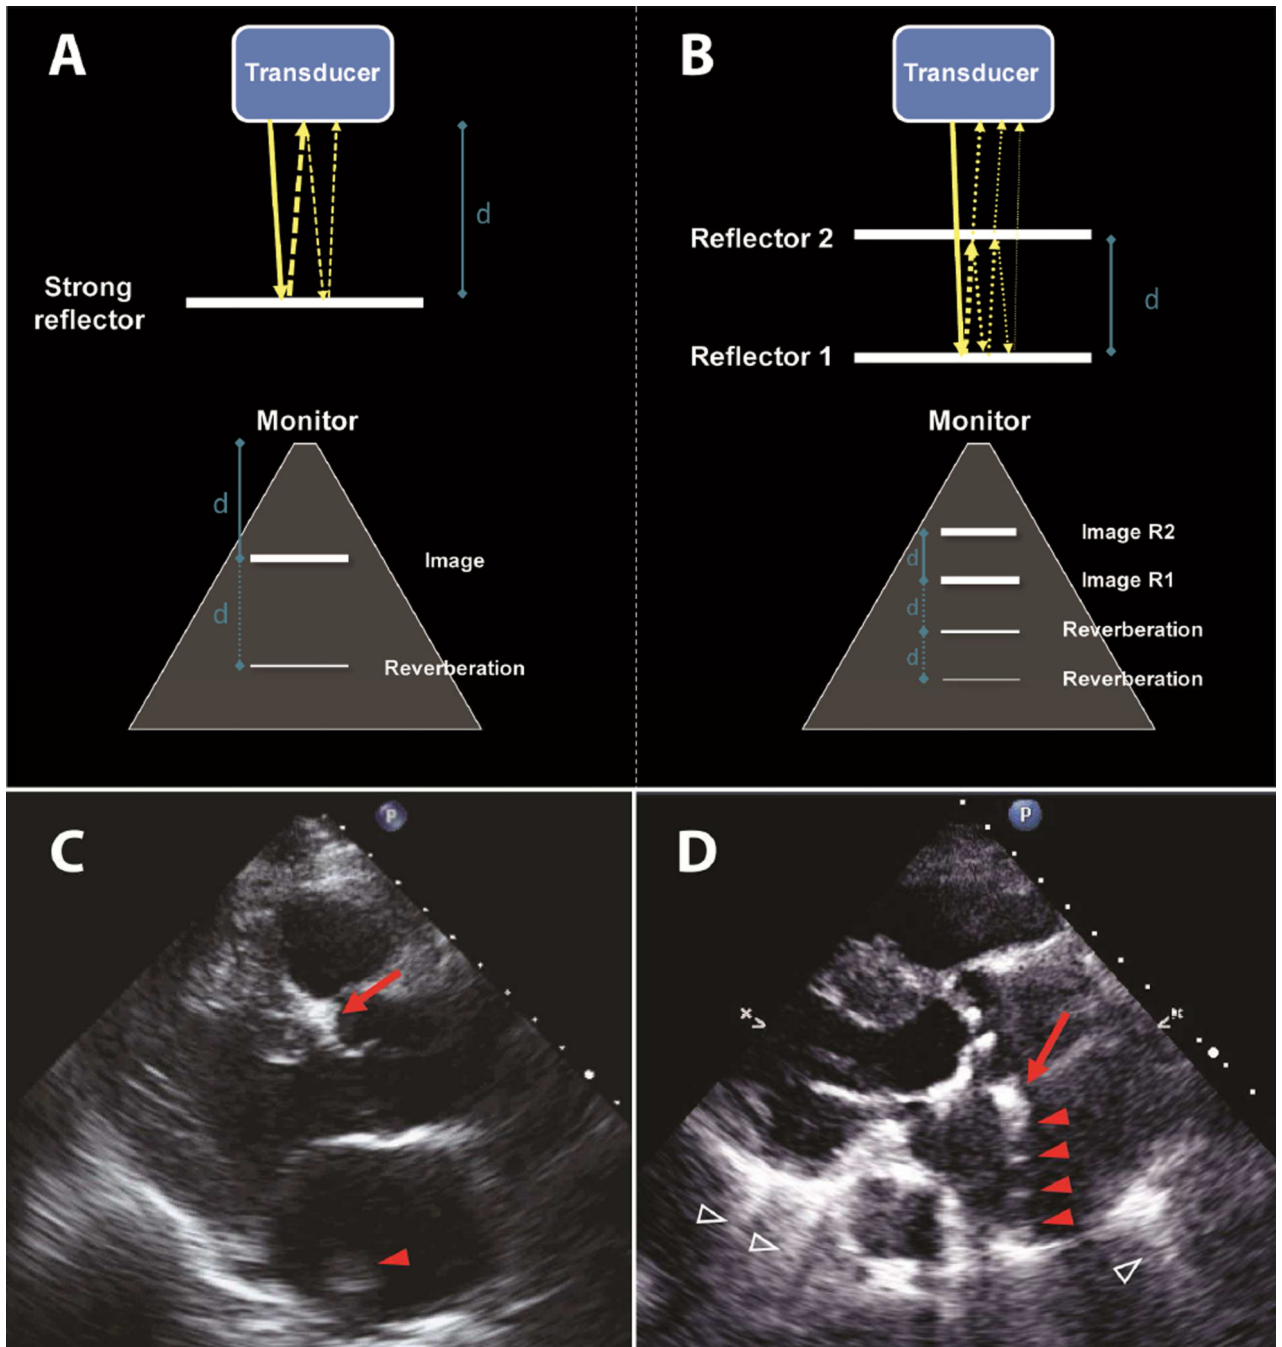
**Figure 2. Reverberation artifact**

(A–B) The theoretical genesis of a reverberation artifact (animation in Movie Clip 1). The second reflector can either be the transducer itself (A) leading to a reverberation at twice the distance to the probe, or another strong reflector (B) located above the first reflector.

layered' aortic calcification (arrow) acting as the first and second reflector (Movie Clip 3). Comet-tail reverberations below a strongly reflecting pericardium can be observed as well (empty arrowheads).

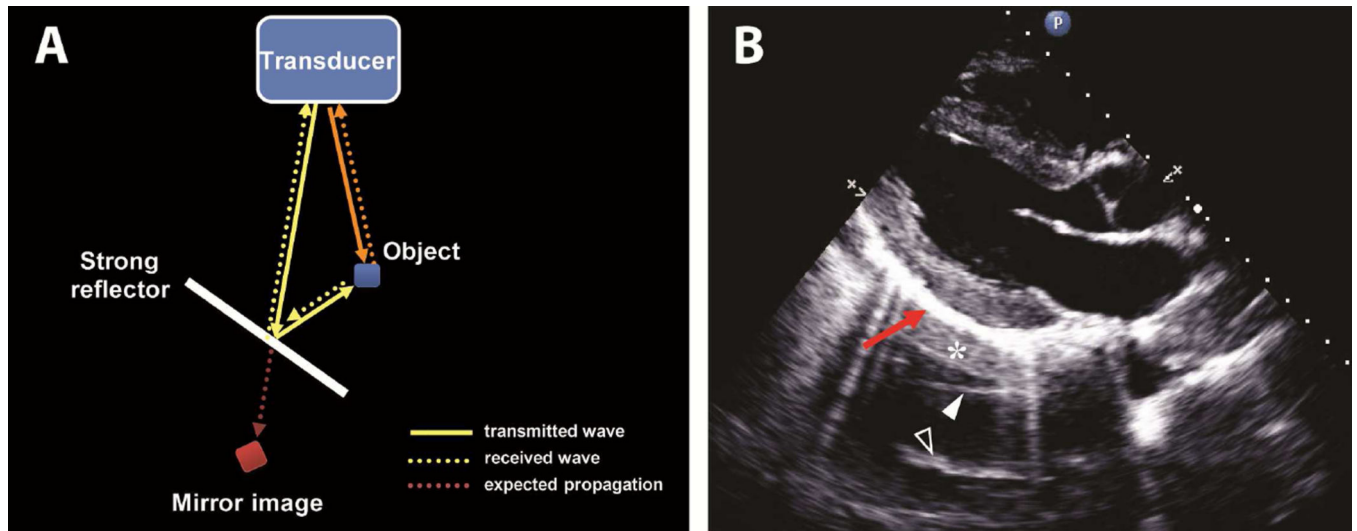
**Figure 3. Mirror artifact**

(A) The theoretical genesis of a mirror artifact (animation in Movie Clip 4). (B) Parasternal long axis image showing a mirror artefact below the pericardium-lung interface (red arrow), moving images in Movie Clip 5. Notice the mirror image of the posterior myocardial tissue (\*), the posterior mitral leaflet (full arrowhead) and the anterior mitral leaflet (empty arrowhead). Comet-tail reverberations below the pericardium due to the strongly reflecting lung interface can be observed as well.

A mirror artifact typically appears below a strong reflective surface that acts much as a mirror does with light, producing a duplicate image behind the mirror of the real structures in front of the mirror; the mirrored images move in the opposite direction from the mirror as do the real structures<sup>3, 14</sup>. The reflection mechanism is similar to that of a reverberation: ultrasound waves hitting a strong reflector are reflected (angle of reflection = angle of incidence) towards objects closer to the transducer than the reflector. These intervening objects reflect the waves back to the strong reflector, which in turn sends them back to the transducer. Due to the assumption of wave propagation – that all the returning sound comes from objects in the initial direction of the sound beam - the scanner displays these objects below the strong reflector, at a distance equal to the distance between strong reflector and the true intervening objects. The most common strong (specular) reflector that causes mirror artifacts is the lung, best appreciated in the parasternal long-axis view (Figure 3–B) and apical 4-chamber view on transthoracic echocardiograms and in the mid-esophageal view of the descending thoracic aorta on transesophageal echocardiograms. Mirror artifacts are usually easy to identify in two-dimensional images as a copy of structures located above a reflective surface. However, the three-dimensional shape of a reflective surface can sometimes mirror structures that are not located in the respective scanning plane, thereby complicating correct interpretation<sup>15</sup>.

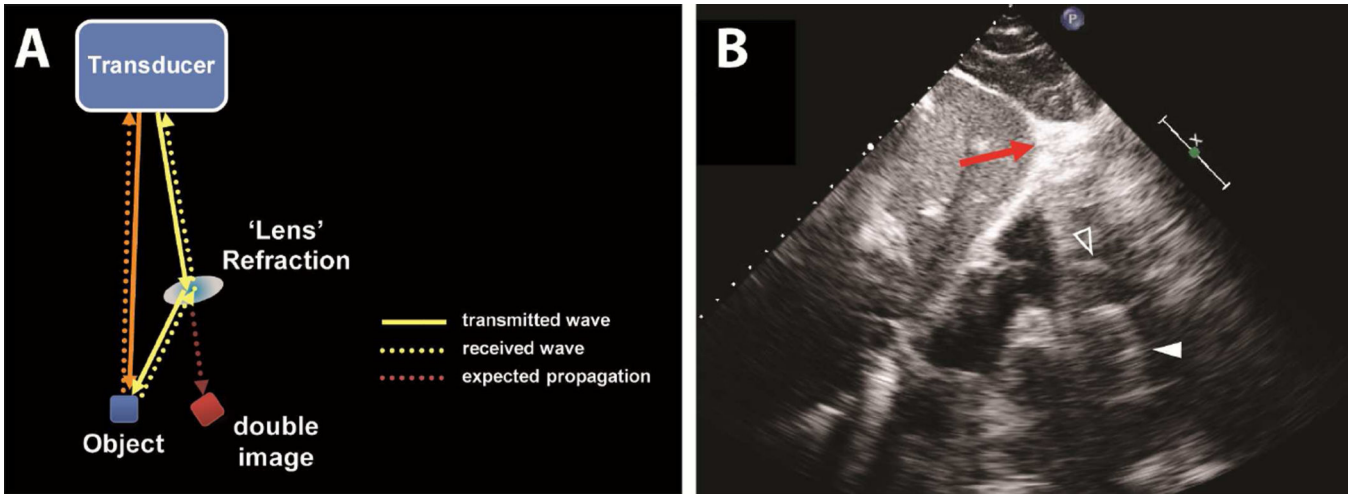
**Figure 4. Refraction artifact**

(A) The theoretical genesis of a refraction artifact. Ultrasound waves directed through a 'lens' are refracted towards the respective cardiac object and back, resulting in a duplicate of this object in the initial beam direction (animation in Movie Clip 6). (B) Double image of the aorta (full arrowhead) in a subcostal short-axis image of the heart, due to refraction of the ultrasound beam at perihepatic fatty tissue (arrow). A Swann-Ganz catheter in the right ventricular outflow tract is doubled as well (empty arrowhead). Moving images in Movie Clip 7.

In routine clinical practice refraction artifacts are typically recognizable because they create impossible anatomic relations, such as intersecting duplicated images of the mitral valve in long-axis imaging<sup>22</sup>, or the aortic root and left ventricle in short-axis imaging (Figure 4)<sup>21</sup>. However in apical long-axis images more subtle doubling of the ventricular wall can occur due to refraction at the apex (pericardium, fat) complicating assessment of left ventricular dimensions and ejection fraction. Adjusting the image settings and changing the probe angulation are possible strategies to avoid refraction in such cases<sup>7</sup>.

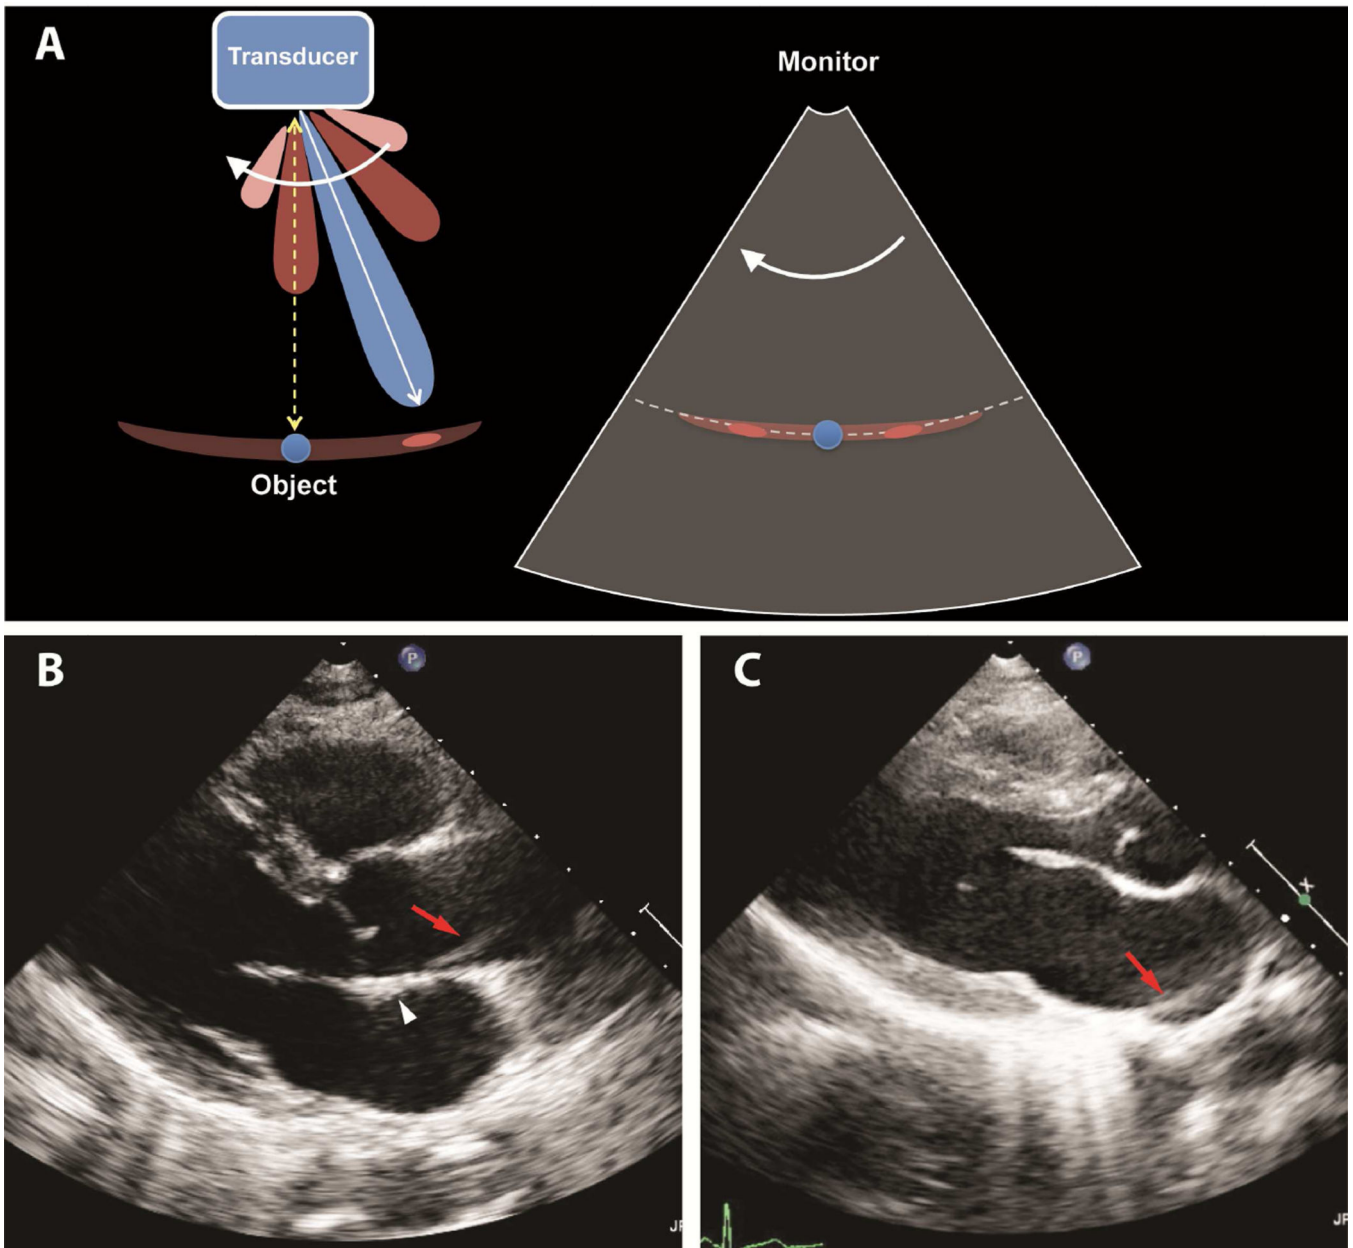
**Figure 5. Side lobe artifact**

(A) The genesis of a side lobe artifact. While ‘interrogating’ the imaging plane in a radial direction, side lobe energy can encounter a strong reflector. Reflections of side lobe energy are interpreted as if originating from the direction in which the transducer is ‘looking’. Ultimately, this leads to a linear ‘arc-like’ artifact at both sides of the strong reflector (short animation in Movie Clip 8). (B) Parasternal long axis view with linear side lobe artifact (arrow) in the aorta ascendens due to a calcified sinotubular junction (arrowhead). This artifact can sometime be misinterpreted as a dissection flap. (C) Parasternal long axis view of a healthy patient with strongly reflecting pericardium, causing a side lobe artifact in the left atrium (arrow). In moving images (Movie Clip 9) comet-tail reverberations, acoustic

shadowing, near field clutter and a mirror image of the mitral valve leaflets can be observed as well.

Clinical recognition is important to avoid misdiagnosis of thrombi or vegetations generated by side lobe artifacts from highly reflective annular or prosthetic interfaces. In addition, side lobe artifacts from highly reflective aortic sinotubular junctions could be mistaken for aortic dissection flaps (Figure 5–B).

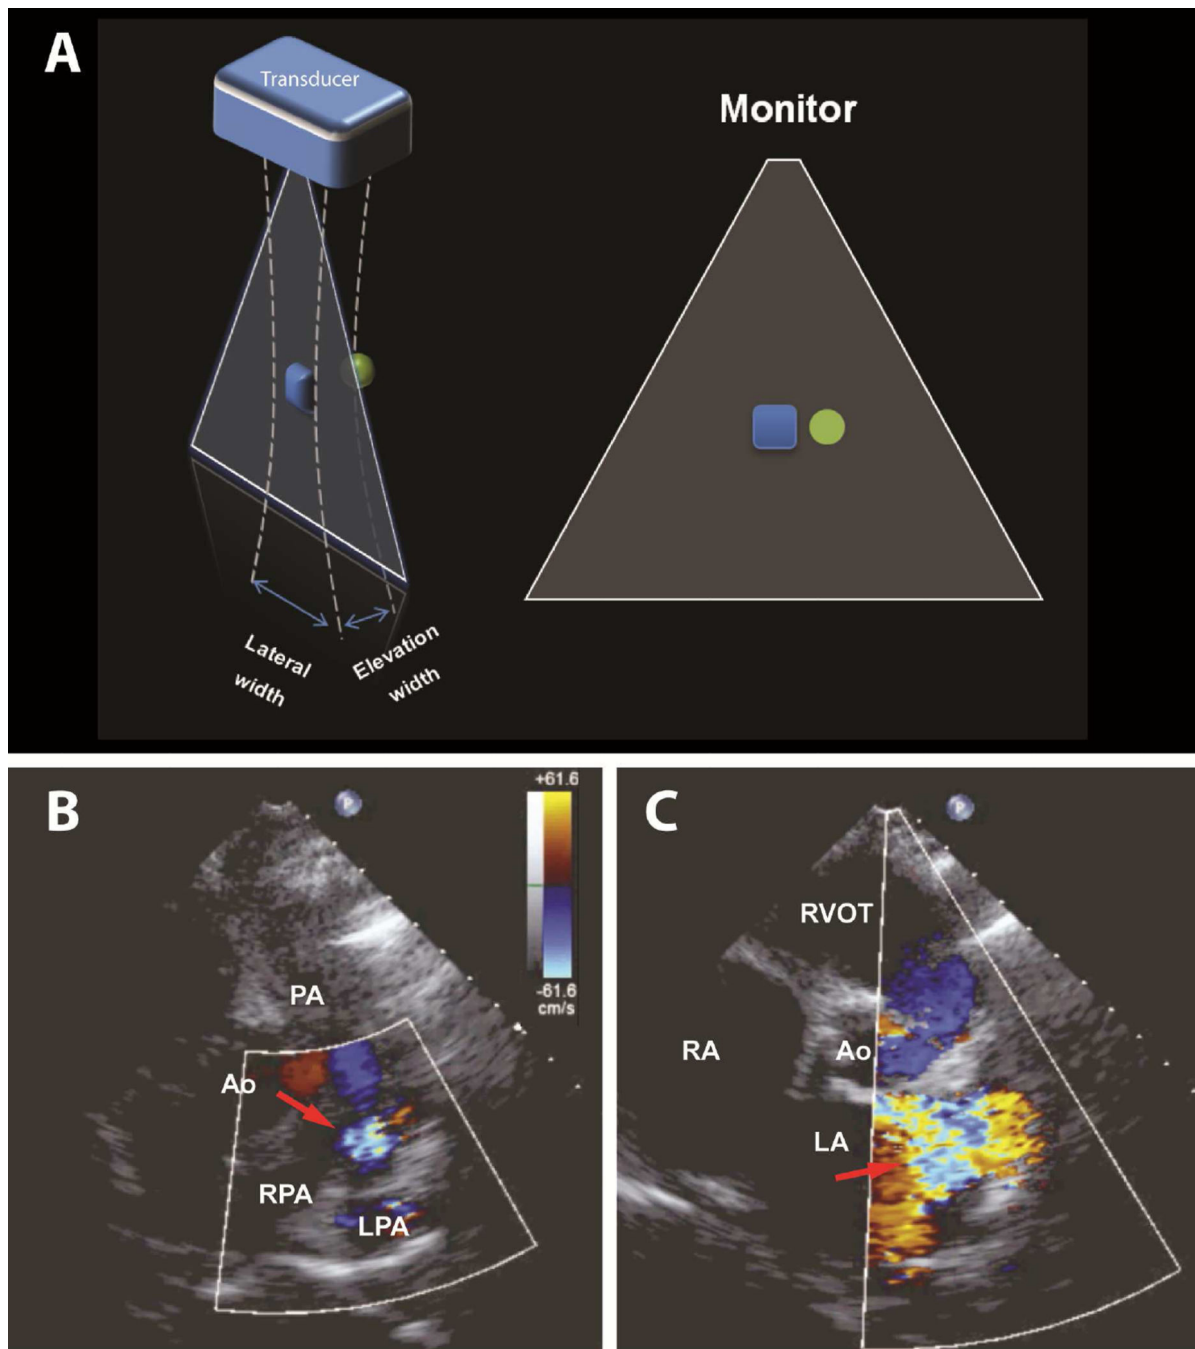
**Figure 6. Beam width artifact**

(A) The lateral width and elevation width of the ultrasound beam respectively cause a decrease in lateral resolution and the occurrence of beam width artifacts. The blue squared object within the scanning plane is correctly identified in the center of the beam. However, due to the elevation width of the beam, the green circular object outside of the imaging plane is incorrectly positioned within the scanning plane. (B) Parasternal short-axis image of pulmonary arteries showing unexplained turbulent flow into the left pulmonary artery (LPA, arrow), without evidence of shunting or stenosis. (C) Tilting of the probe out of the scanning

In clinical practice, beam width artifacts from highly reflective annular or prosthetic interfaces could be confused for thrombi or vegetations (similar to side lobe artifacts). Furthermore, it is important to recognize out-of-plane artifacts displaying strong Doppler signals in adjacent structures, e.g. disturbed LVOT flow in aortic stenosis patients producing apparent tricuspid regurgitation (TR) (without typical direction or vena contracta) or prominent mitral regurgitation (MR) eccentrically directed toward the LAA producing apparently disturbed systolic flow in the pulmonary artery (Figure 6, B–C).

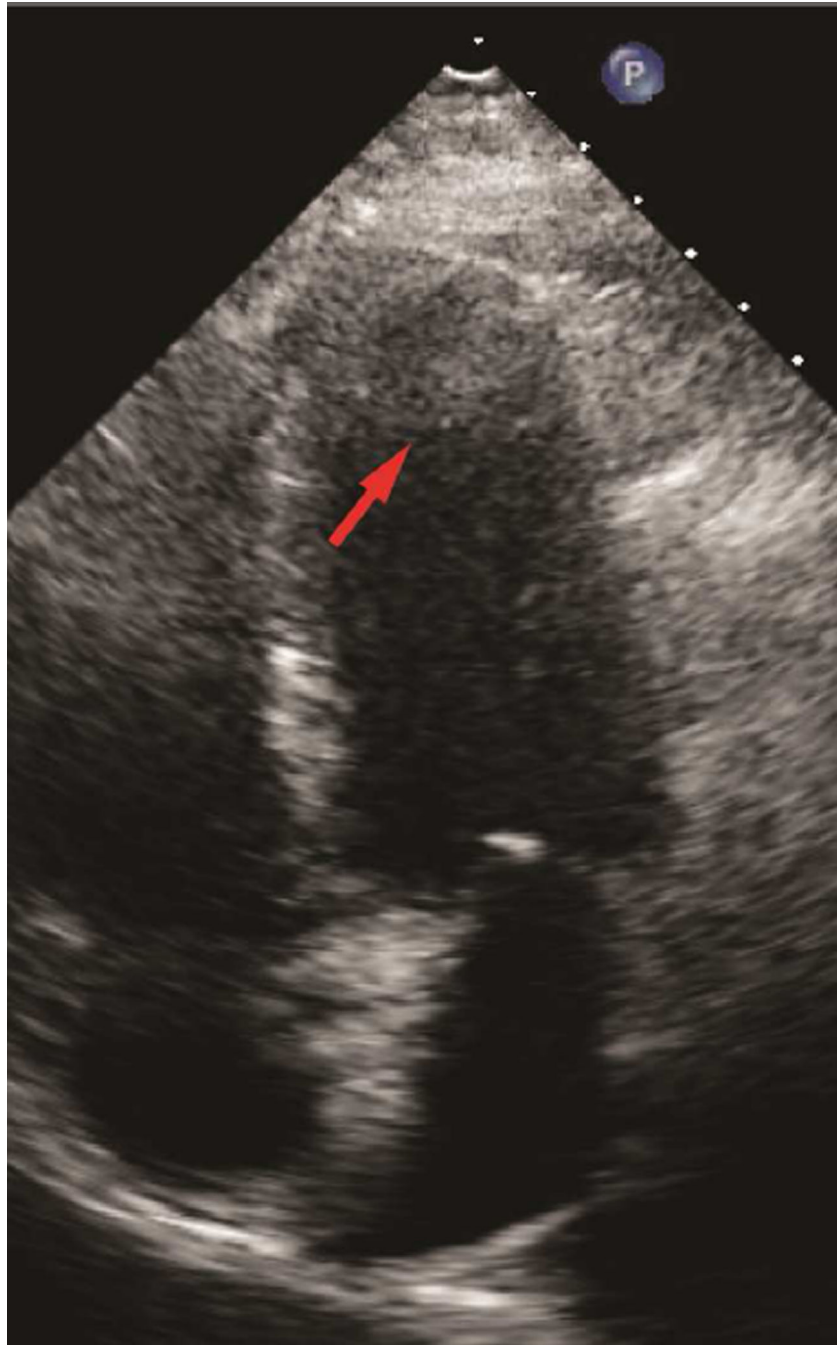
**Figure 7. Near field clutter** (arrow) in apical 4-chamber view, mimicking apical thrombus. Moving images (Movie Clip 10) show normal apical myocardial kinetics, and no relationship between clutter and myocardial motion.

Structures in the near field are sometimes obscured due to the high amplitude of oscillations by the transducer itself, causing a so called "near field clutter"<sup>7</sup>. This is especially relevant in case an apical ventricular thrombus is suspected (Figure 7, Movie Clip 10). The introduction of harmonic imaging and the technologic advances in transducer design have already reduced the occurrence of this type of artifact. In contrast to a thrombus, clutter is unaffected by ventricular wall motion and appears to pass through the wall. When uncertain, one can apply color Doppler and reduce the scale in order to demonstrate blood flow through the apex, thus refuting the possible thrombus; alternatively, one can switch to other (parasternal/subcostal) imaging planes or use contrast echocardiography to confirm or refute the presence of an apical thrombus.

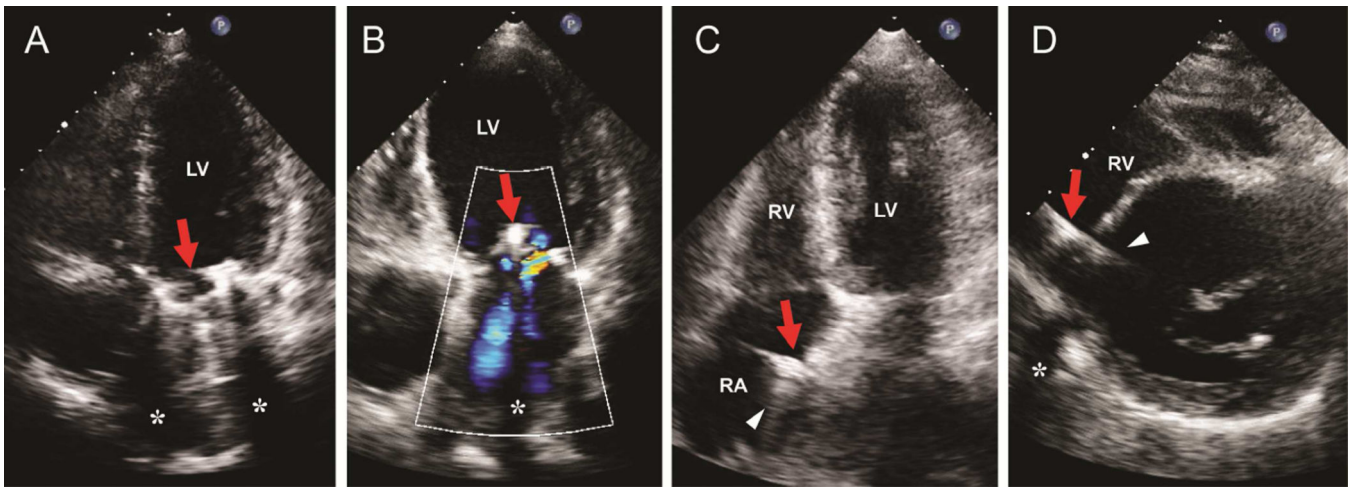
**Figure 8. Cardiac devices as a source of image artifacts**

(A) Mechanical mitral valve prosthesis causing multiple reverberations and comet-tails below the prosthesis (arrow) as well as two acoustic shadowing regions below the prosthesis frame (\*) (Movie Clip 11). (B) Acoustic shadowing (\*) distal from an implanted MitraClip device (arrow). Notice the shadowing of the color flow signal as well, potentially leading to underestimation of residual mitral regurgitation post clip. (C) Pacemaker wire in right atrium (arrow) with linear comet-tail reverberation (arrowhead) below the wire and side lobe artifact extending in radial direction. (D) Defibrillator wire in right ventricle (arrow) with linear arc-like side lobe artifact crossing the anatomical borders (interventricular septum). Should not be misinterpreted as a dislocated (perforated) wire into the left ventricular cavity (Movie Clip 12). RA, right atrium; RV, right ventricle; LV, left ventricle;

Implantable cardiac devices such as pacemaker/ICD leads, catheters, mechanical circulatory support devices, and valve prostheses, typically represent strong reflectors that are prone to the above reflection-related artifacts (reverberations/comet-tails, shadowing and mirroring) as well as side lobe and beam width artifacts<sup>27, 28</sup>. Cardiac devices therefore complicate the interpretation of echocardiographic images (Figure 8), and demand careful examination of the device and surrounding structures from different imaging views.

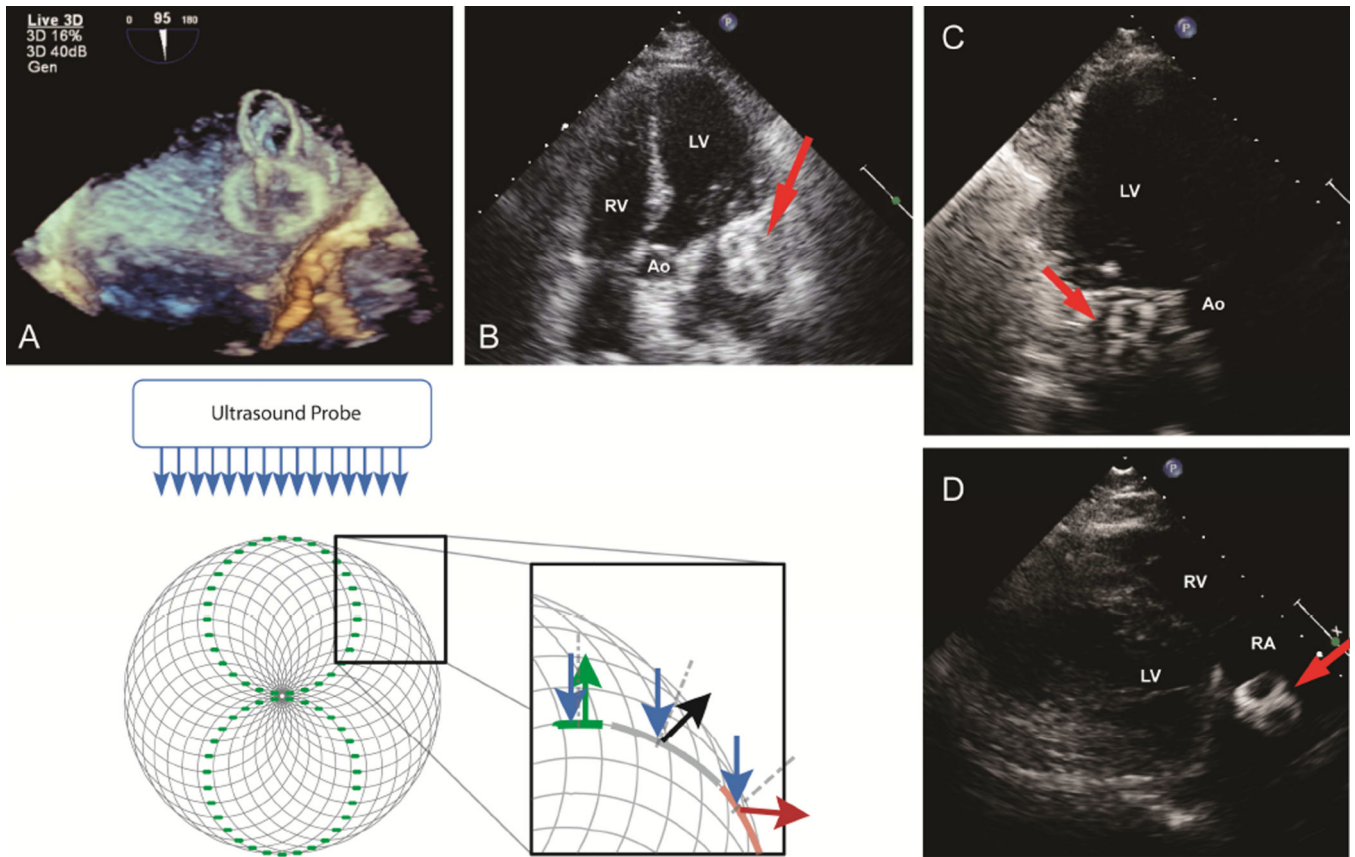
**Figure 9. The figure-of-eight artifact in the echocardiographic assessment of disc occluders**  
 (A) Three-dimensional echocardiography of an Amplatzer Cardiac Plug after successful implantation in left atrial appendage. (B) Apical 5-chamber view in the same patient, with an Amplatzer Cardiac Plug in the correct position presenting as a figure-of-eight (Movie Clip 13). (C) Apical 3-chamber view (slightly off-axis) in a patient following left atrial appendage occlusion. (D) A patent foramen ovale (PFO) occluder device in a parasternal off-axis image of the interatrial septum in a patient a few years after PFO occlusion (Movie Clip 14). (Central image) Because of the epitrochoidal mesh geometry of the disc occluders, sound is reflected back to the probe only by the small segments of mesh with fibers orthogonal to the beam direction. These align in a figure-of-eight (as shown by the green lines on the figure). Adapted from Bertrand et al.<sup>29</sup> with permission.

In addition, devices with specific geometric designs can sometimes generate uncommon artifacts due to the interaction between ultrasound waves and the device geometry, bearing in mind the physical principle that for a specular reflector the angle of reflection equals the angle of incidence. The *figure-of-eight* artifact (Figure 9) obtained when imaging a percutaneous disc occluder is a typical example of such a device-specific artifact based on

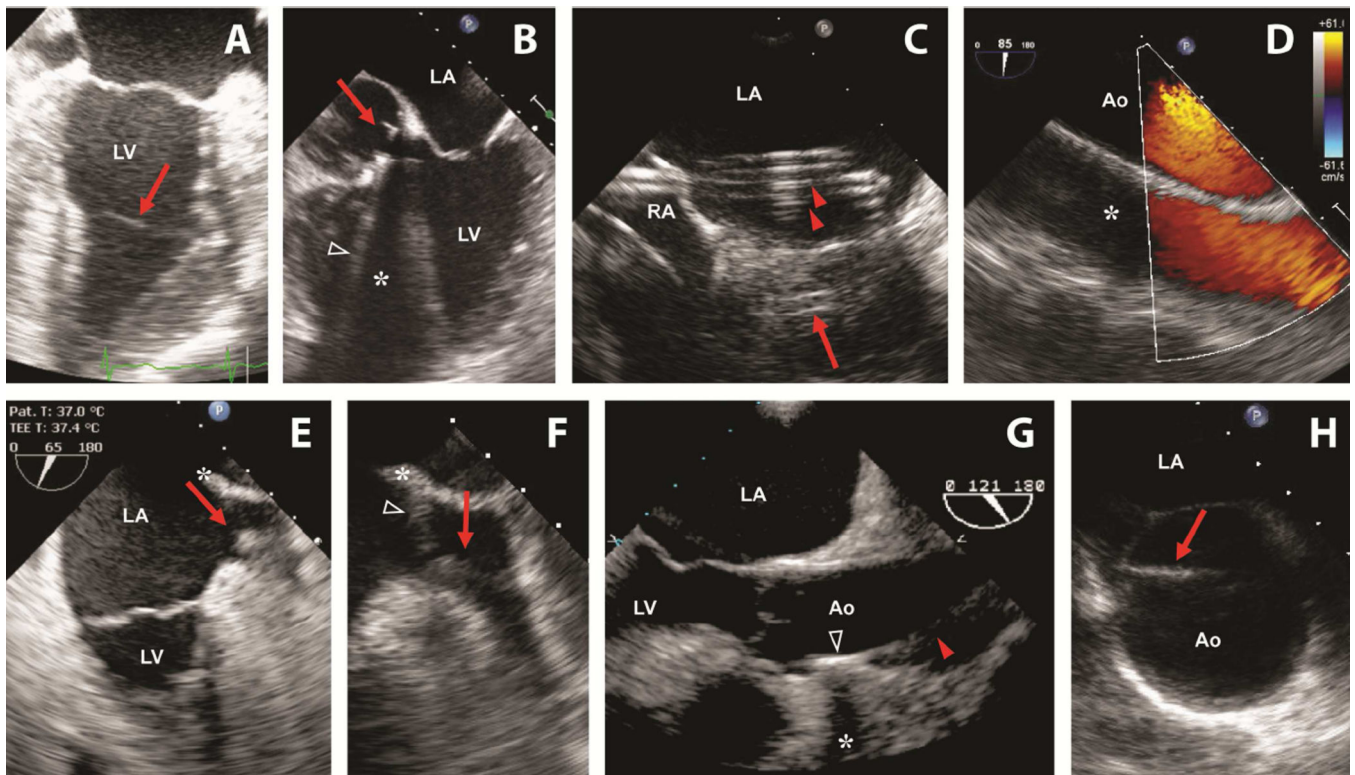
**Figure 10. Transesophageal image artifacts**

(A) Reverberation artifact of mitral valve leaflet at exactly twice the distance from the probe, presenting as a wire in the left ventricular cavity (Movie Clip 15). (B) Mechanical aortic valve casting an acoustic shadow over the majority of the right ventricle (\*) and a reverberation (comet-tail) to the side (arrowhead) (Movie Clip 16). (C) Transseptal guiding catheter during pulmonary vein isolation procedure presenting with a series of closely-spaced reverberations (arrowheads) due to reflections at the upper and lower side of the (hollow) catheter and one reverberation at twice the distance to the probe due to reflection at the transducer itself. (D) Mirror artifact (\*) of the ascending aorta mimicking two parallel aortas. Notice the mirroring of the color flow in the mirror image as well, the mechanism being similar i.e. the assumption of wave propagation (Movie Clip 17). (E) Reverberation artifact in the left atrial appendage mimicking thrombus. Detailed analysis from multiple angles (F) and applying color flow imaging in the respective region confirms the presence of a reverberation from the warfarin ridge (\*) rather than true thrombus (Movie Clips 18–20). (G) Side lobe artifact (arrow) from a calcified sinotubular junction (arrowhead) extending in the ascending aorta (Movie Clip 21) should not be misinterpreted as a dissection flap. (H) Similarly, a reverberation in the ascending aorta might be misinterpreted as being a dissection flap.

mirroring mechanism, further enhancing confusion of two adjacent vessels instead of one (Figure 10-D). A special case of Doppler flow mirroring is so-called pseudo-MR in mechanical mitral valve prostheses due to mirroring of left ventricular outflow tract (LVOT) flow as will be discussed below<sup>17-19</sup>.

Although this overview article is mainly focused on routine transthoracic echocardiography, the above artifacts are frequently encountered in transesophageal echocardiography as well.<sup>4, 23, 39–41</sup> Figure 10 displays a selection of common artifacts in transesophageal echocardiography. The most relevant clinical situations in this respect are: (1) excluding thrombus in the LAA (Figure 10, E–F), and (2) excluding aortic dissection<sup>42</sup> (Figure 10, G–H). Reverberations, mirror artifacts and side lobe artifacts in particular play an important role in these settings due to the often linear aspect of the artifact resembling a dissection flap in the ascending or descending aorta<sup>43–47</sup>, or mimicking a thrombus in the LAA<sup>48, 49</sup>. Historically, lack of recognition of artifacts in transesophageal echocardiography for aortic dissection created the impression that echocardiography lacked specificity for the diagnosis relative to other modalities such as magnetic resonance imaging<sup>50</sup> – a misimpression that can be eliminated by understanding the nature of artifacts. Furthermore, in the early years of transesophageal imaging, occasional patients were being operated on because of artifacts – now largely eliminated by our understanding. Even so, to date patients are still being anticoagulated rather than immediately cardioverted for atrial fibrillation because of image artifacts. This again shows the importance of understanding the physics of ultrasound reflection, refraction, and beam formation – a practical consequence of that knowledge.
