Effects of Mobile Telephones on the Function of Implantable Cardioverter Defibrillators

Objective: We investigated whether mobile telephones affect the function of implantable cardioverter defibrillators (ICDs).

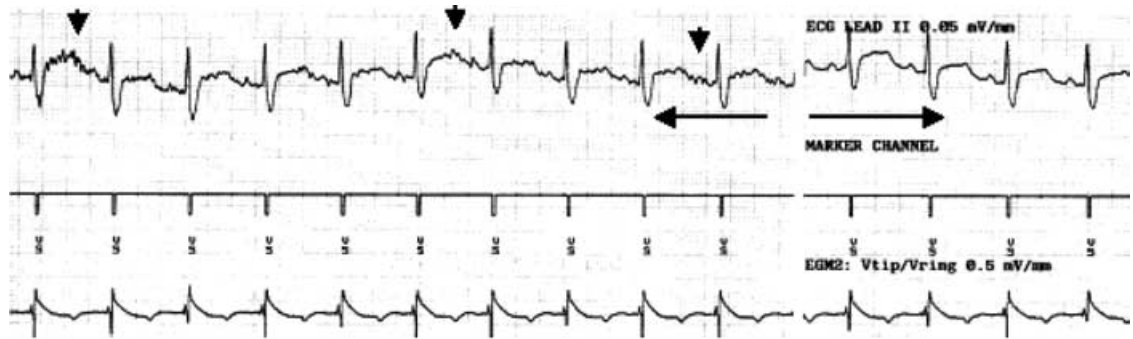
Figure 1. The programmer electrocardiogram (top trace) of one ICD recipient (Patient 40) showed artifacts (indicated by arrows) while the one mobile phone was ringing, and while the investigators were communicating over the two phones (8594;). The simultaneous intracardiac electrocardiogram revealed no artifacts. The artifacts disappeared when the mobile phones were switched off (8594;).

In 4 patients with Medtronic units (patients 31, 33, 38, and 40) and 1 patient with a Guidant unit (patient 8), there were intermittent artifacts on the surface ECG of the programmer while the mobile phones were ringing and during phone communication (Fig. 1). The size and frequency of these artifacts were correlated with the distance between the mobile phones and the programmer head, and was greatest when the phone antennae were in contact with the programmer head. The intracardiac ECGs recorded simultaneously showed no such artifacts.
