Experimental and Numerical Analysis of Multiple Low-Velocity Impact Damages in a Glass Fibered Composite Structure

Abstract: Glass fiber-reinforced polymer structures (GFRPS) are widely used in civil and mechanical fields due to their light weight and corrosion resistance. However, these structures are prone to damage with very-low-energy impacts. The reliability of such structures is of prime importance before their installation and usage. This study aimed to identify, visualize, localize, and verify multiple barely visible impact damage (BVID) in a GFRPS using a combination of guided waves (GW)-based online structural health monitoring (SHM) and thermal strain-based nondestructive testing (NDT) approaches. Global NDT techniques like the use of a laser Doppler vibrometer (LDV) and digital image correlation (DIC) were used in the experimental analysis. The effectiveness of the experimental LDV-GW process was also checked numerically with the spectral element method (SEM). A threshold-based baseline free SHM approach to effectively localize the damages was proposed along with quick DIC verification of composite structure with thermal loading based on short-pulse heating as an excit

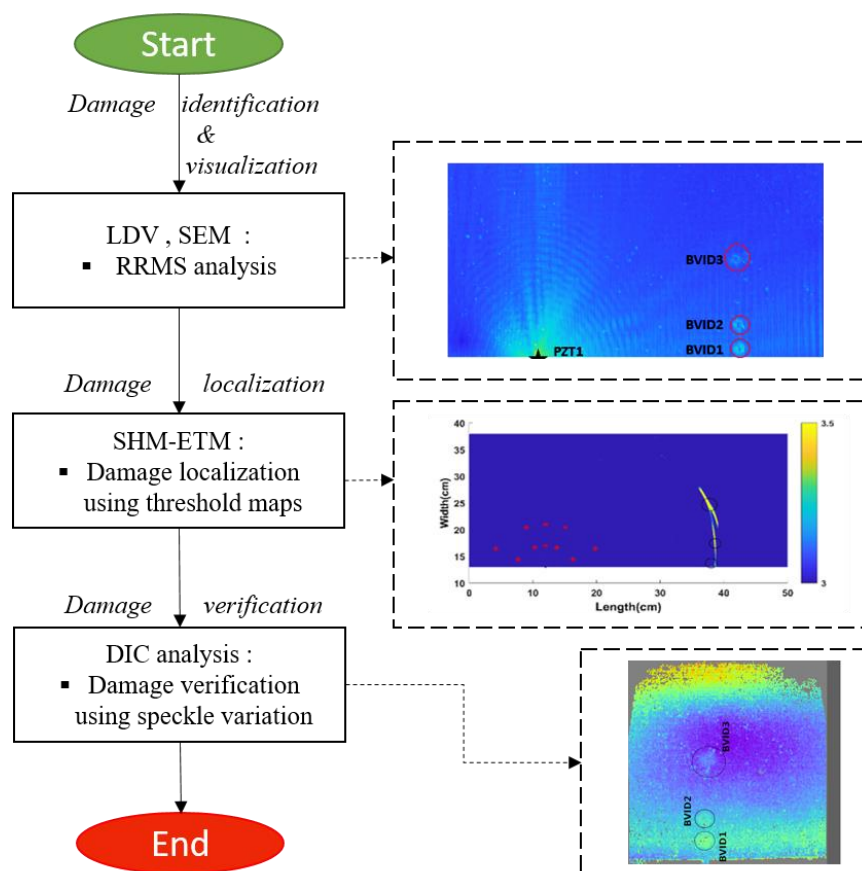
The flowchart (Figure 1) briefly explains the methodological process involved in analyzing the GFRPS using combined NDT and SHM methods. The process involves damage-identification, visualization, localization, and verification.

Figure 1. The methodological flow chart in damage analysis.

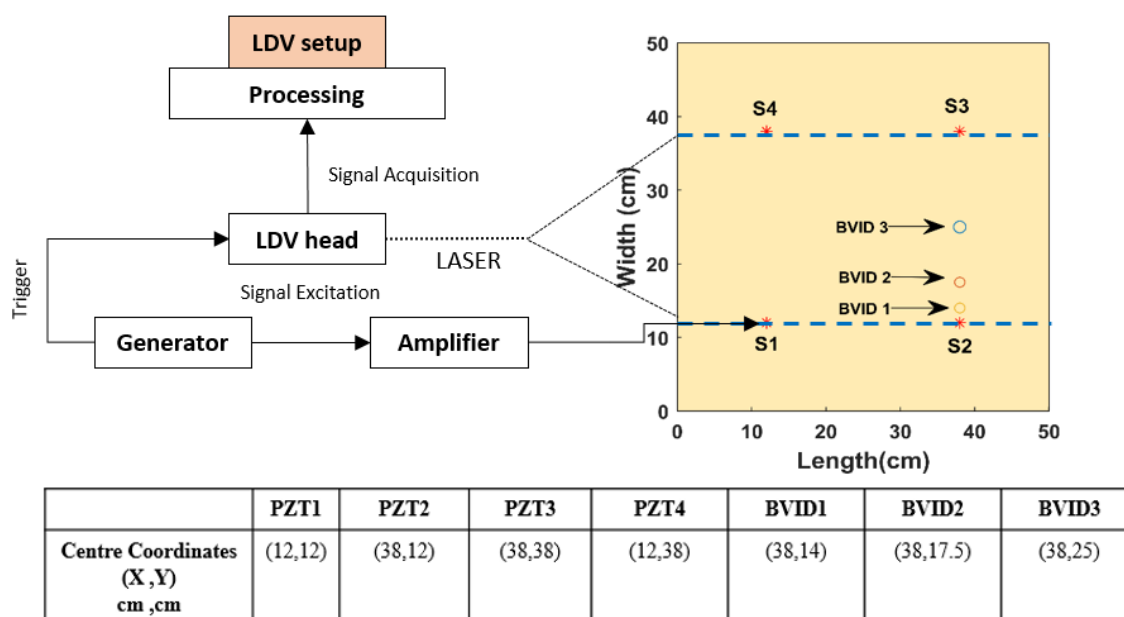
The 0.2 cm thick GFRPS has 12 layups stacked in $[0/90]_{3s}$ format, which are bonded together by HEXCEL-212Na adhesive. The material is procured from the G.ANGELONI group [30] (Venice, Italy). These materials are largely used in the mechanical and construction industries. The GFRPS is of dimensions $50 \times 50 \text{ cm}^2$ in length and breadth. Multiple BVIDs of $\varnothing 0.9 \text{ cm}$ (BVID1) and $\varnothing 1.2 \text{ cm}$ (BVID2 and BVID3) are made with an impact force of 20, 25, and 30J. This is done by dropping a steel ball attached to a steel beam from varying heights guided via a pipe. All the 4 PZTs ($\varnothing 1 \text{ cm}$ and 0.1 cm thin) are made from SONOX material P502 [31] and are attached to the GFRPS using cyanoacrylate glue. The PZTs (S1–S4) and BVIDs location coordinates are presented in Figure 2.

Figure 2. Schematic LDV experimental setup used with PZT and BVID coordinates.

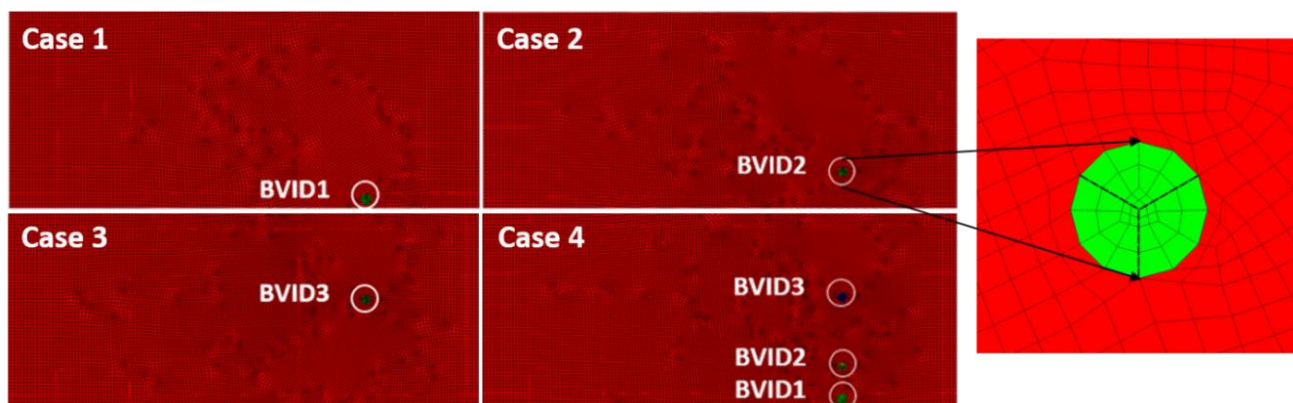
**Figure 3.** SEM_GFRP model cases studied.

The four model cases (Figure 3) were made numerically as the structure obtained already had three BVIDs in the initial state itself. Thus, SEM models added an advantage to visualize how the GW propagation would be with the individual BVIDs.

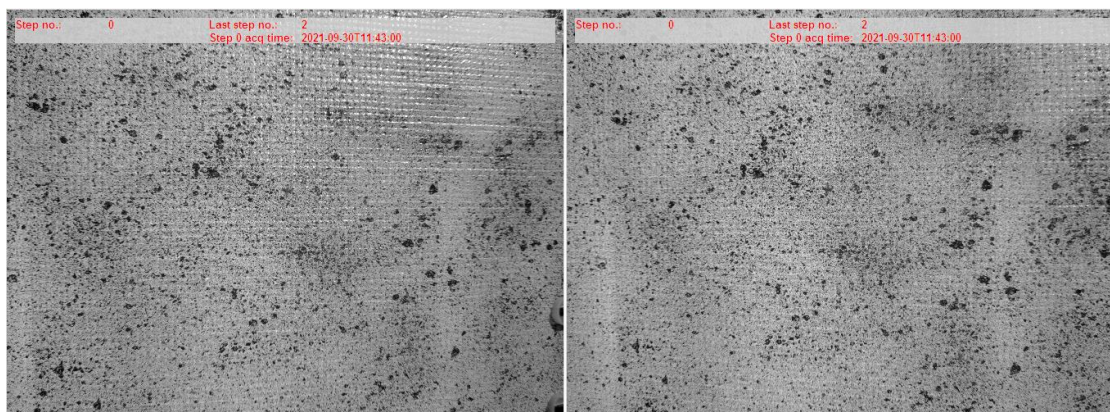
The examined GFRPS was coated by the typical DIC speckle pattern (registered by two cameras as shown in Figure 6), so the damages were invisible. The specimen was observed under the heating process realized by the light source. Since the damage location was initially localized with SHM, the lamps were focused in the localized area. The reference picture was made at stable room temperature, and then the whole heating took two minutes. During this time, each camera registered two new photos every one second (sampling frequency equal to 2 Hz). For the analysis of picture sequences, the commercial ISTRA 4D software (version 4.6) was used.

Figure 6. The exemplary view, which was registered by camera no. 1 (left) and camera no. 2 (right). The defects were invisible.

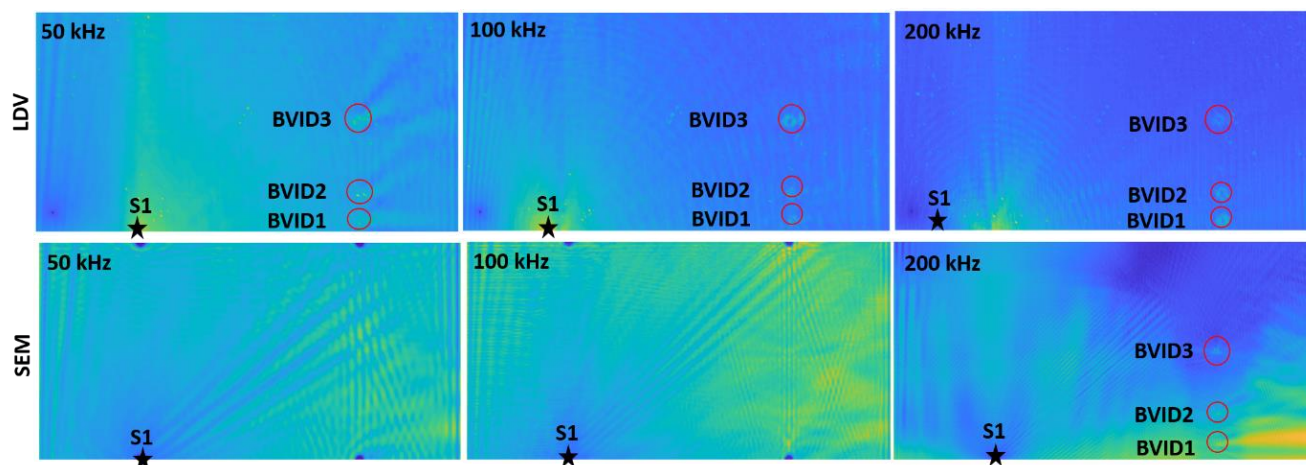
RRMS studies were carried out with the LDV and SEM data to visualize the damage. A constant power/weight factor value of $a = 0.5$ was used for all the calculations. Table 2's case results are shown in Figures 7 and 8. Initially, cases 4 and 5 (Figure 7) were considered for the visualization study as they represent the real damage scenarios.

Figure 7. Cases 4 and 5: LDV_RRMS and SEM_RRMS plots for S1 excitation.

After analyzing all the frequencies, it was found that both LDV_RRMS and SEM_RRMS 200 kHz plots identified all the BVIDs more prominently with rounded red circles (Figure 7). Table 2's other cases (1–3) were also checked only with 200 kHz. Thus, only 200 kHz was chosen as the identified frequency for other RRMS and SHM results (Section 4.2). The SEM_RRMS plots, as shown in Figure 8, identified the inner numerically made BVIDs (1, 2, and 3) separately and proved that the methodology can be used for single damages.

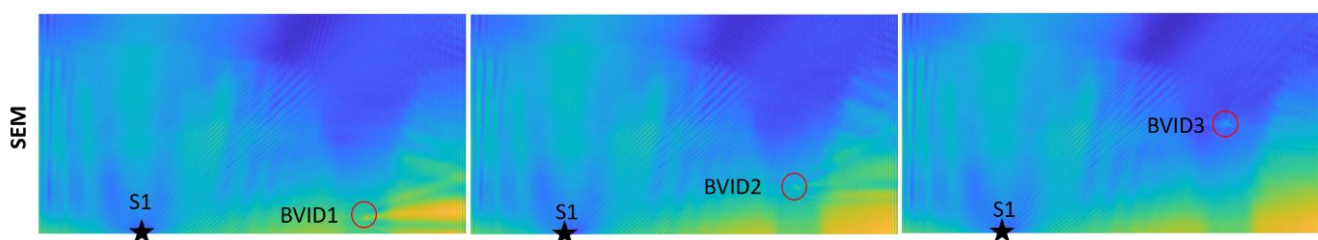
Figure 8. Cases 1, 2, and 3: SEM_RRMS plots for 200 kHz excitation.

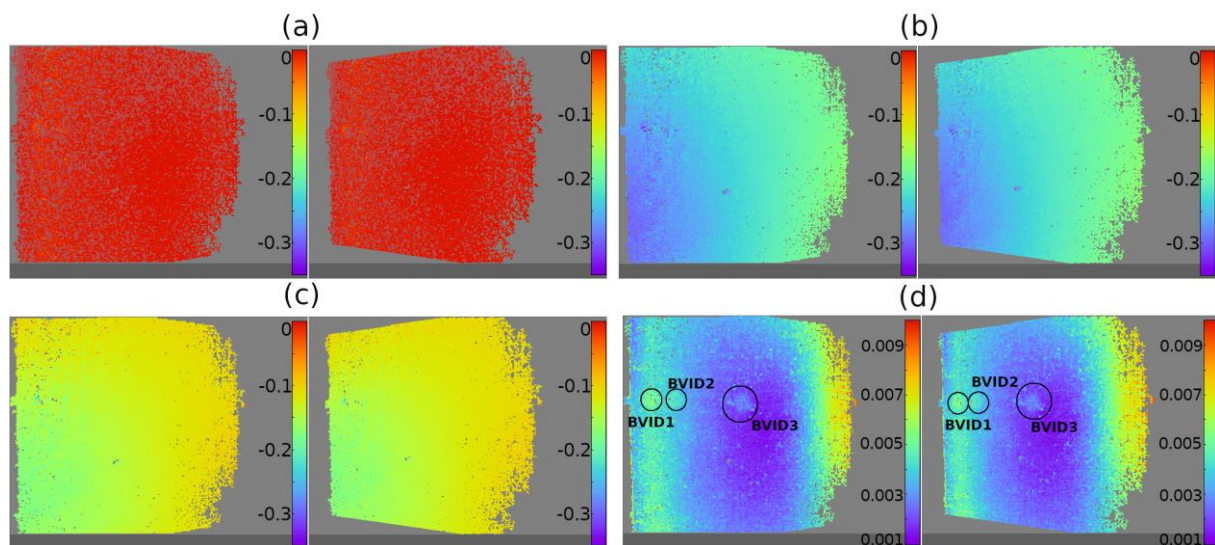
The collected data were carefully analyzed, considering the displacements in three directions and strain fields. In Figure 11a–c, the horizontal displacement of points in the first, 120th, and 240th steps (after two minutes of heating) were shown, respectively. In the figures, the horizontal displacement field was quasi even in each step and corresponds to the boundary conditions (clamping on the right side). In such a short period of heating, there were no visible differences between point displacements in damaged and undamaged regions.

Figure 11. Horizontal displacement of points obtained by DIC measurements: (a) the first step (0.5 s of heating), (b) the 120 steps (after one minute of heating), (c) the 240 steps (after two minutes of heating), and (d) the estimated standard deviation of the displacement in the horizontal direction (mm). In (a–c) the color was kept: from 0.35 mm (violet) to 0 mm (red).

However, the estimated standard deviation of the displacement in the horizontal direction for every data point (shown in Figure 11d) allows to differentiate the failure areas (damages); the standard deviation for damages was greater than for healthy regions in the neighbourhood. Similar observations were made for the other directions.
