Reprocessed Materials Used in Rotationally Moulded Sandwich Structures for Enhancing Environmental Sustainability: Low-Velocity Impact and Flexure-after-Impact Responses

Keywords: rotational moulding; sandwich; environmental sustainability; reprocessed materials; low-velocity impact (LVI); flexure-after-impact (FAI); impact damage

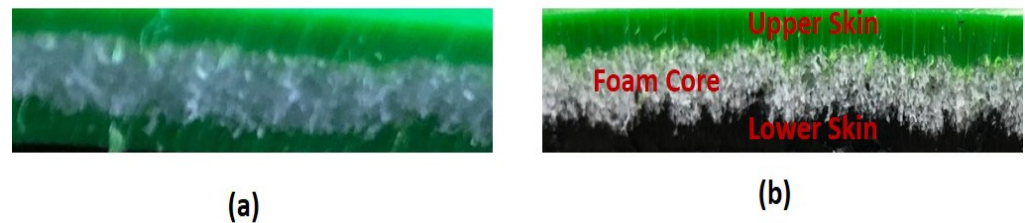
Figure 1. Rotationally moulded (a) non-reprocessed and (b) reprocessed sandwich structures.

Similar manufacturing conditions were used for manufacturing of both types of sandwiches. The upper skin layer material was added first inside the mould (Ferry Industries, Stow, OH, USA), and heated up to 135 °C by placing the mould in the heating oven (Ferry Industries, Stow, OH, USA); after that, the mould was taken out from the oven to add the foam core materials and heated back in the oven up to 160 °C; finally, the lower skin layer materials was added following the same method and heated up to 195 °C to fully expand the foam core layer along with the proper formation of the upper and lower skin layers. Examples of sandwich samples are given in Figure 1.

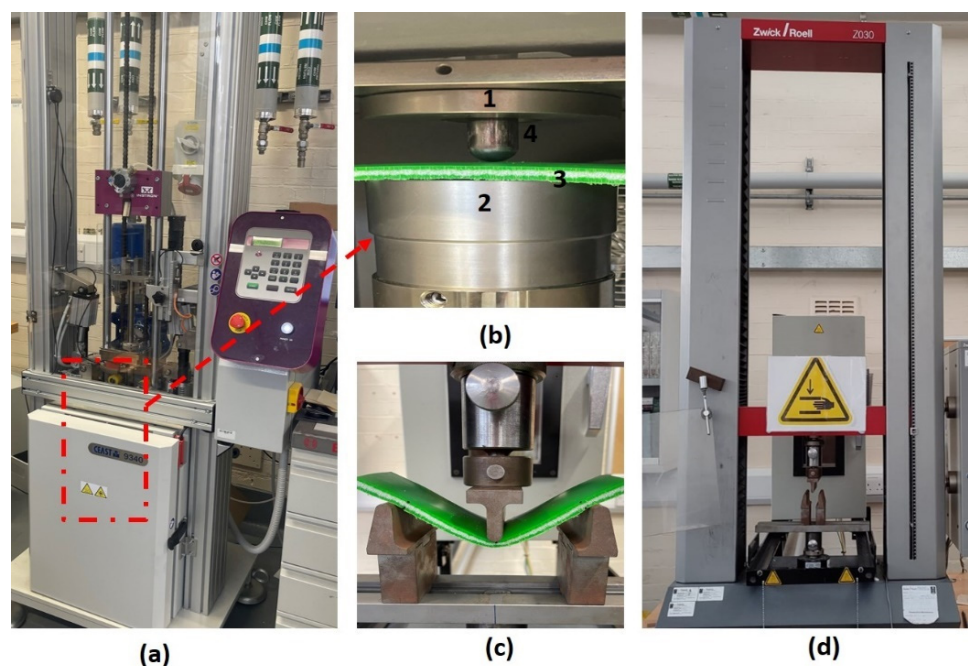
Figure 2. Testing equipment and set-up; (a) low-velocity impact testing machine, (b) impact testing sample holder arrangement (1 and 2—upper and lower parts of the sample holder, respectively; 3—sandwich specimen; 4—impactor nose), (c) three-point bending set-up with sandwich specimen for flexure-after-impact (FAI) test, and (d) FAI test machine.

An instrumented falling-weight impact tester (INSTRON CEAST 9340, Norwood, MA, USA) was used to conduct the low-velocity impact test (LVI) of sandwich structures (Figure 2). ASTM-D3763-02 standard was followed to perform the testing at 15 J and 30 J incident energy levels. The hemispherical impactor nose had a diameter of 19 mm. Initially, sandwich panels were cut from the 300 mm cube moulded products, and these panels were utilized to obtain the testing specimens with dimensions of 200 mm length, 75 mm width, and 8 mm thickness. LVI tests were carried out by placing and clamping test specimens in the sample holder of the impact machine. The impactor hit the specimens on upper skins. For each sandwich type, three specimens were tested at each impact energy level. From the impact testing, force-time, force-deflection, and absorbed energy-time data were analysed.

A three-point-bending test set-up was used for measuring the FAI properties of impacted and non-impacted reprocessed and non-reprocessed sandwiches in order to measure, compare, and analyse their post-impact residual strength and behaviours. FAI tests were performed following the ISO-178 [19] test standard in a Zwick/Roell, (Stourbridge, UK) universal tester with a 10 kN load cell, support span length of 130 mm, and 3 mm/min displacement rate up-to a total deflection of 50 mm (Figure 2). Three specimens were tested for both impacted and non-impacted specimens of reprocessed and non-reprocessed sandwich types. The test specimen deflection was measured according to the ISO-178 test standard requirements from the test machine's crosshead displacement, applying the compliance correction. Residual strength values were calculated at flexural impact force points (F_m) using the following equation:

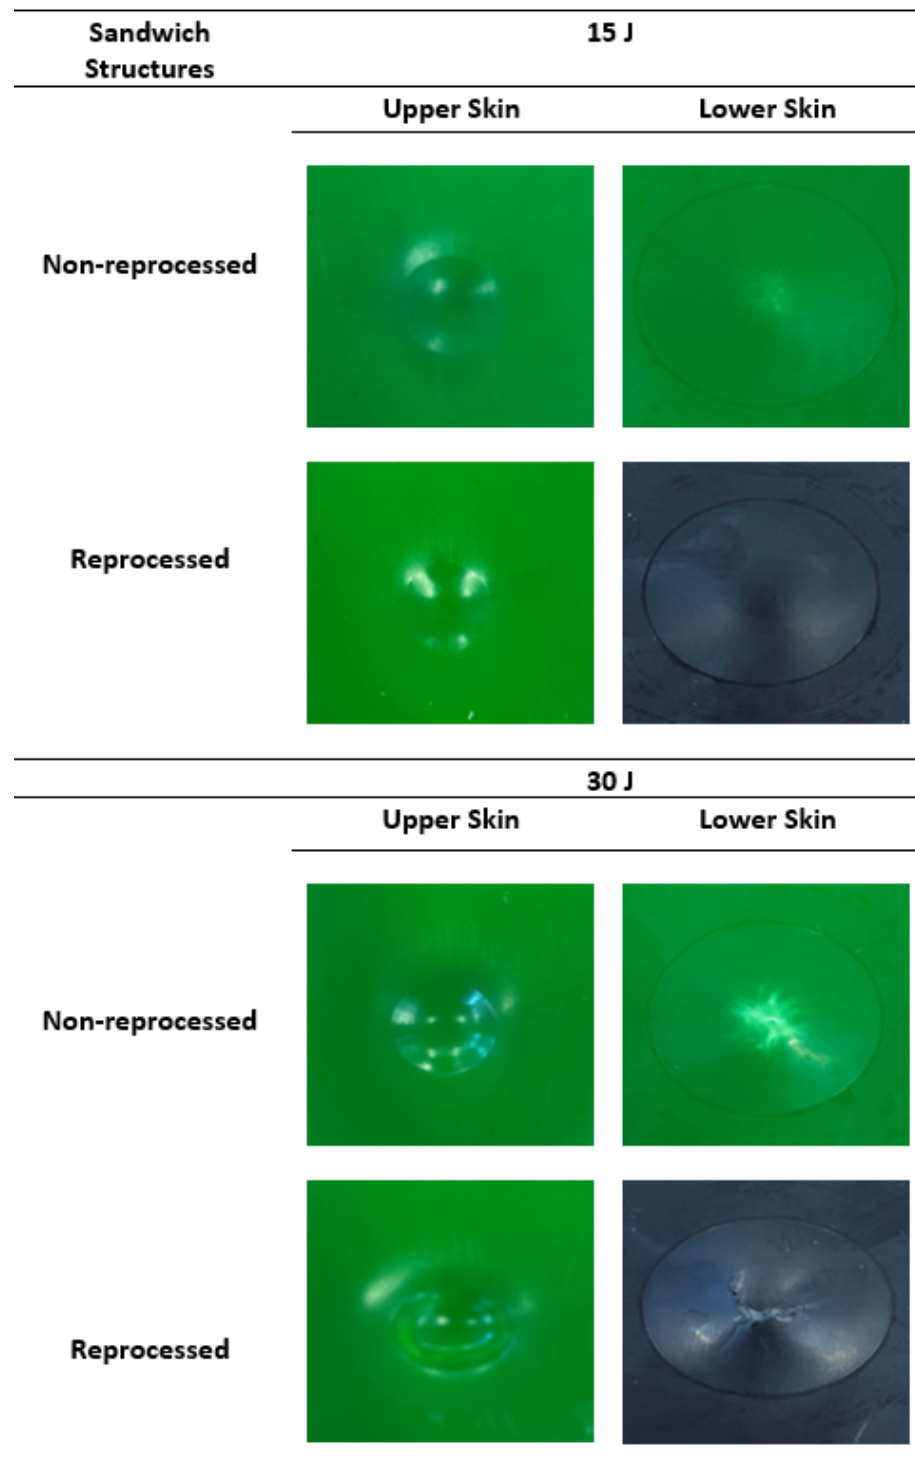
Figure 4. Impact damage at lower and upper skins of non-reprocessed and reprocessed sandwich structures at 15 J and 30 J impact energy levels.

Figure 4 provides the outer and lower skin images of non-reprocessed and reprocessed sandwich specimens after impact at 15 J and 30 J to understand the initial and overall damage mechanisms. The indentation depth was seen on upper skins for both sandwich structures, and the indentation depth became deeper with increasing impact energy levels, as expected. At 15 J impact energy, the non-reprocessed sandwich showed protrusions with white stretch marks at the lower skins. Similarly, reprocessed sandwich specimens showed protrusions but no white stretch marks, and this could be due to the use of black colour pigment for moulding the lower skins of reprocessed sandwiches, which ultimately made the white stretches invisible. The protrusion area was increased with the impact energy level. The white stretch marks became larger and more obvious at 30 J without any crack in the lower skins for non-reprocessed specimens. Reprocessed sandwich specimens clearly showed a large crack in the lower skin at 30 J. This supports the earlier observation in Section 3.1 about a slight drop in the peak impact force of force-deflection or force-time graphs of reprocessed sandwich structures.

Comparing damage at 15 J and 30 J impact energies of both sandwich types, it is clear that the crack starts from the lower skins, and this observation was also found in previous studies [5,6]. When the impactor attacks and transfers impact energy to the upper skins in an impact event, the compression force is applied, and the indentation depth is created. This ultimately leads to the bending of whole structure and particularly the tension or stretching force in the lower skins. As a result of this, white stretch marks are clearly formed in the lower skins. Due to the bending, the foam core layer is squeezed along its

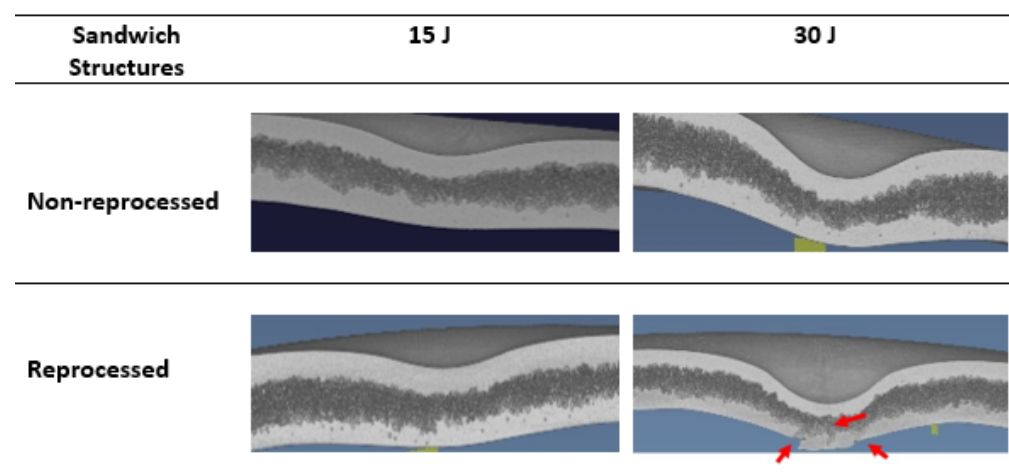
Figure 5. Section views of the X-ray damage images taken at the middle of the damage area of impacted non-reprocessed and reprocessed sandwich specimens at 15 J and 30 J impact energy levels. Red arrow marks indicate the cracks.

thickness reduction. For the further increase of impact energy level, the stretching or tension force is reached in their upper limit, and hence, they cannot be accommodated further, which ultimately creates a crack in lower skins. To investigate this damage mechanism in details, the X-ray μ -CT scanning technique was used to scan the inside of the damage area. This X-ray scanning normally supplies the damage images in cross-sections of different layers that help to understand the damage progression behaviour of the tested sandwich structures [21]. The X-ray- μ -CT-scanned section-view images at the middle of the damage area of impacted non-reprocessed and reprocessed sandwich specimens are given in Figure 5. At 15 J, indentation depth at upper skins, core layer thickness reduction, and lower skin protrusion damage modes were visible for both sandwich structures. At 30 J, these damage modes became larger for non-reprocessed sandwich structures. However, for reprocessed sandwich structures, the crack clearly started from the lower skins and propagated into the foam layer. For both types of sandwich structures at 15 J and 30 J energy levels, the buckling of the whole structure was visible. The buckling event can happen to a sandwich structure that has a tough foam core layer, and the foam core layer can provide good support to the skin layers during the impact [22]. The X-ray-scanned images at different positions of the damage area of reprocessed specimens at 30 J are provided in Figure 6 since the crack was formed only in reprocessed sandwich structures at 30 J. At positions a and e, no crack was seen, as they were at the very edges of the damage area. If positions b, c, and d are considered, the damage mechanism can be easily understood. The crack was initiated from the lower skin and propagated into the foam layer, which also cracked, and finally reached to the upper skin. The upper skin did not show any crack because the impact energy at 30 J was not enough to create any crack in the upper skin except the indentation depth. Based on these observations, the steps in the damage progression mechanism are drawn in Figure 7. Advantageously, no delamination was observed at the skin–foam interfaces. This gives a unique strength point of rotationally moulded sandwich structures since normally, delamination is a major concern of any skin–foam–skin sandwich structures and reduces the mechanical load bearing capacity of the structure significantly after impact. Additionally, all the damage modes are visible and easy to detect. Hence, there is no concern for the bare visible damage in the structure, which propagates very rapidly in the structure from a small damage and provides no chance of taking preventive measures before the catastrophic failure of the whole sandwich structure. The observed damage mechanisms will be supportive to develop a mathematical theoretical analysis using damage mechanics theories in the future, which is not covered in this study.

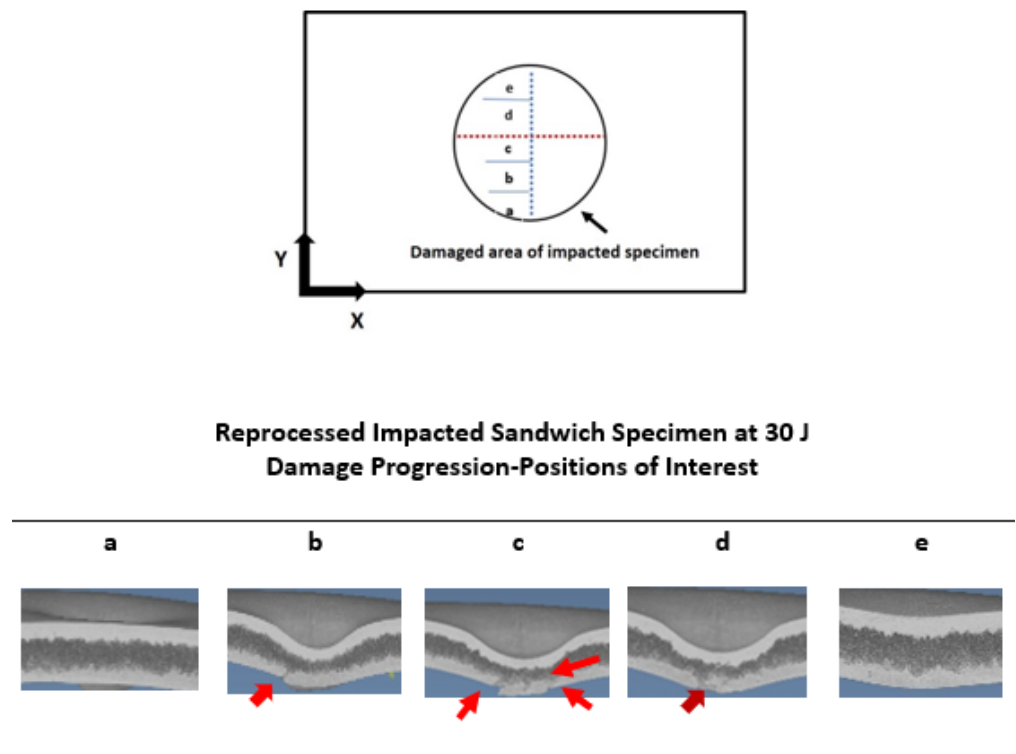
Figure 6. Progression of impact damage (a–e positions of interest) for reprocessed sandwich structure at 30 J. Red arrows indicate the cracks. Positions of interest (a–e) represent the different points of the damaged area of impacted specimen, shown in the upper image of this figure.

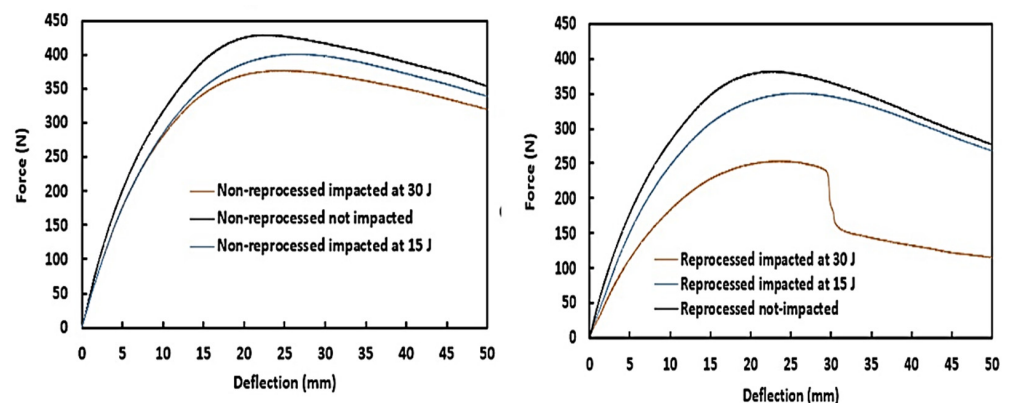
Figure 8. Force-deflection curves at FAI tests of non-reprocessed and reprocessed sandwich structures using three-point-bending test set-up.

Force-deflection curves of FAI tested non-reprocessed and reprocessed sandwich structures are given in Figure 8. Flexural test provides very crucial mechanical responses of any structures to the external loads [23] combining tensile and compressive forces. FAI properties are also included in Table 3 for both not-impacted and impacted types of

sandwich structures. In Figure 8, the reprocessed sandwich specimens show two different types of curves. The first type of curve was demonstrated with reprocessed not-impacted and impacted at 15 J specimens where the flexural force was seen to increase up to the peak impact force with a subsequent smooth transition to the decrease of force until a total of 50 mm overall structure deflection was reached. Reprocessed specimen impacted at 30 J exhibited the second type of curve since a drop in the flexural force was seen just after the peak impact force, followed by a slow decrease of force until the 50 mm deflection point was reached. This occurred due to the damage progression from the impact damage origin to the edge of the tested specimen and ultimate failure of lower skin. For all tested (not-impacted and impacted at 15 J and 30 J) non-reprocessed sandwich specimens, only one type of force-deflection curve was observed; flexural force values were reached up to the peak impact force and decreased to the 50 mm deflection point without any disruption. Because of this, as expected, no significant changes in the impacted damage of the non-reprocessed specimens were found during FAI tests. In contrast, Figure 9 shows the lower skin failure during the FAI test of reprocessed specimen impact at 30 J, which also supports the drop in the peak impact force of its force-deflection curve. Damage was progressed from the origin of impact crack to the edge of the specimen due to applied tensile forces in the lower skin during the FAI test, and hence, lower skin was failed. The broken foam core layer was also clearly noticed. Although the lower skin was failed, the reprocessed sandwich structure was still able to carry on the load, as the broken foam core and indented upper skin were supporting the load. In Figure 9, only reprocessed specimen impacted at 30 J was presented, as no other specimens either from non-reprocessed or reprocessed sandwich types showed any significant FAI damage progression.

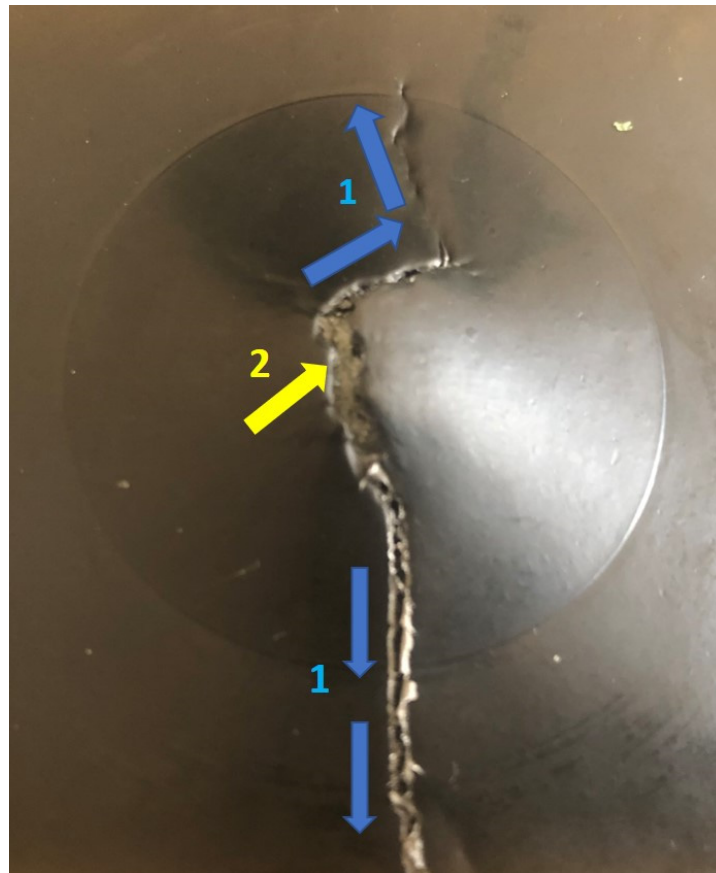
Figure 9. Lower skin damage progression of 30 J impacted reprocessed sandwich specimen during FAI test. 1 with blue mark—damage progression directions; 2 with yellow mark—cracked foam core.
