Analysis of Filler Metals Influence on Quality of Hard-Faced Surfaces of Gears Based on Tests in Experimental and Operating Conditions

Abstract: Hard-facing as a type of the coating depositing is increasingly used today. Physical-chemical-metallurgical characteristics of contact layers in tribo-mechanical systems depend on the operating conditions and the conditions under which the work surfaces were created. That is the reason the influence of the processing procedures and regime, used in the contact surfaces formation, on development of the wear process of contact elements, is being considered ever more. To determine the influence of the hard-facing technology on characteristics of the gears' working surfaces, the experimental investigations were performed on samples hard-faced on the steel for cementation, by varying the filler metals (FM) and the hard-facing regimes. The samples tested were hard-faced by five "hard" and three "soft" filler metals. Experimental investigations included measuring the hard-faced layers' hardness and determination of their microstructure, as well as the wear resistance in the laboratory conditions, on tribometer and on a specially designed device f

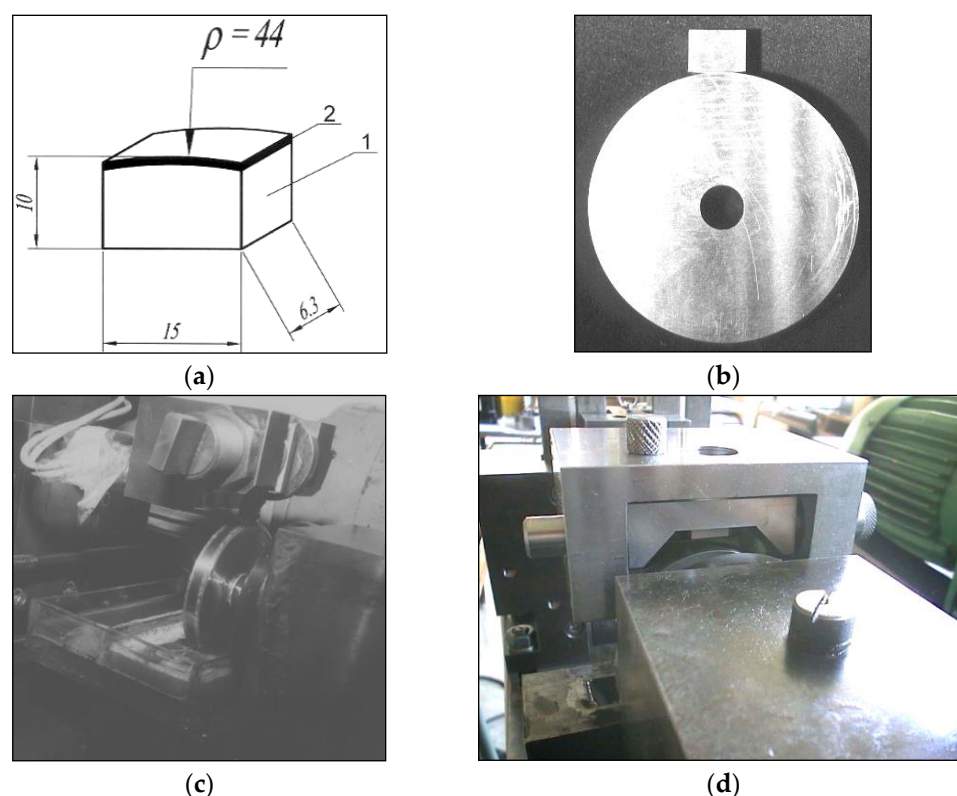
Figure 1. Tribological tests illustration: (a) Tribometer samples tested on tribometer (1—the base metal, 2—hard-faced layer, ρ —tooth curvature radius); (b) Appearance of the disc and block prepared for the test; (c) Tribometer TPD-3 with a disc submerged into oil and block above; (d) Block fixed in the holder before establishing the contact with the rotating disc.

The test samples were made of the cementation steel 20MnCr5, the chemical composition of which is given in Table 1. Those samples were prepared in such a way that they could simulate operation of the meshed teeth of the concrete gears, in conditions set in the device for the exploitation investigation, Figure 1.

After the hard-facing and heat treatment, the samples' deposited surfaces were ground on the machine for circumference grinding. The samples round radius (Figure 1) corresponds to the calculated value of the mean radius of the gear teeth being regenerated:

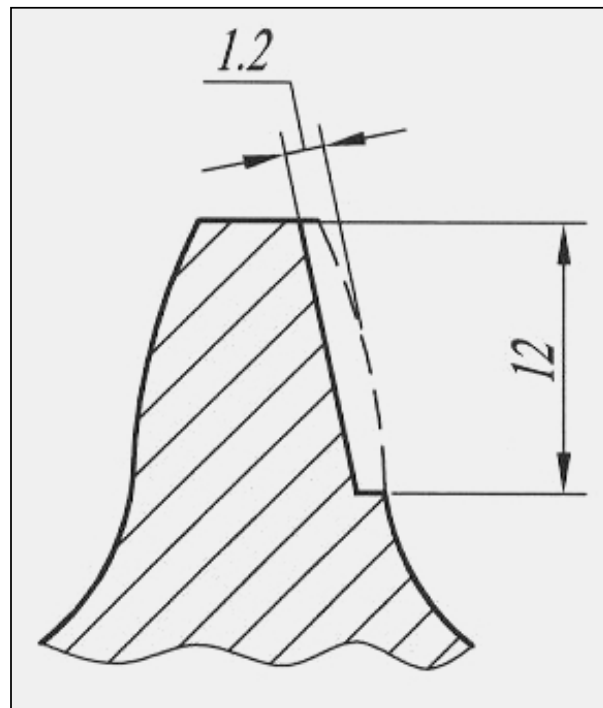
Figure 2. Schematic presentation of the tooth prepared for hard-facing.

- removal of the cemented layer from the active working surfaces of the teeth by grinding on a sharpener (in practice that corresponds to removing the damaged layer of the side of the tooth) to a depth of 1.5 + 0.2 mm and 12 mm along the height of the tooth (Figure 2),

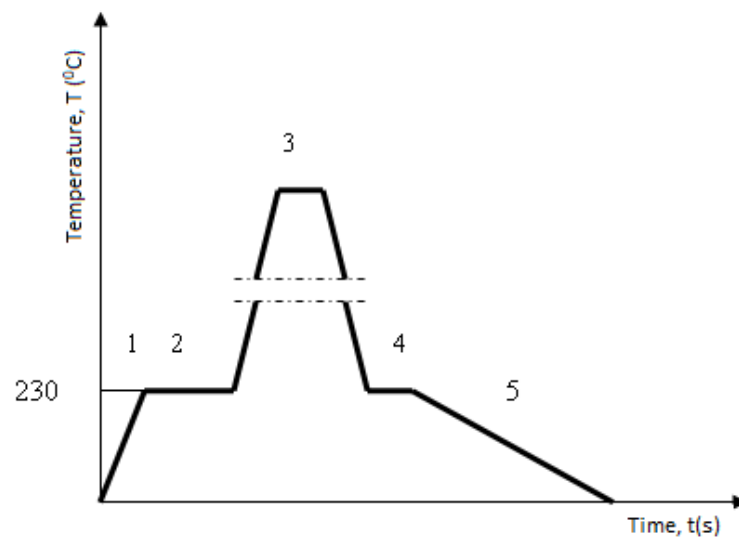
Figure 3. Diagram of the heat treatment regime during the hard-facing: 1—slow heating in the oven; 2—holding at the preheating temperature ($T = 230\text{ °C}$, $t = 2\text{ h}$); 3—hard-facing; 4—returning to the furnace ($T = 230\text{ °C}$, $t = 1\text{ h}$); 5—slow cooling together with the oven.

In the case of tooth regeneration by hard-facing with “soft” filler metals (EVBCrMo and EVB2CrMo), the technological regeneration procedure was significantly different from the previously described ones. It consists of the following operations (Figure 3):

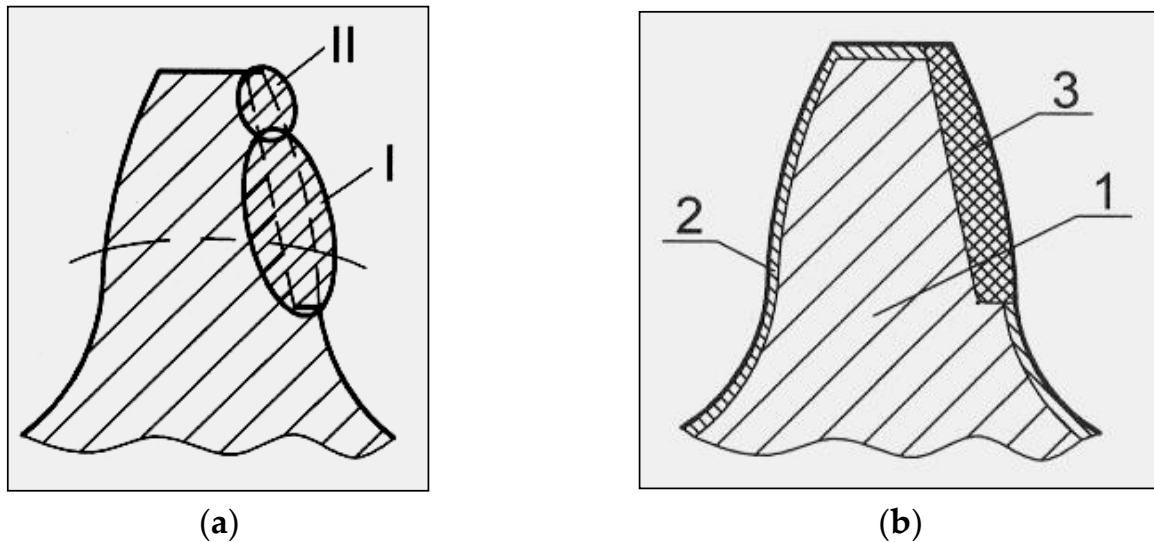
Figure 4. (a) Appearance of the tooth hard-faced in two passes; (b) Appearance of the tooth cross-section after the reparative hard-facing and machining (1—the tooth core; 2—the cemented layer; 3—the hard-faced part of the tooth flank).

The hard-facing of all teeth was performed in two passes. In the first pass, the bottom of the tooth and part of the head (I) were hard-faced and, after removing the slag, the remaining part of the head (II) was welded, Figure 4a. “Fronius” brand welding machine was used to perform the welding operations.

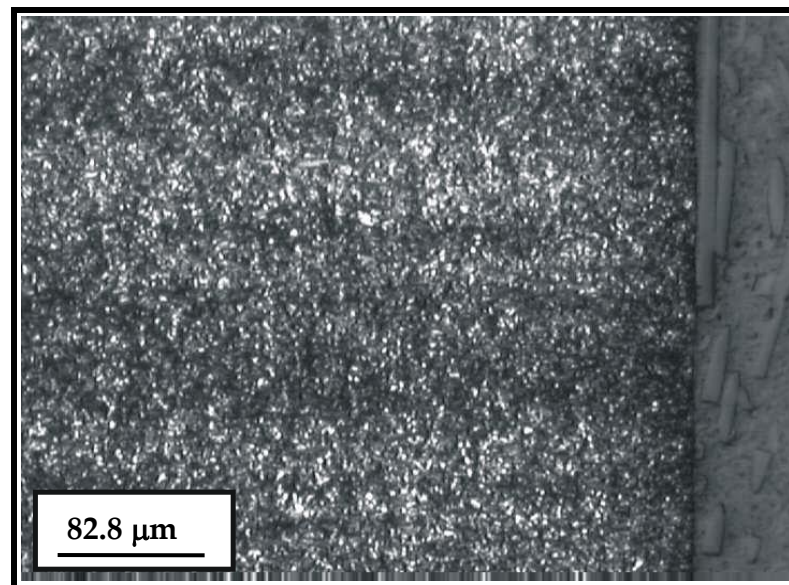
Figure 5. Microstructure of the cemented layer.

The basic microconstituent of the cemented layer is the tempered martensite (dark areas in Figure 5). The microstructure of the surface and sub-surface (cemented layer and the bulk) of the newly manufactured sample is shown in Figure 6.

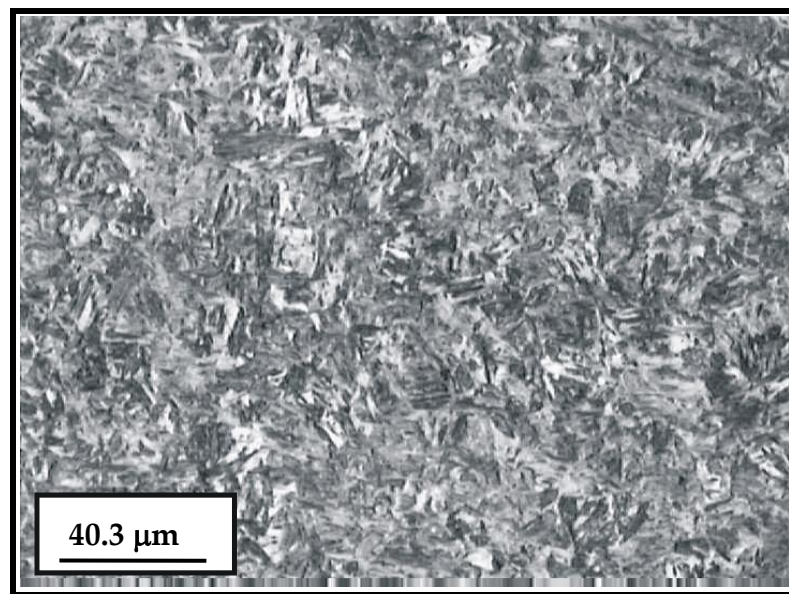
Figure 6. Structure of the cemented sample bulk.

The smaller share of residual austenite can be noticed in the microstructure. In the surface zone, depths of up to 0.2 to 0.3 mm are present the individual larger carbides of the alloying elements. Based on the martensite needles appearance, it can be concluded that the microstructure is fine-grained, which points to the fact that the heat treatment regime was appropriately executed. In Figure 6, it can also be noticed that the microstructure contains larger needles of the transient structures (bainite) and the ferrite areas.

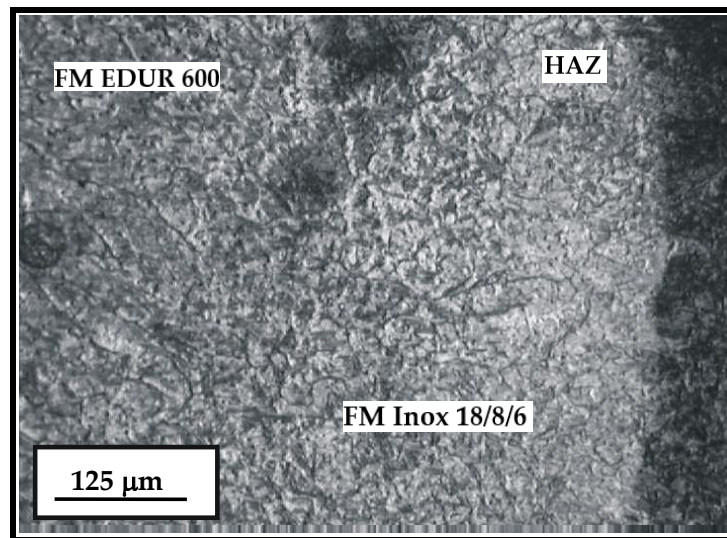
Figure 7. Microstructure of the HAZ and the hard-faced layer with the two filler metals—Inox 18/8/6 + EDUR 600; EDUR 600—left; Inox 18/8/6—middle; HAZ—right.

The microstructure of the hard-faced layer deposited with the two different filler metals (Inox 18/8/6 and EDUR 600) is shown in Figure 7. On the left-hand side of the figure, one can notice the bar-like dendritic structure of the hard-faced layer deposited by the “hard” electrode EDUR 600. In the central portion of the figure is the hard-faced layer deposited by the electrode Inox 18/8/6 with the less prominent expressed dendritic structure. The joining line of the FM Inox 18/8/6 and the heat affected zone (HAZ) of the base metal is, relatively, prominent and very uneven.

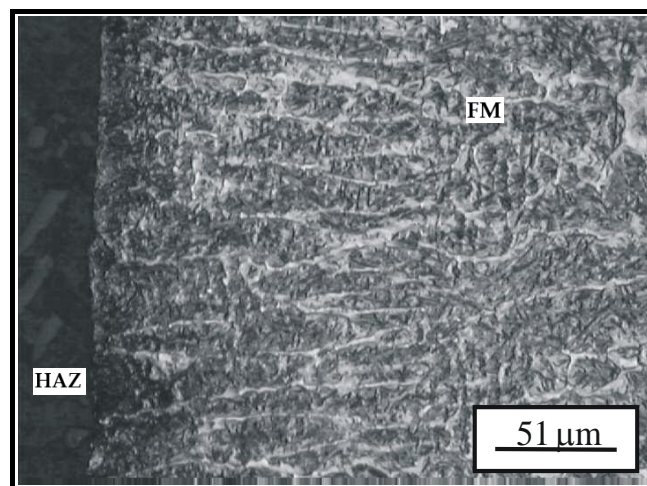
Figure 8. Microstructure of the hard-faced layer executed by the FM Castolin 2.

Figure 8 presents a microstructure of the hard-faced layer executed by the FM Castolin 2. According to Figure 8, the layer hard-faced by the FM Castolin 2 is characterized by prominent dendritic structure. The average width of dendritic needles is 10–15 μm , which is very favorable. However, the dendrites are highly inhomogeneous, which is shown by the different etching degree of their surfaces. In the layer, hard-faced by Castolin 2, the carbide phase is present, excreted mainly at the dendritic boundaries. The growth direction of dendrites is mainly perpendicular to the sample's surface.

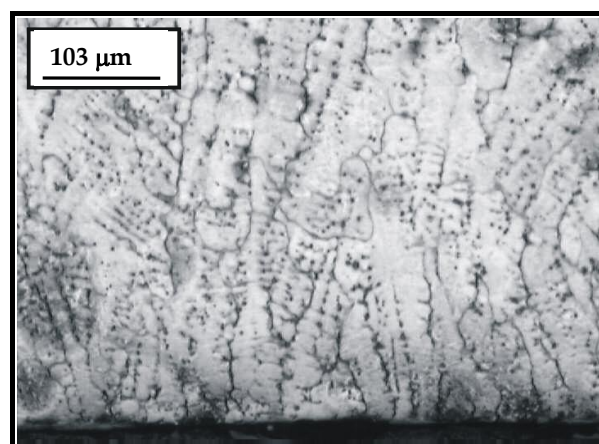
Figure 9. Elongated dendritic structure of the hard-faced layer executed by the GTAW welding procedure and filler metal DUR 600-IG.

Figure 9 shows the elongated dendritic structure of the hard-faced layer executed by the GTAW welding procedure and filler metal DUR 600-IG that extends all the way to the surface of the hard-faced sample. The registered dendrites have the growth direction perpendicular to the working surface; the dark spots on their edges are mainly excreted impurities, carbide phase and alike.

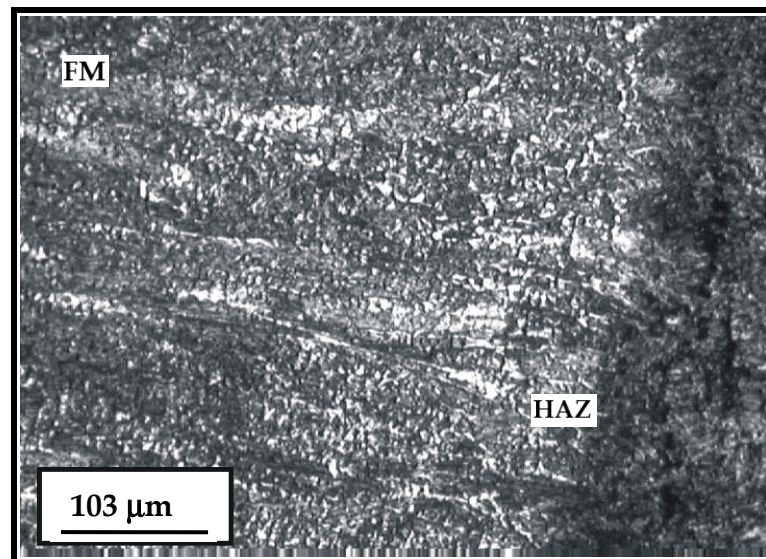
Figure 10. Microstructure of the hard-faced layer executed by FM UTP 670 (light areas) and HAZ (dark area).

The sample hard-faced with the FM UTP 670 has the medium to large-grained structure, with individual dendrites width of 30 to 80 μm . The large share of excreted carbides along the grain boundaries is noticed in the structure (light areas in Figure 10), however the largest portion is within the metal grains.

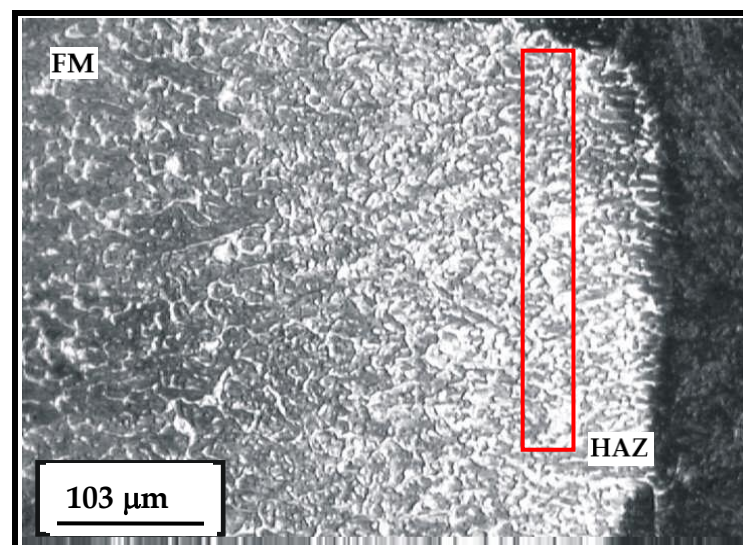
Figure 11. Microstructure of the hard-faced layer executed by the FM Tooldur (light area) and HAZ (dark area); the red-framed area is the zone of the largest portion of the carbide phase.

The hard-faced layer obtained by the FM Tooldur is characterized by prominent dendritic structure. From comparison of microstructures of all the hard-faced layers, one can conclude that in this structure, the largest share of the carbide phase is present (Figure 11). The largest portion of the carbide phase is in the area immediately next to the HAZ, where it is excreted both on the grain boundaries and within the grains. The smaller share of the carbide phase is present in other zones of the hard-faced layer and at the surface, where this phase is mainly excreted along the edges of dendrites and grain boundaries.

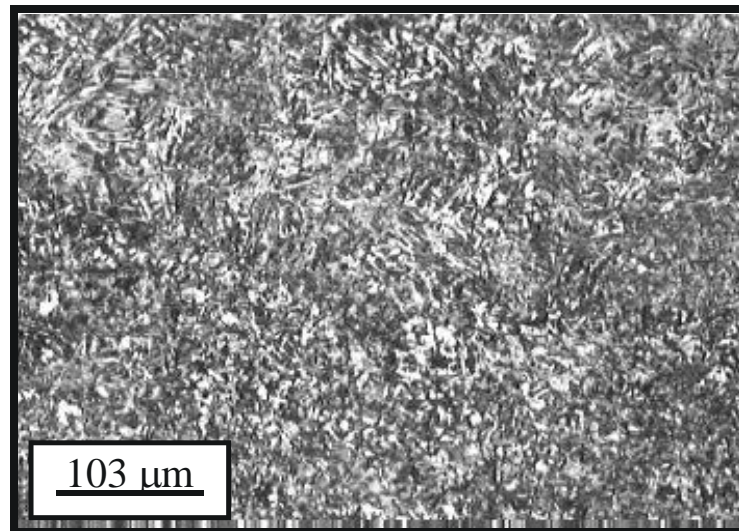
Figure 12. Microstructure of transition between the cemented layer and transient layer in the hard-faced layer executed by the FM EVBCrMo, chemically and heat treated.

Figure 12 shows the microstructure in the transition zone between the cemented layer (fine-grained structure) and the transient cementation zone, which is present in the

hard-faced layer (executed by the FM EVBCrMo), as well. The basic microconstituent in this structure is the tempered martensite with the smaller share of the carbide phase and residual austenite. The size of the martensitic needles is mainly fine grained, which points to the fact that the soft annealing process after the hard-facing and subsequent chemical and heat treatment processes were correctly executed.

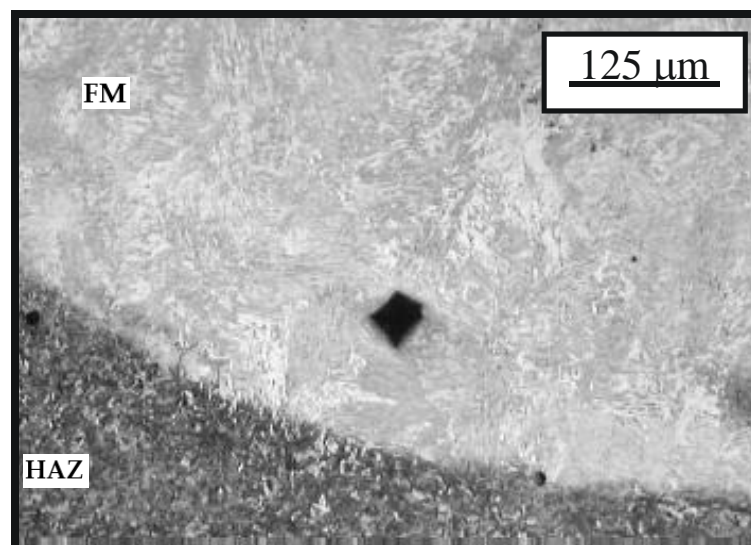
Figure 13. Microstructure of the transition zone between the hard-faced layer executed by the FM EVB2CrMo (light area) and the base metal (HAZ); state: hard-faced + soft-annealed + cemented + heat treated.

The microstructure of the cemented layer in the hard-faced layer executed by the FM EVB2CrMo is shown in Figure 13 [21]. The first cemented and then heat-treated layer is characterized by somewhat greater inhomogeneity with respect to the layer hard-faced by FM EVBCrMo. The basic microconstituent in the hard-faced layer zone is the tempered martensite. The hard-faced layer is the light area in the figure, while the base metal (namely the HAZ) is the dark area. Based on difference in the etching intensity of the base metal and the hard-faced layer, one can conclude that there is a more prominent difference in their chemical compositions.

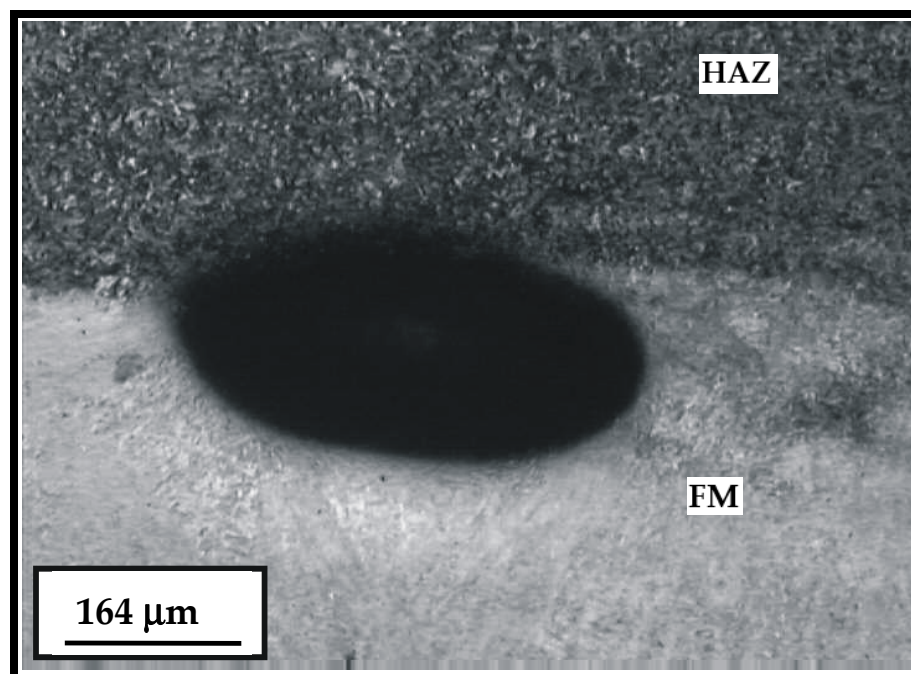
Figure 14. Microstructure of the hard-faced layer executed by the FM Phönix 120 K/E with appearance of the gas bubble in the HAZ.

The hard-faced layer microstructure obtained by the filler metal Phönix 120 K/E is noticeably medium to fine-grained (Figure 14). Based on the degree of etching intensity, one can establish the difference in the chemical composition between the base and filler metal. An example of the individual gas bubble at the joining line BM-FM is also shown.

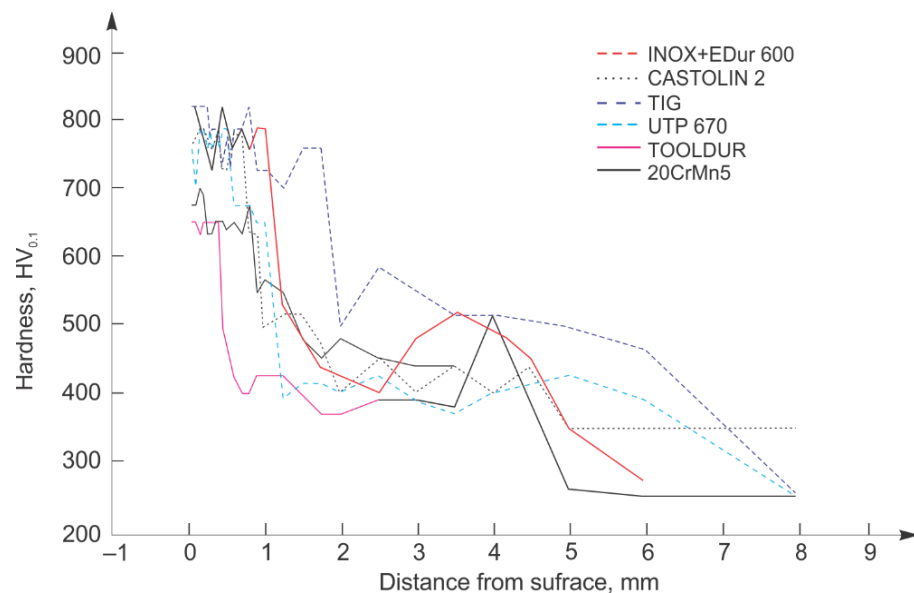
**Figure 15.** Hardness distribution diagram of samples hard-faced with “hard” filler metals.

Microhardness was measured on the same device by the Vickers (HV0,1) method with indentation force of 1 N and indentation time of 15 s. Results of the microhardness measurements of the samples hard-faced by the “hard” filler metals, and the newly made samples are shown in Figure 15.

Comparing the microhardness distribution of the newly made and “hard” hard-faced layers, one can notice that the latter mainly possess prominently higher microhardness of the subsurface layers with respect to the cemented layers, with exception of the hard-faced layers executed with the Tooldur FM.

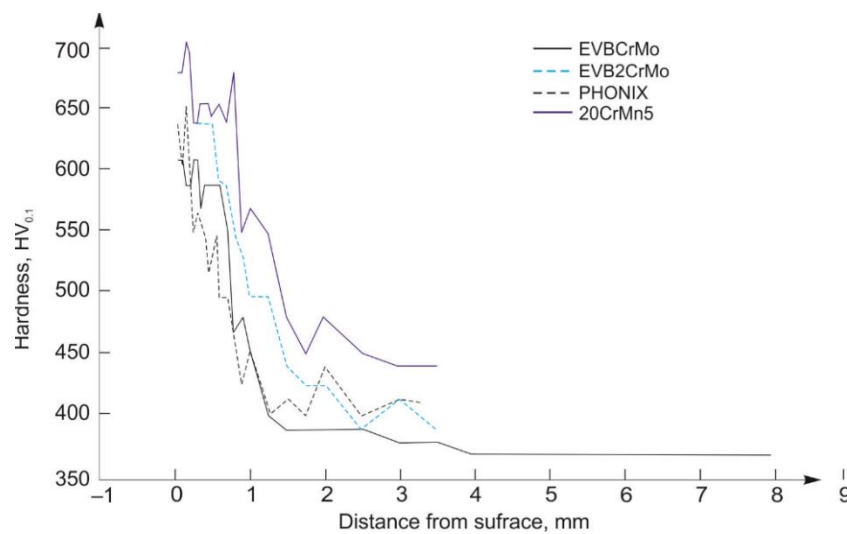
Figure 16. Hardness distribution diagram of samples hard-faced with “soft” filler metals.

Microhardness of samples hard-faced by the “soft” filler metals, cemented and heat treated, are shown on a diagram in Figure 16.

From the aspect of the microhardness distribution of the “softly” hard-faced samples, hard-faced layers executed with the EVB2CrMo FM possess the microhardness values very close to those of the newly made samples. For the hard-faced layers executed with the EVBCrMo FM, the hardness distribution is somewhat less favorable, while the hard-faced layers executed with the Phönix 120 K/E 425 B/E7018-1 FM possess the worst microhardness distribution.

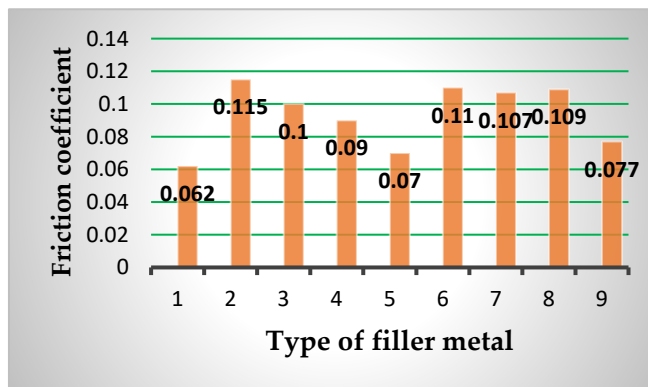
Figure 17. Comparison of the average values of the friction coefficient for various filler metals (Numbers correspond to notation of Table 7).

Based on the conducted tribological investigations, the average friction coefficient values were determined (μ_{av}), which are shown in Table 7 and in Figure 17. Topography of surfaces of the tested blocks was determined as well. The wear trace width was measured on a universal microscope UIM-21 and the results are presented in Figure 18.

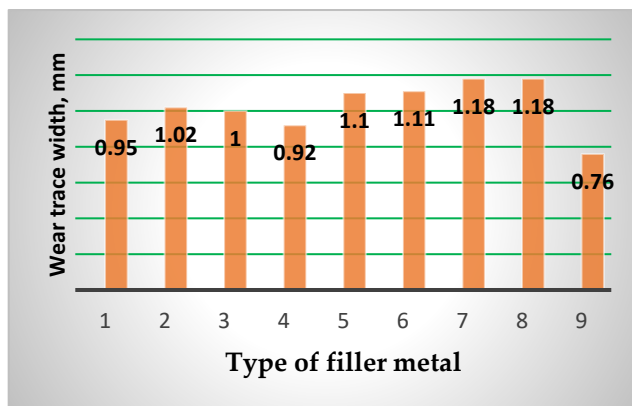
Figure 18. Comparison of the wear traces values for various filler metals (Numbers correspond to notation of Table 7).

What concerns the wear traces (what is of the utmost importance) is the elements that were cemented and quenched had the smallest values by far. From the hard-faced blocks the best appearance was by those obtained by the combination FMs Inox 18/8/6 and EDUR 600. The hard-faced layers obtained by the “soft” FMs Phönix 120 K/E 425 B/E7018-1 and EVB2CrMo were the worst from this aspect, as well.

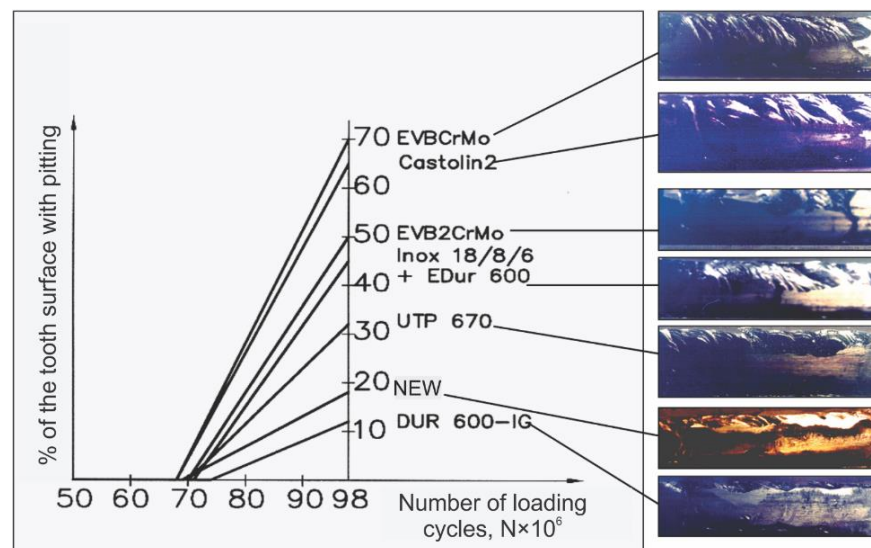
Figure 19. The development rate of the destructive pitting on the teeth flanks.

Analyzing the periods of the service life until appearance of the destructive pitting, of the regenerated and newly made gears, led to a diagram shown in Figure 19. When drawing this diagram, the dependence of the destructive pitting rate, namely increase of the percentage share of the teeth area, affected by destructive pitting, on the load cycles number (i.e., operating time of the testing device) was assumed as a linear function. This dependence is not linear, however, for the purpose of illustrating its trend, it is presented as a straight line whose slope determines the spreading rate of the pits that define the destructive pitting.

What concerns the phenomenon of pitting, it is noticed that the threshold exists when the first pits appear, for all the tested gears, around $70 \cdot 10^6$ load cycles, as well as that all the applied hard-facing procedures produce the effect similar to the newly made gears. However, in the following phases of the destructive pitting, one can notice significant differences in its development, what is obvious from the diagram shown in Figure 19. The best results are exhibited by the new gears and those regenerated by hard-facing with DUR 600-IG filler metal.
