Supplementary Information

Reversible Polymer-Gel transition for Ultra-Stretchable Chip-Integrated Circuits through Self-Soldering and Self-Coating and Self-Healing

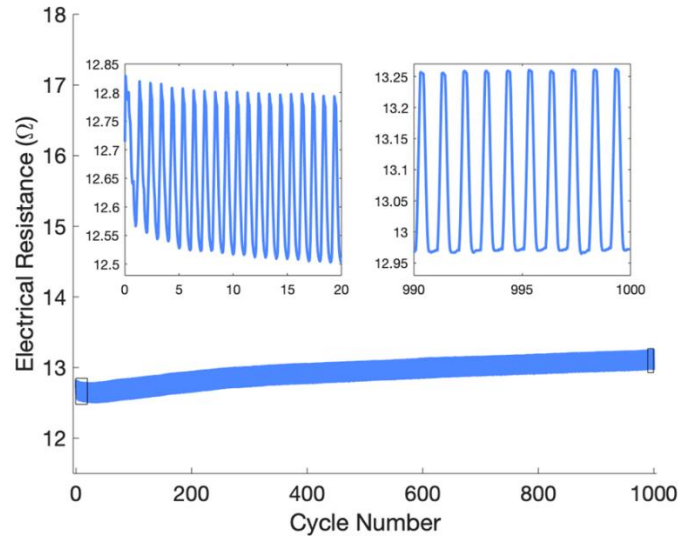
Supplementary Figure 4. Electromechanical characterization. Electromechanical coupling of a printed sample with a 10Ω resistor, under repetitive 40% strain.

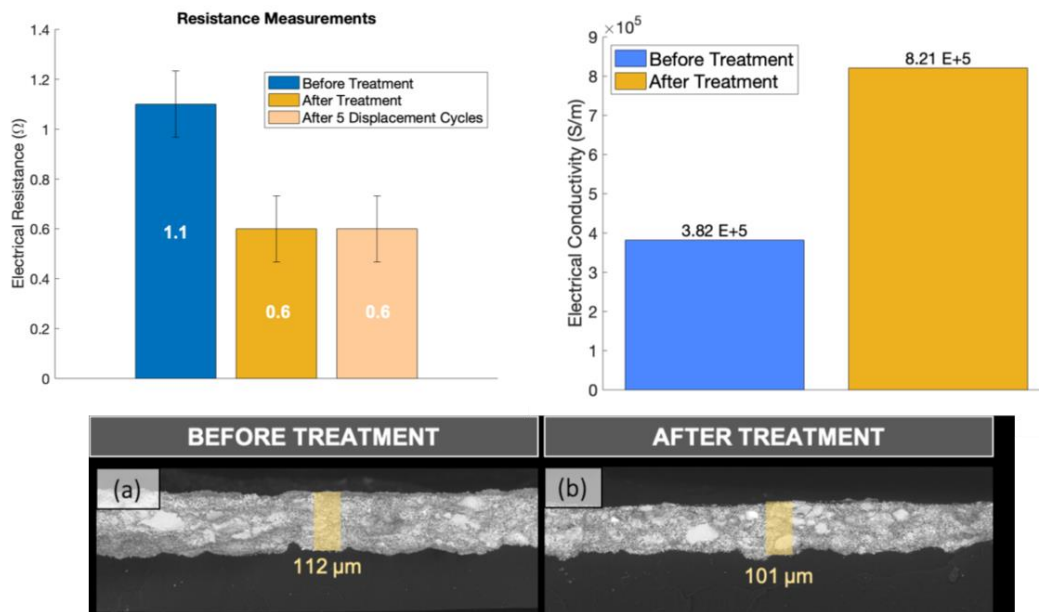
Supplementary Figure 5. Characterization of the printed samples. Characterization before and after the vapor exposure. Before Treatment: Thickness = 112 μm; Electrical Resistance Average= 1.1Ω. After Treatment: Thickness = 101 μm; Electrical Resistance average = 0.6Ω.

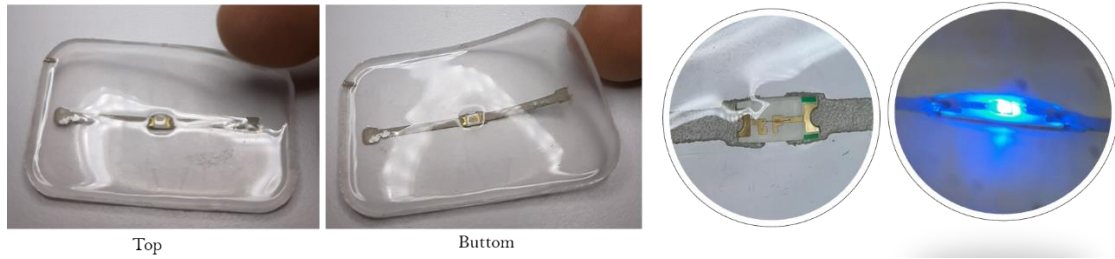
Supplementary Figure 10. Fully coated sample. The microchip is as well coated using the POL-GEL process. To do so, a 2mm thick substrate, was used. The printed trace drowned almost to the bottom of the substrate, but did not expose.

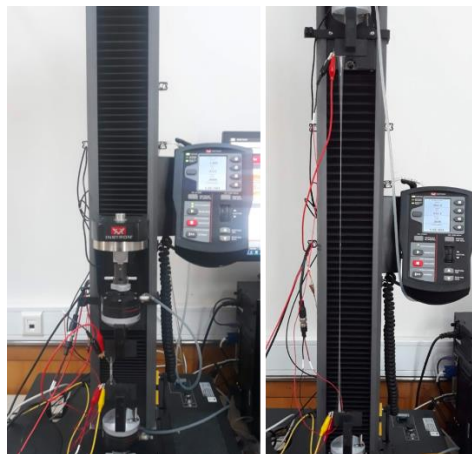
Supplementary Figure 17. Strain test setup. An example of a sample at 0%, and ~900% strain.
