Journal of Orthopaedics

Original Article Osteolysis in total hip arthroplasty after head and inlay revision surgery

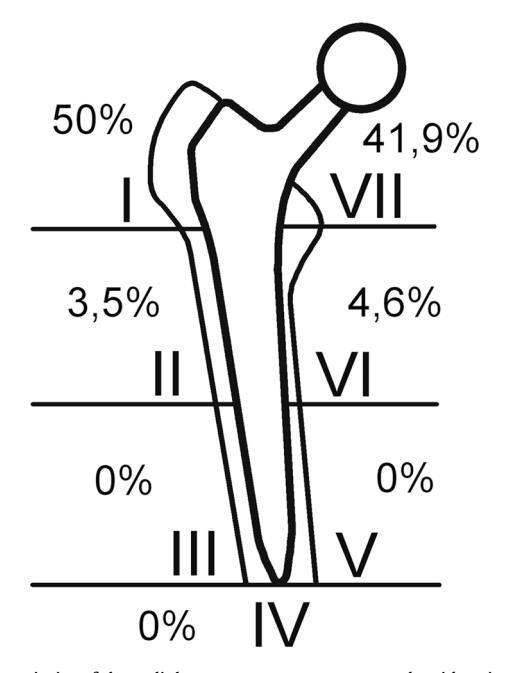
Fig. 1. The majority of the radiolucent areas was, as expected, evident in the Gruen zones 1 and 7.

For analyzing the osteolytic zones on the anterior-posterior Xrays, an image editing software called GIMP, version 2.8, was used. Because the aim was to assess the quantity of radiolucent zones around the femoral shaft, it was necessary to find a way to measure their size as accurate as possible. By knowing the size of the ball head and coloring it, it was possible to calculate any other isochromatic stain in the X-ray. Histograms were used to analyze the amount of colored pixels which was needed to cover the ball head and the radiolucent zones. Then the size of the osteolysis could be easily calculated. The X-rays taken before and after revision surgery were compared and the change of size of the periprosthetic radiolucent zones was analyzed. The results were double-checked and it was noticed, that the measurement error did not exceed five percent in any case. For describing the localization of the osteolytic zones the classification of Gruen et al.¹ was used (Fig. 1).

As expected, osteolytic areas were more often found in the proximal Gruen zones.

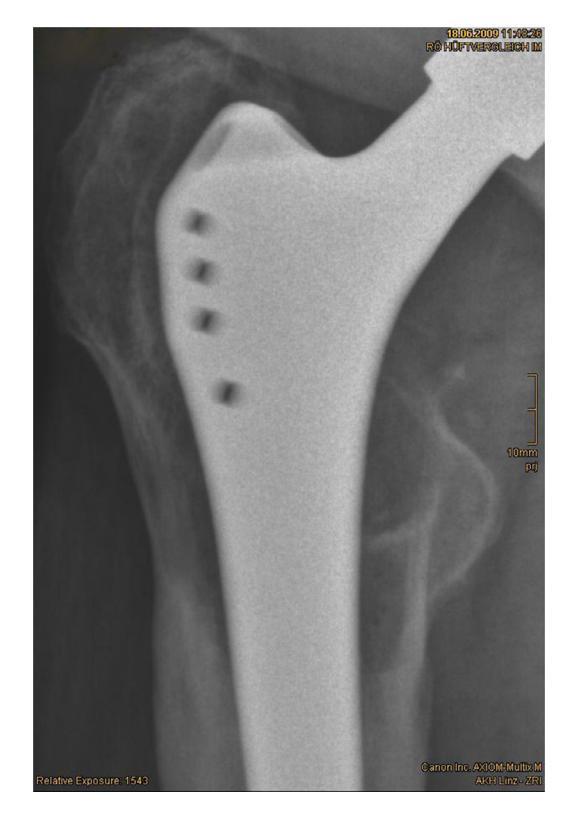
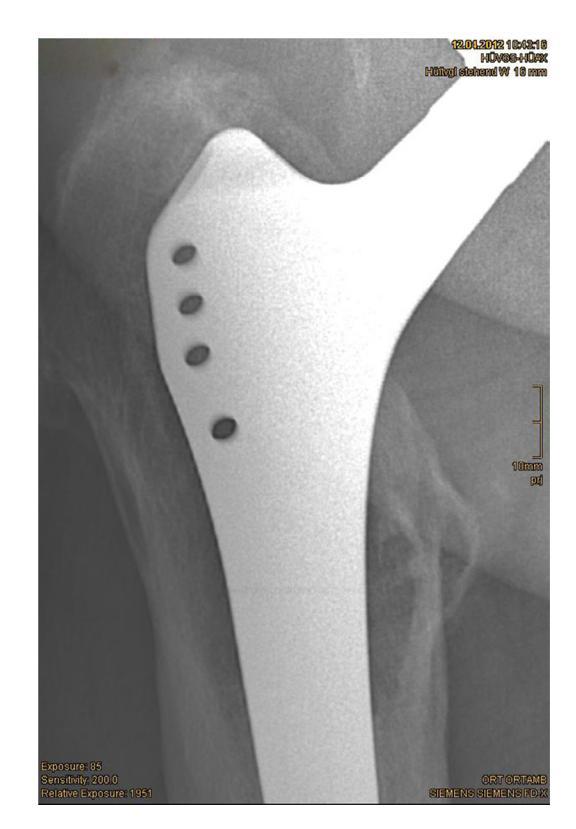
Fig. 2 and 3. (Continued).

Figs. 2 and 3. Reduction of osteolytic zones by 46% within 33 months.

The mean relative enlargement of the osteolytic zones was 10.5% (-86% to +305%). In 29 cases (57%) a reduction of radiolucent

areas could be found, in 22 cases (44%) an increase was evident (Figs. 2 and 3).
