# The Complex Management of Mechanical Prosthetic Valve Thrombosis

Khalid Saeed Al-Asad<sup>1</sup>, Rand Sabanci<sup>1</sup>, Layan El-khatib<sup>2</sup>, Mohammed Qintar<sup>3</sup>, Christopher Hanson<sup>3</sup>

Saeed Al-Asad K, Sabanci R, El-Khatib L, et al. (June 30, 2023) The Complex Management of Mechanical Prosthetic Valve Thrombosis. *Cureus* 15(6): e41214. DOI 10.7759/cureus.41214

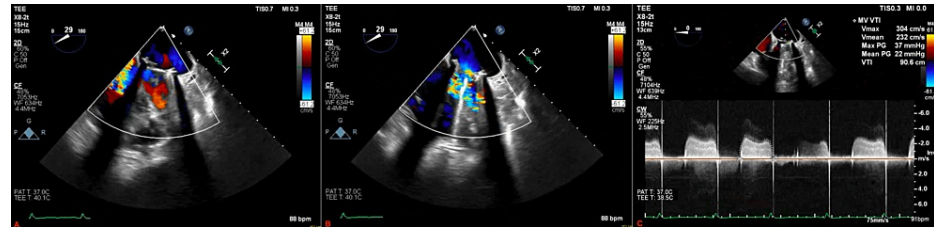
**FIGURE 1: Initial transesophageal echocardiogram.**

(A) Mechanical prosthesis during systole, (B) mechanical valve prosthesis during diastole with turbulent blood flow on color doppler, and (C) elevated pressure gradients across the mechanical prosthesis.

management of a heart failure exacerbation. She was also started on IV Heparin with a plan to bridge to Warfarin therapy given the underlying mechanical mitral prosthesis. Her respiratory status gradually improved throughout the course of her hospital stay, and she was weaned off supplemental oxygen. As part of the complete workup, her transthoracic echocardiogram (TTE) showed normal left ventricular function but revealed right ventricular dysfunction and elevated pressure gradients across the mechanical mitral valve, suggesting severe stenosis. The mitral valve leaflets were not well visualized, and a transesophageal echocardiogram (TEE) was needed to complete the evaluation. TEE revealed a frozen posterior leaflet of the prosthetic valve with an overlying thrombus on the atrial side (Figure 1).

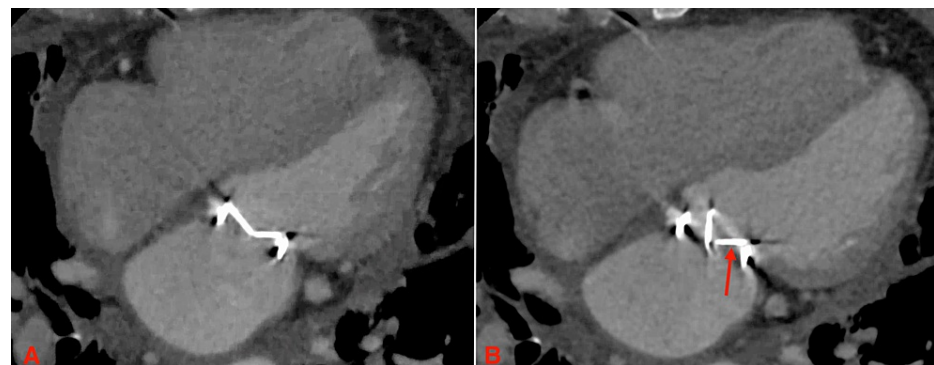
**FIGURE 2: Structural computed tomography of the heart.**

(A) Appropriately closed mechanical mitral valve leaflets during systole and (B) fixed valve leaflet (red arrow) during diastole with narrowing of the mitral opening.

The patient was counseled on her underlying condition and was informed that the standard of care in her situation would have been mitral valve replacement via conventional surgery. She, however, expressed a desire to explore all other nonsurgical options, considering her prior numerous thoracic surgeries. She was offered fibrinolytic therapy as well as the off-label use of a percutaneous aspiration thrombectomy device, which she opted to proceed with. She was subsequently evaluated by structural cardiology and underwent a structural CT scan of the heart for planning. The study confirmed that the posterior leaflet of the mechanical valve was frozen but did not visualize the thrombus on the mechanical prosthesis (Figure 2). In light of this, the procedure was deemed inappropriate and was subsequently canceled.

When suspecting PVT, a thorough physical exam should be performed. One common finding in patients with obstructive PVT is the muffling or disappearance of the prosthetic sounds or the development of a new murmur [1]. Other signs of congestive heart failure, including jugular venous distention, lower extremity pitting edema, and crackles on chest auscultation, are typically present. Initial basic work-up includes cardiac biomarkers, which are typically normal or mildly elevated, and chest radiographs that may show signs of pulmonary vascular congestion and pulmonary edema. A definitive workup incorporates echocardiography, TTE, and TEE, with emphasis on structural abnormalities, leaflet motion, and pressure gradients across the prosthesis. CT or cinefluoroscopic imaging is also part of the investigatory evaluation. Invasive hemodynamic testing is rarely done for the evaluation of PVT [1]. Our patient's imaging studies revealed elevated pressure gradients across the mitral prosthesis and fixation of one leaflet, and they were able to visualize the thrombus density on echocardiography. Structural CT demonstrated the frozen prosthetic valve leaflet of the mechanical mitral valve.

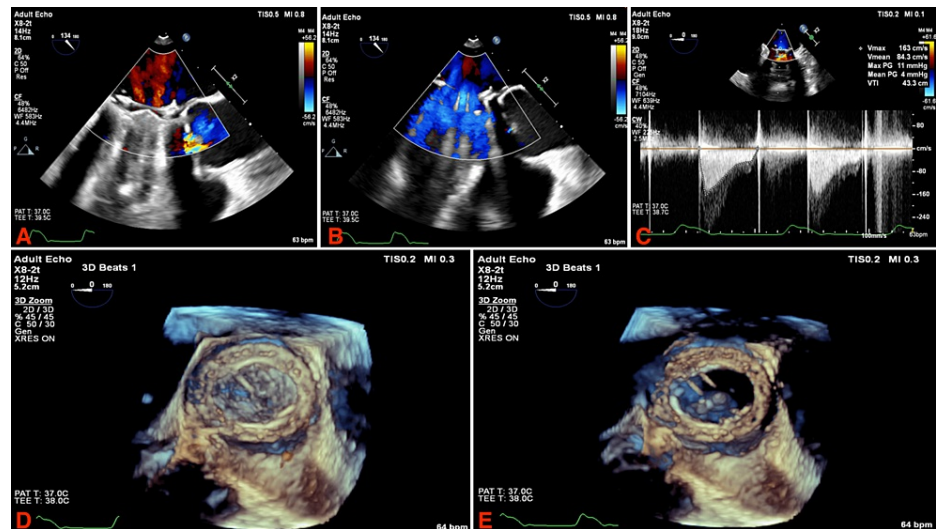
**FIGURE 3: Intra-operative transesophageal echocardiogram.**

(A) 2D visualization of the mitral prosthesis during systole with color doppler; (B) 2D visualization of the mitral prosthesis during diastole with color doppler; (C) pressure gradients across the mitral prosthesis; (D) 3D visualization of the mitral prosthesis during systole; (E) 3D visualization of the mitral prosthesis during diastole.

Eventually, the patient was evaluated by the cardiothoracic surgical team with the intention of undergoing a repeat surgical mitral valve replacement. By that time, she had significantly improved from a clinical standpoint, and her INR was in the therapeutic range. Through shared decision-making involving the medical and surgical teams as well as the patient, she was discharged from the hospital on Warfarin and oral diuretics and was scheduled for surgery 30 days after her initial presentation. The patient underwent a follow-up TTE 10 days prior to her scheduled surgery with the hope that her frozen leaflet had normalized while her INR was within the goal range; however, the study did not show any significant changes. The patient presented to the operating room on her scheduled appointment, whereby a TEE was performed, showing normalization of the pressure gradients across the mitral valve and that the previously frozen leaflet was then functional (Figure 3). The patient was subsequently discharged and treated medically on an outpatient basis without major complications.
