CLINICAL CASE

Hisian Lead Electrical Decay After TAVR Intervention

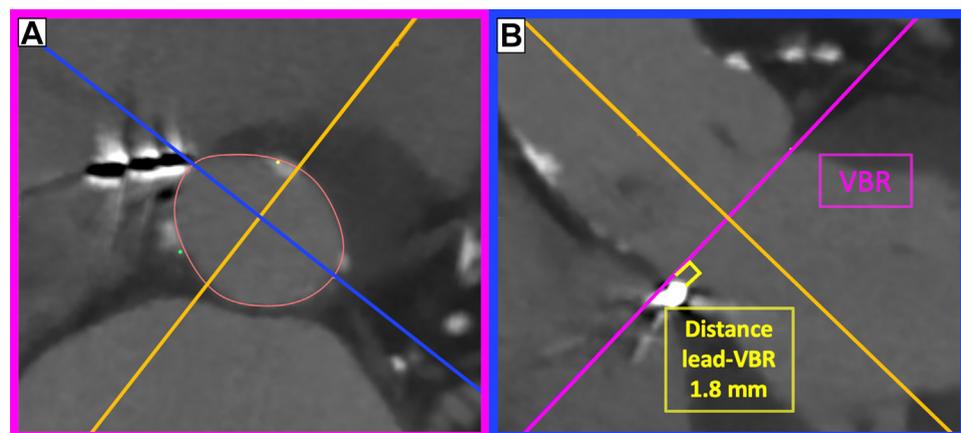
FIGURE 1 Pre-Transcatheter Aortic Valve Replacement Computed Tomography

(A) Axial view of the aortic valve virtual basal ring (VBR). The Hisian lead can be observed already at this level between the right and noncoronary cusps. (B) The long axis of the left ventricular outflow tract at the level of contact of the pacemaker into the septum. The pink line is the aortic valve VBR. The distance between the VBR and the pacemaker is 1.8 mm (yellow line).

burden, coronary artery bypass grafting patency, and favorable femoral route for TAVR. The calculated virtual basal ring (VBR) area was 583 mm², with a perimeter of 87 mm. Of note, the PM lead was found pointing sharply into the septum <2 mm below the VBR (Figure 1).

procedure. The present case emphasizes that such distance can be so short (1.8 mm) that it becomes impossible to implant the THV safely above the PM and completely avoid it. Indeed, THV implantation that is too high may increase the risk of device embolization. Further experience and CT analysis will be needed to discover how frequently Hisian leads are in such close proximity to the VBR.

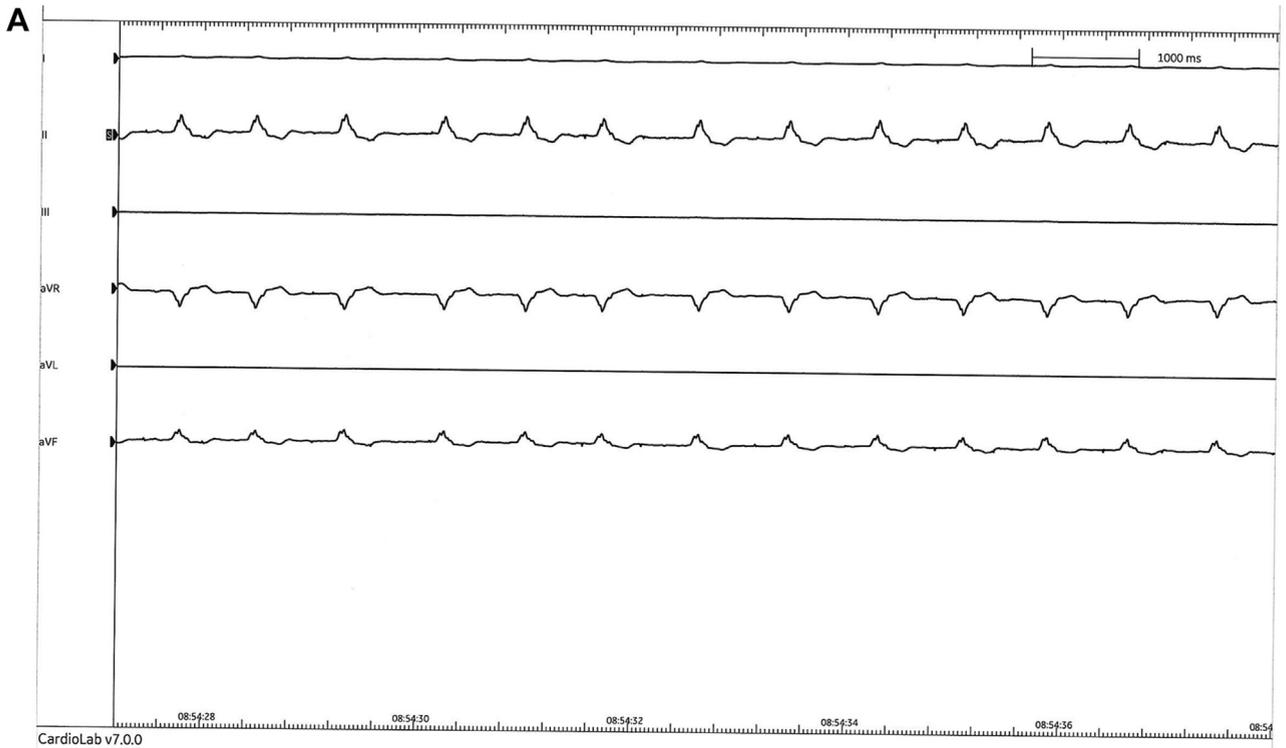
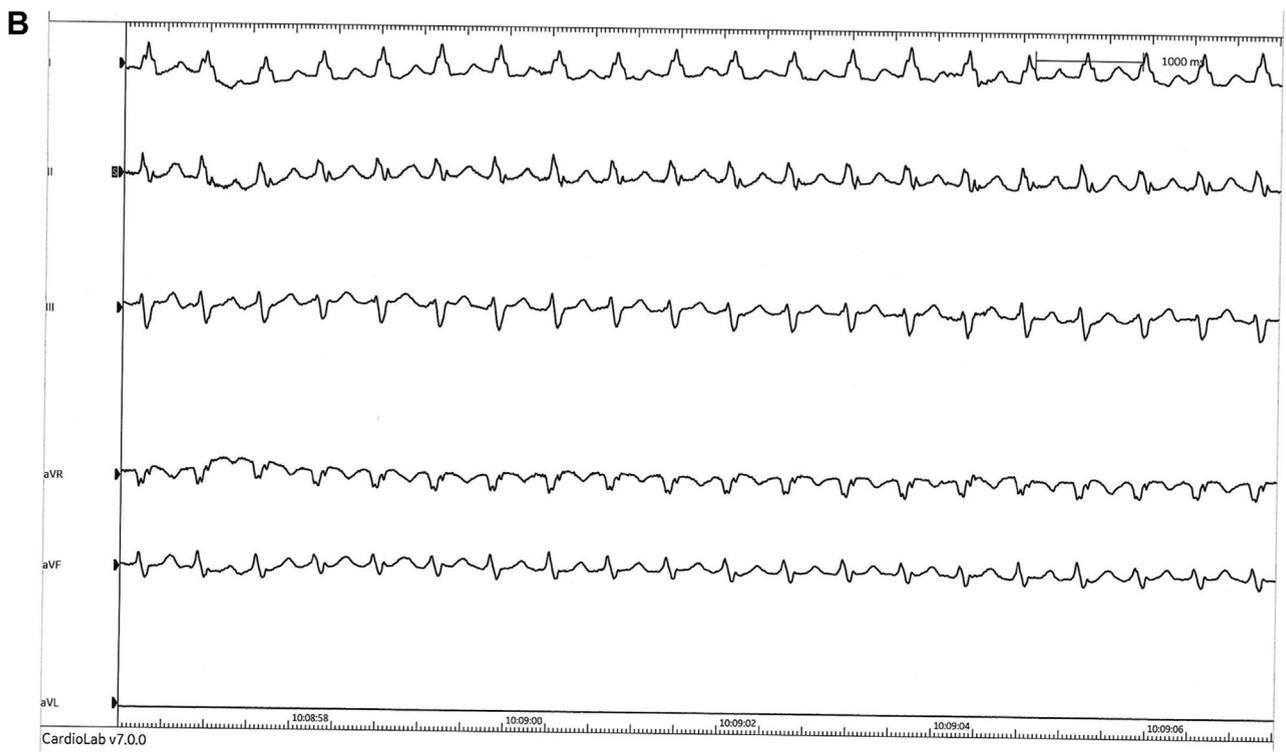
FIGURE 5 ECG Pre- and Post-PM Replacement

(A) Electrocardiogram pre-pacemaker replacement. (B) Electrocardiogram post-pacemaker replacement.

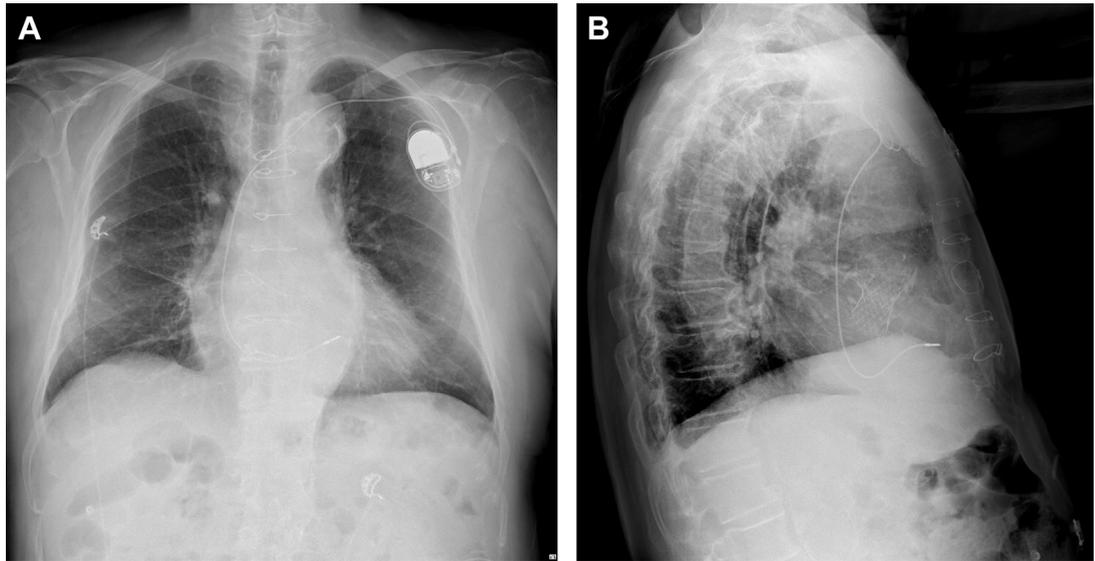
FIGURE 6 Final Thoracic X-Ray

(A) Thoracic x-ray film before discharge in anteroposterior view. (B) X-ray film in lateral view.
