# **CHARACTERISTICS ON FRACTURES OF TIBIA AND FIBULA IN CAR IMPACTS TO PEDESTRIANS AND BICYCLISTS – INFLUENCES OF CAR BUMPER HEIGHT AND SHAPE**

**Otte, D.\*; Haasper, C. \*\***

\* Accident Research Unit \*\* Trauma Department Medical University  
Hanover, Germany

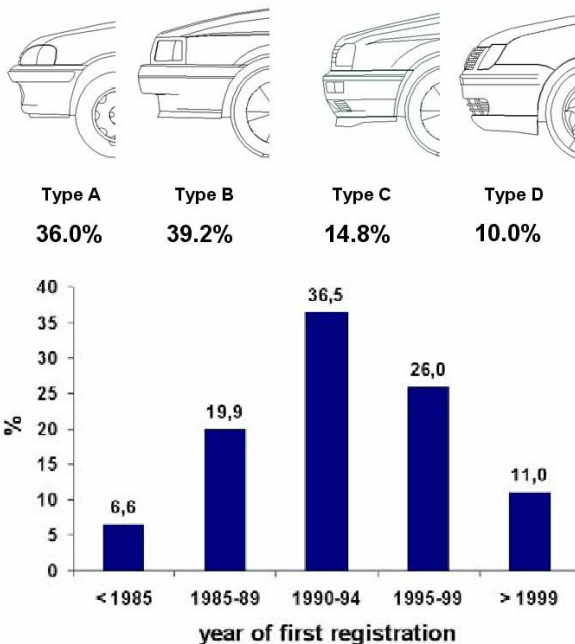
For classification purposes the frontal shapes of passenger cars were sub-divided into 4 different types A, B, C, D (figure 1) regarding the shape of the bumpers.

Figure 1: Classified frontal shapes of bumpers and the incidence of involvement in accidents with pedestrians and bicyclists (n= 181, all vehicles = 100 %)

Corresponding to the relatively old population of vehicles in the current accident situation, two thirds of the bumpers were protruding and rather rectangular (Type A at 36.0% and Type B at 39.2%). Newer, significantly rounded bumper structures, which have also been integrated into the front of the vehicle (Type C and D), are represented in accidents in only 14.8% (Type C) and 10.0 % (Type D) of the cases.

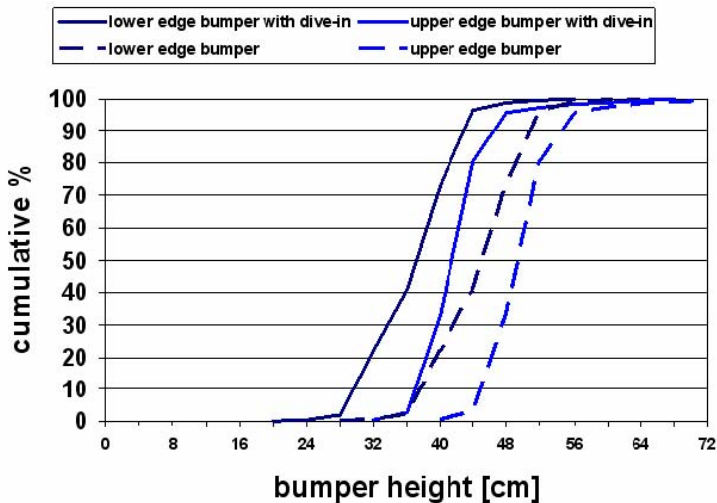
The effective height of impact was derived from the sideways profile of the vehicle and the part protruding most was chosen as impact transfer point, the height of which was measured from the road level. If this was not a well-defined point, but rather an area, as can be seen for the shown picture of type B in figure 1, this was taken into account by entering two values for the "lower and upper edge of the bumper". Eighty percent of the bumpers had an effective static impact height of at least 40 cm and at most 52 cm with a maximum at 70 cm for Sport Utility Vehicles SUV (figure 2). The so-called nose-dive of the front occurring during the application of the brakes due to the distribution of the braking power was provided for with a reduction of 8 cm for establishing the effective dynamic bumper height and resulted in the fact that 80 % of the effective dynamic impact power is transferred between heights of 32 cm at least and 44 cm at most.

Figure 2: Cumulative frequency of the bumper heights, a measured static height and a derived dynamic height including an 8-cm nose dive (n= 181, 100 %)

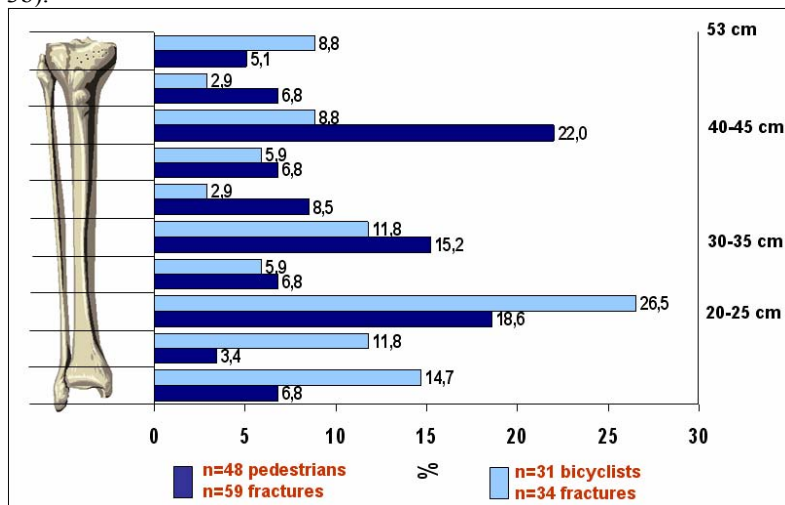
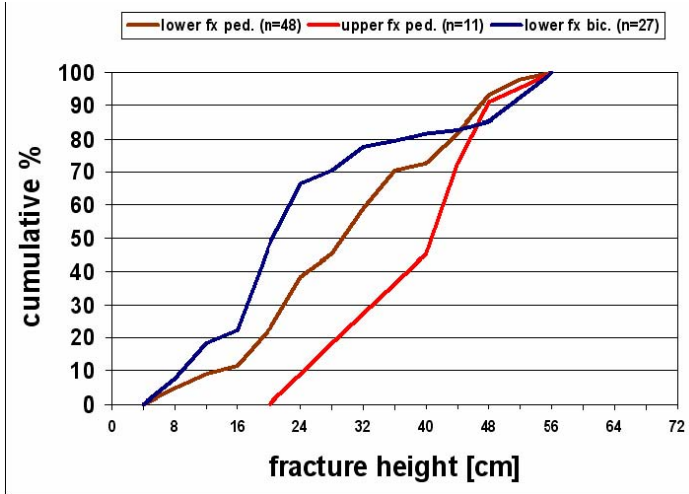
Figure 3a: Incidence of fractures of the lower leg (Tibia and/or Fibula - total length of the lower leg =100 %) and cumulative incidence of the fracture heights from the level of the road in cm Figure 3b: Incidence of fractures of the lower leg (Tibia and/or Fibula - total length of the lower leg =100 %) and cumulative incidence of the fracture heights from the level of the road in cm

In more than half of the cases (53.8%) both bones of the lower leg, tibia and fibula, of the pedestrians, were fractured; in 23.8% only the tibia and in 22.4% only the fibula. In 36.7% of the cases of bicyclists both bones of the lower leg, tibia and fibula, were fractured; in 21.5% the tibia only and in 41.5% the fibula only. Each long bone was subdivided into intervals as percentages of 10% each. If several fractures had occurred on one bone, these were separately included in the evaluation as lower and upper fractures. Clusters of fractures were found for pedestrians at 31 to 40 % (18.6%), at 51 to 60 % (15.2%) and at 81 to 90 % (22.0%).

This corresponds to the three most frequently occurring fracture heights at the lower leg of pedestrians at bumper heights of 20 to 25 cm (18.6%), of 30 to 35 cm (15.2%) and of 40 to 45 cm (22%). Eighty percent of all fractures of pedestrians occurred at effective dynamic bumper impact heights of at least 32 cm up to 44 cm above road level (Figure 3). Eighty percent of all fractures of pedestrians occurred at a height of 19 cm to 45 cm above road level. This demonstrates that the location of the fracture at the lower leg of pedestrians is frequently situated below the point of force transmission during the bumper impact to the leg that has been determined.

In comparison to pedestrians the bicyclists suffered fractures much more frequently in the lower distal region of tibia/fibula, 26.5% in the area of 20 to 30% height from the ankle joint and 14.7% up to 10% near the joint area. Two-third of the fractures of bicyclists suffered from heights on the leg up to 28 cm compared to 36 cm for pedestrians (figure 3b).

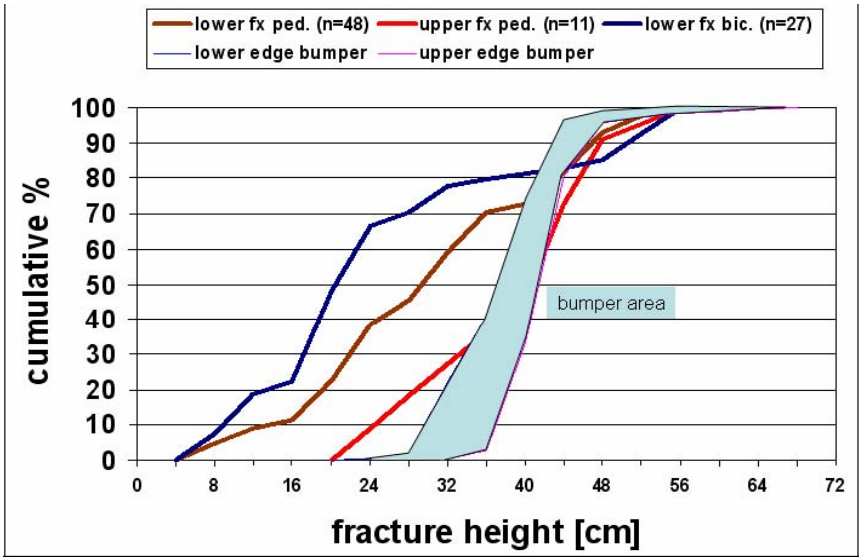
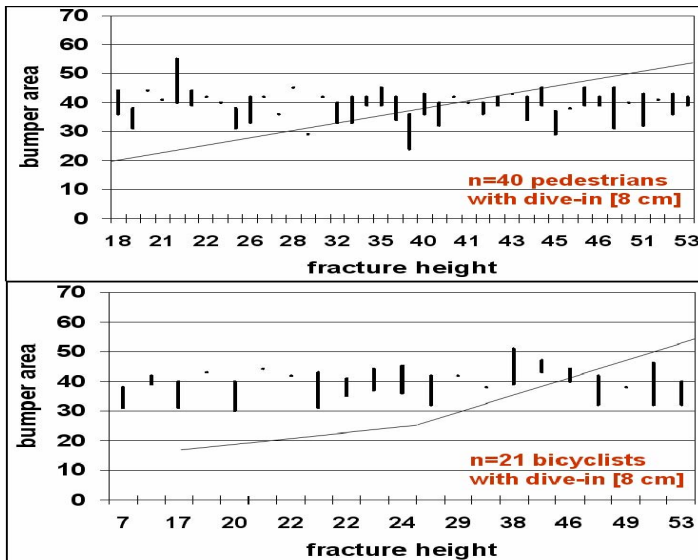
Figure 4a: Measured fracture heights and effective dynamic bumper heights in cm (the line indicates identical heights). The x-axis is non-linear; representation of individual data only  
 Figure 4b: Measured fracture heights and effective dynamic bumper heights in cm (the line indicates identical heights). The x-axis is non-linear; representation of individual data only

If the heights of the fractures are correlated to the effective, dynamic heights of the bumpers, it turns out that 80% of all fractures of pedestrians are located between 19 and 46 cm, whereas 80% of the impact forces are transferred at heights of 32 to 44 cm of the lower leg. Thus the cause of the fractures is frequently located above the fracture itself (Figure 4). Fracture height and bumper height were for pedestrians only identical in 1.5% of the cases, in 47.5% they were lower and in 35% higher.

For bicyclists it can be seen that the height of the fracture is mostly located much lower on tibia/fibula mostly near the ankle joint area. 80% of the fracture heights were found between 9 to 48 cm, while 80% of the bumper heights could be established between 32 and 46 cm above ground level.

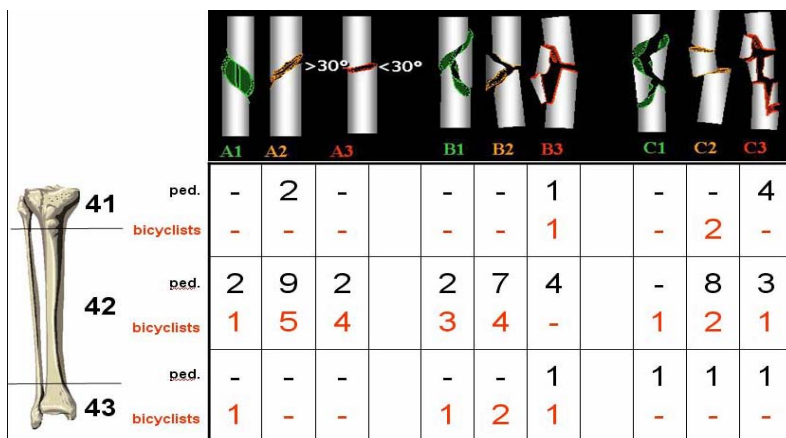
Figure 5: Incidence of fractures according to the AO classification, comparing overall situation and impact velocities <40 km/h

Especially frequently fractures occurred in the shaft region as shown in Figure 5 (location 42). For pedestrians and bicyclists a nearly same distribution of frequencies can be established. But pedestrians seems to suffer more complex fracture types as multiple fractures (Type C2 n=8), as well as the wedge fracture named after Messerer (Type B2 n=7) and the Oblique fracture Type A2 (n=9) also frequently occurred for bicyclists. Remarkable is for bicyclists that multiple fractures types C occurred very few and B1/B2 types are relatively more frequent.

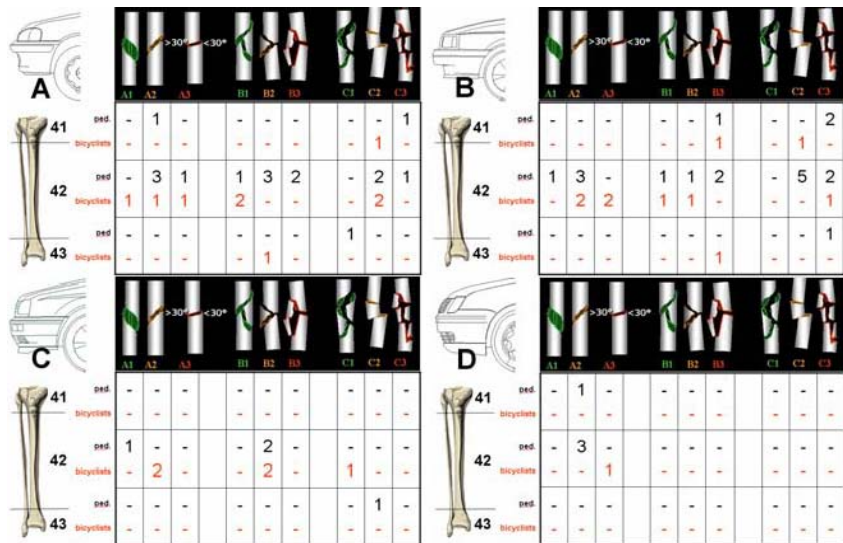
Figure 6: Incidence of fractures according to the AO classification for different bumper types A, B, C, D; comparing the total population and impact velocities <40 km/h

The analysis of different bumper shapes shows that for pedestrians as well as for bicyclists the bending wedged fractures (Type B2) occurred with all bumper shapes, multiple fractures (Types C2 and C3), however, only occurred in collision with cars having A and B bumpers labeled as "old" (figure 6). In contrast, the bumper shapes of the newer cars with integrated and rounded bumper shapes (groups C and D) showed fewer fractures altogether on the one hand, and on the other hand only oblique fractures of the types A1, A2, B2 and no C fractures occurred. Generally, these constitute easily treatable fractures, as a rule without treatments possibly leading to complications.

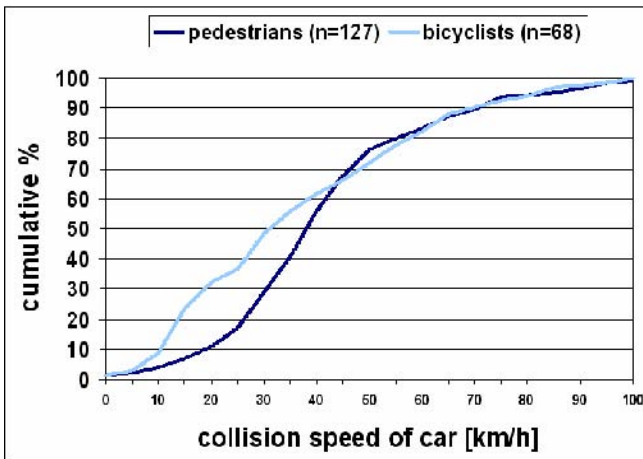
Figure 7: Cumulative incidence of collision speeds of passenger of accidents involving cars and pedestrians compared to bicyclists resulting in fractures

80 % of the documented fractures occurred at collision speeds of up to 55 km/h (Figure 7). Eighty percent of the pedestrians were hit between 20 and 70 km/h of car velocity. The impact speed of bicyclists was mostly lower than for pedestrians (up to 30 km/h: 50% of bicyclists compared to 30% of pedestrians). A correlation between origin of the fracture and the kind of fracture based on the impact velocity was not established. For pedestrians the types of fractures close to the knee (area 41 proximal lower leg) obviously all occur in the lower speed ranges, whereas the shaft fractures in the middle third occurred more frequently at velocities > 40 km/h. Fractures in the area of the ankle (distal lower leg) nearly all occurred at higher impact velocities while these occurred often for bicyclists in lower speed ranges too.

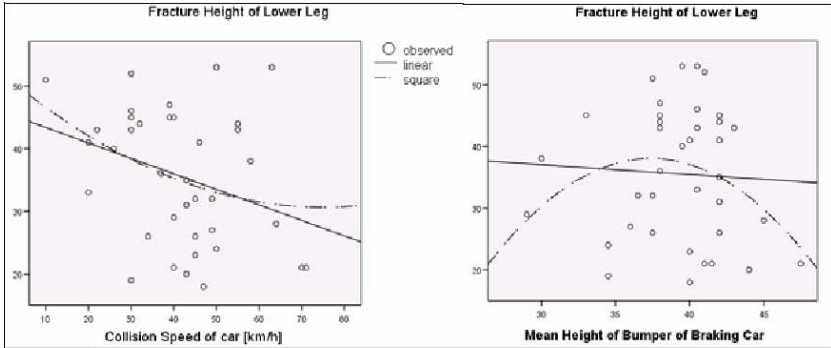
collision speed car	mean height of bumper
height of fracture	correlation by Pearson	-.321	-.055
	significance	.053	.745
	N	37	37

non standard coefficient		standard coefficient	T	significance
	B	standard error	Beta		
(constant)	50.139	18.761		2.673	.011
collision speed of car	-.246	.125	-.319	-1.963	.058
mean height of bumper of braking car	-.110	.464	-.039	-.238	.814

Figure 8: Regression analysis for pedestrian-car-accidents of the correlation between collision speed, the height of the fracture and the height of the bumper

In the statistic tests of pedestrian fracture and bumper height a low negative correlation between collision speed and the height of the fracture ( $r=-0.321$ ,  $p=0.053$ ) resulted; no correlation to the mean bumper height was found (figure 8). If the simultaneous effects of collision speed and the height of the bumper on the height of the fracture are investigated based on a regression analysis, it turns out that only the collision speed has an influence of the origin of the fracture (high-lighted yellow) and at  $p= 0.058$  a statistically low one. This interrelation can be expressed in a three-dimensional diagram (figure 9). Using a square fit of the regression analysis it was proved, that the height of the fracture is reduced significantly with the increase in impact velocity on the one hand and

only increases with very high speeds of approximately 60 km/h, and that on the other hand, the height of the bumper seems to have very little influence on the height of the fracture. Still, for very low and very high bumpers a lower height of the fractures occurred more frequently and only for bumper heights between 33 and 43 cm a constant correlation was found.

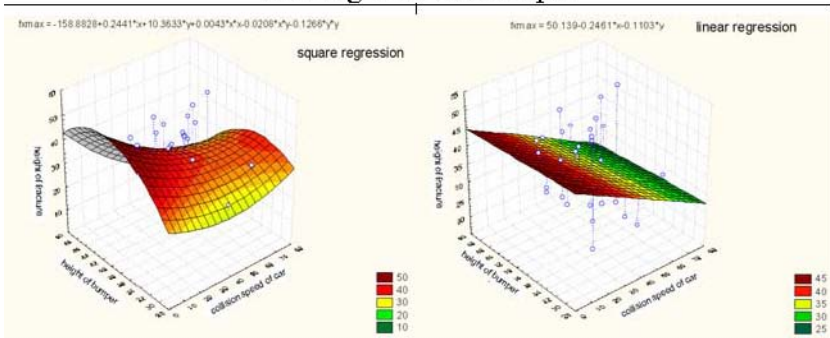
Figure 9: Linear and quadratic adaptation of the regression areas of collision speed vs. height of the fracture of pedestrians vs. height of the bumper in a 3-D-diagram

pedestrian bumper and fracture heights using a square fit of the regression analysis, that the height of the fracture is reduced significantly with an increase in impact velocity on the one hand and increases only with very high speeds of approximately 60 km/h on the other hand, and that on the other hand, the height of the bumper seems to have very little influence on the height of the fracture. Still, for very low and very high bumpers a lower height of the fractures occurred more frequently and only for bumper heights between 33 and 43 cm a constant correlation was found. The numbers of bicyclists was too low for statistical analysis. But it can be assumed that the lower leg of the bicyclists is positioned on the pedals mostly near the dynamic load transmission zone of the bumper and is therefore more direct loaded, pushed away and fractured more on the lower part of the tibia near the joint region. That can explain that fractures caused by bending moment are much less than on the pedestrian situation.
