Humeral bone fragility in patients with shoulder prosthesis: a case of humeral periprosthetic refracture

We report a case of humeral periprosthetic refracture in a 66-years-old female patient.

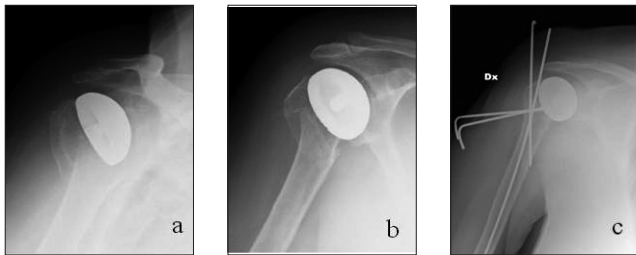
Figure 1 a, b, c - Radiograph of periprosthetic fracture and post-operative after synthesis.

In June 2010, twenty days after the first surgery, the patient fell down causing a periprosthetic fracture (type 2 Campbell) of the humerus (Figure 1a, 1b) treated with osteosynthesis with K-wires (Figure 1c) and immobilization for 30 days followed by a rehabilitation phase. The classification of the periprosthetic fracture in this case refers to that Campbell because it is a resurfacing prosthesis without stem.

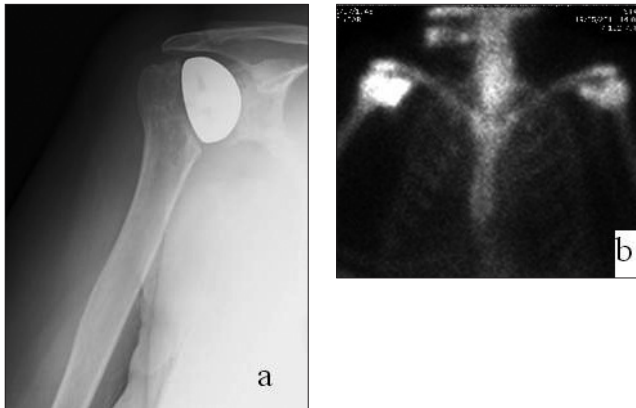
Figure 2 a, b - a) Radiographic evaluation shows the consolidation of the fracture. b) Scintigraphic image compatible with the mobilization of the implant.

However the patient complained of a worsening of pain for which has been subjected to X-ray studies (Figure 2a), CT scans and scintigraphic investigations (Figure 2b) that showed a mobilization of the implant.

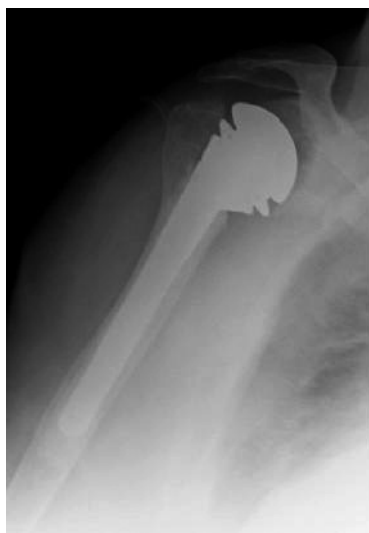
Figure 3 - Radiograph after prosthetic explantation and reimplantation.

ght shoulder with cemented hemiarthroplasty (Bigliani) (Figure 3). In November 2011, the patient fell down again by getting a new periprosthetic fracture (type B2 Worland) (Figure 4a).

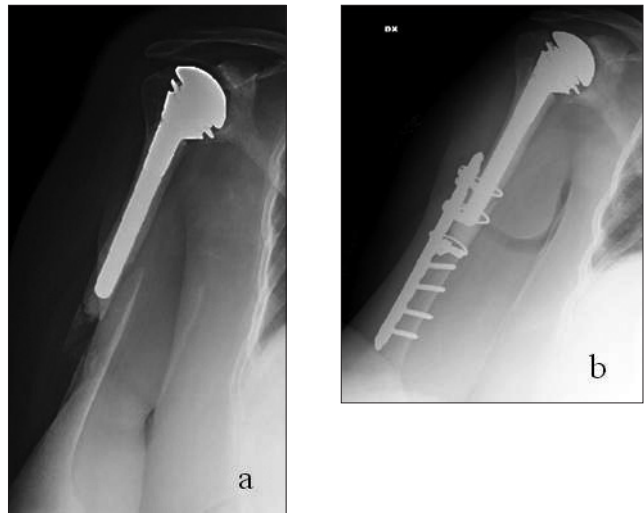
Figure 4 a, b - a) Radiograph after new periprosthetic fracture. b) Post-operative X-Ray after surgical synthesis of the fracture.

The fracture is treated with reduction and fixation with plate, screws and cerclage (Figure 4b).
