Carbon dioxide rebreathing caused by deformed silicon leaflet in the expiratory unidirectional valve

Abstract

Key words: Anesthesia machine, circle breathing system, incompetent unidirectional valves

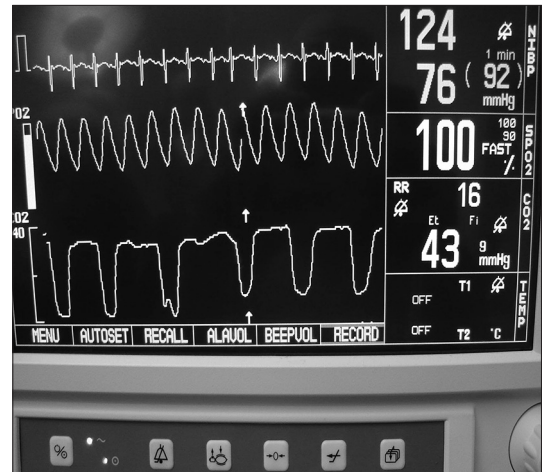
Figure 1: Capnogram showing elevated baseline and higher end-tidal carbon dioxide

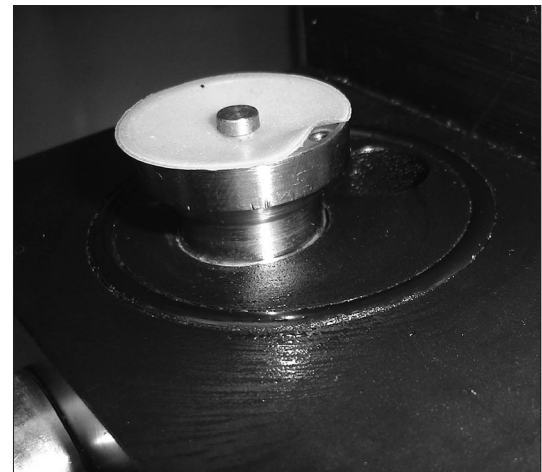
The UDV leaflets in question were made of silicon and were too thin. Each time the valve opened, only a portion of the leaflet was lifted, allowing movement of gas, and after repeated use, this portion of the leaflet remained deformed in an open position. The deformed portion closed only at higher flow rates (or a higher upstream pressure). Low flow rates and smaller tidal volumes used in children were probably not generating sufficient

upstream pressure to close the deformed portion of the leaflet, thereby causing rebreathing of carbon dioxide.

Figure 2: Deformed 'flexible leaflet' of expiratory unidirectional valve (shown after removing the covering dome)

On checking all anesthesia machines with similar UDVs, the inspiratory UDVs were found to be deformed and incompetent in some machines, although no problem was reported during clinical use. The matter was reported to the manufacturer and they concluded that the problem was caused by the thinness of the valve leaflet (0.3 mm). All the leaflets in UDVs were replaced with thicker ones (0.5 mm). No similar problems have been reported since then.

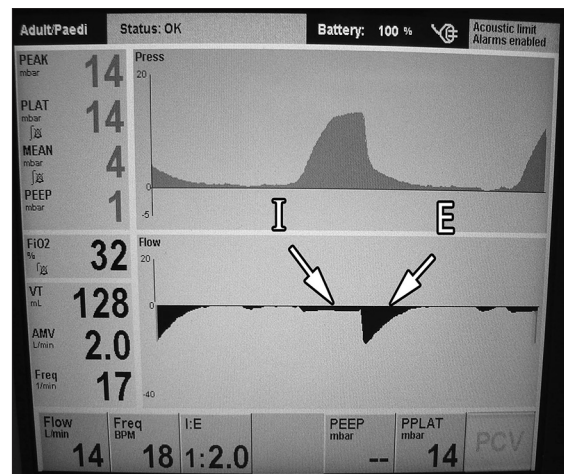
Figure 3: Ventilator display showing the abnormal reverse flow through expiratory unidirectional valve during inspiratory phase (I) and the normal flow during expiration (E)

Incompetent expiratory UDV can be detected by ventilators with a reverse flow alarm.^[1] Standard flow sensors should be able to identify the direction of flow and be able to give an alarm if the flow is reversed due to incompetent valves. The flow sensors used in the above patients were not direction sensitive and did not have a reverse flow alarm.

Continuous revision of acceptable machine standards (e.g., making reverse flow alarm mandatory for flow sensors in the circle breathing system) and quality control of medical equipment must be undertaken, to ensure standards of anesthesia delivery systems.
