Detailed analysis of allergic cutaneous reactions to spinal cord stimulator devices

Abstract: The use of spinal cord stimulation (SCS) devices to treat chronic, refractory neuropathic pain continues to expand in application. While device-related complications have been well described, inflammatory reactions to the components of these devices remain underreported. In contrast, hypersensitivity reactions associated with other implanted therapies, such as endovascular and cardiac rhythm devices, have been detailed. The purpose of this case series is to describe the clinical presentation and course of inflammatory reactions as well as the histology of these reactions. All patients required removal of the entire device after developing inflammatory reactions over a time course of 1–3 months. Two patients developed a foreign body reaction in the lead insertion wound as well as at the implantable pulse generator site, with histology positive for giant cells. One patient developed an inflammatory dermatitis on the flank and abdomen that resolved with topical hydrocortisone. “In vivo” testing with a lead extension fragment placed in the buttock resulted in a negative reaction followed by s

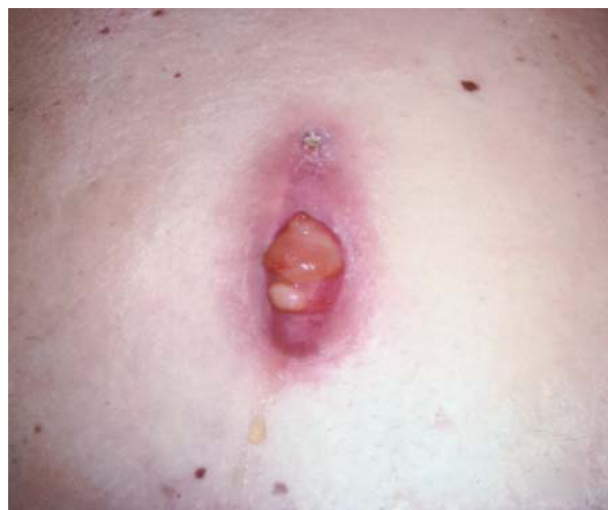
However, despite resolution of the infection, the patient still had a skin inflammatory change that persisted for 5 weeks following implantation (Figure 4). Because of poor

Figure 4 Persistent inflammatory reaction on the upper back (L2 level) 5 weeks post implantation in case 2. Lead strain relief is directly under the inflammatory tissue.

wound healing, the decision was made to remove the dual leads, silastic anchors with associated 0 silk sutures, and the implantable pulse generator. Intraoperative frozen sections revealed acute and chronic inflammation, with a foreign body giant cell reaction (Figure 5A and B). The removal of the soft inflammatory tissue in Figure 4 revealed the underlying leads, and the pocket floor of the implantable pulse generator that had excess lead coils was notable for soft tissue inflammation. Similarly, the tissue was very friable and bled easily with manipulation. Interestingly, there was no fibrotic tissue deposition surrounding the leads, anchors, or the floor of the implantable pulse generator pocket. Normal wound healing then proceeded with an uneventful recovery.

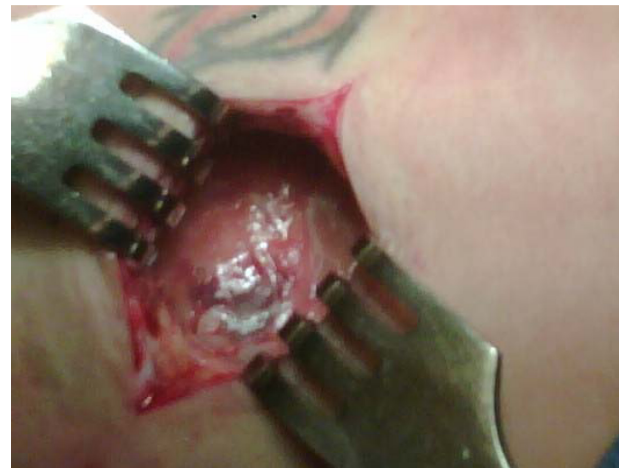
was 13.8. The implantable pulse generator was subsequently removed at approximately 11 weeks post implantation. An inflammatory reaction of the pocket floor was noted with very friable tissue (Figure 7). The fibrous floor of the pocket that is usually well formed at 3 months post-implantation was disrupted by inflammation. There were no signs of purulence or infection. A week later, all her wounds were healing well and the drainage had ceased from the buttock.

Figure 7 Open wound of the right buttock with implantable pulse generator. The floor of the pocket has modest fibrous tissue with a collection of friable reactive tissue.
