# Seronegative spondyloarthropathy-related sacroiliitis: CT, MRI features and differentials

Daya Prakash, Shailesh M Prabhu, Aparna Irodi

Department of Radiology, Christian Medical College, Vellore, Tamil Nadu, India

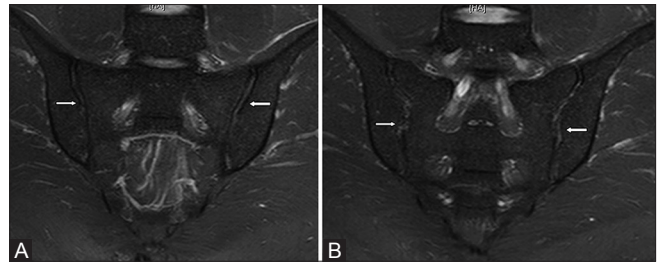
**Figure 1 (A and B):** Normal anatomy of the sacroiliac joint in a 26 year old male. (A) Oblique coronal STIR MRI images show smooth and parallel margins of the cartilaginous lower ventral portion of the joint (arrows). (B) Oblique coronal STIR MRI images in more posterior aspect show irregular edges of the fibrous or ligamentous upper dorsal portion of the joint (arrows). Distinction between compartments of sacroiliac joints is possible on MRI images

The SI joint has two parts, a lower ventral part which is predominantly cartilaginous and an upper dorsal part which is a fibrous joint [Figures 1 and 2]. The cartilaginous segment has smooth and parallel margins, while the fibrous segment shows irregular margins. Bone marrow edema in seronegative spondyloarthritis-related sacroiliitis predominantly involves the lower and posterior part of the joint. Normal anatomic variants of SI joint include accessory SI joint (seen in the posterosuperior portion of the joint) [Figure 3], bipartite iliac bone plate [Figure 3], and iliosacral complex.<sup>[1]</sup>

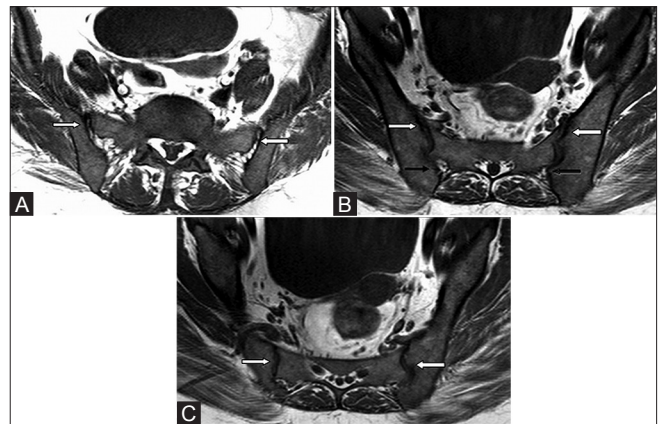
**Figure 2 (A-C):** Normal anatomy of the sacroiliac joint. Axial T1W MRI images at three different levels in a 29 year male: (A) upper portion is predominantly ligamentous (arrows); (B) mid portion is cartilaginous in its anterior aspect (white arrow) and ligamentous in its posterior aspect (black arrows); (C) lower portion is cartilaginous only (white arrows)

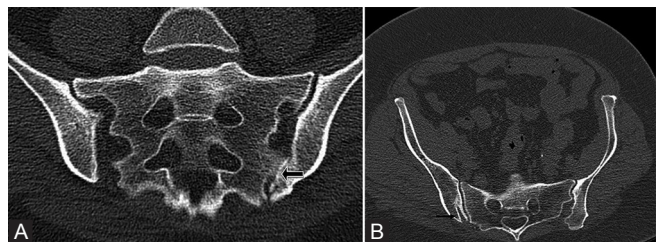
**Figure 3 (A and B):** Anatomic variants of the sacroiliac joints. (A) Oblique coronal CT section of the sacroiliac joint in a 69 year old male shows left accessory sacroiliac joint (black arrow) with degenerative changes and osteophytes. (B) Oblique coronal CT image in a 58 year old female shows right bipartite iliac bone plates (black arrow)

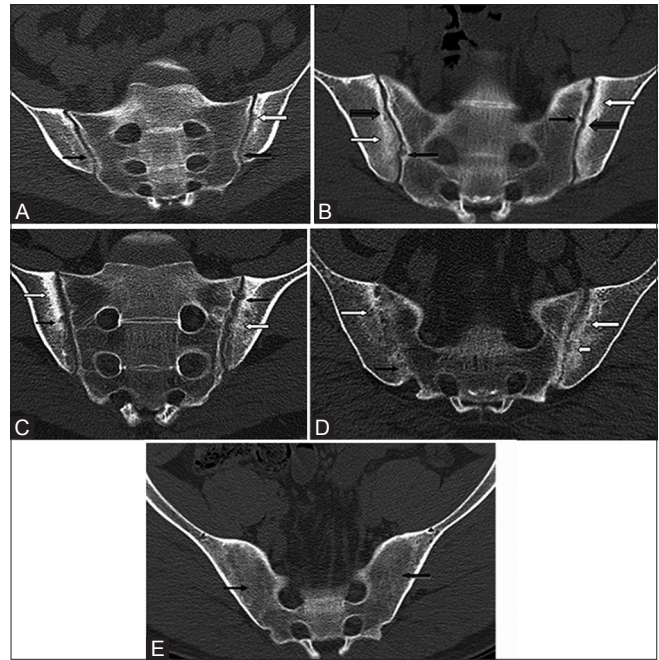
**Figure 4 (A-E):** Sacroiliitis on CT. (A) Oblique coronal CT scan in a 27 year old male with ankylosing spondylitis shows erosion on the left iliac articular surface (white arrow) with bilateral diffuse reduction of joint spaces and blurring of the articular cortex (black arrows). (B) Oblique coronal CT scan in a 49 year old female with ankylosing spondylitis shows bilateral reduction in joint space, erosions on both iliac side (thick black arrows) and sacral side (thin black arrows), along with bilateral subchondral sclerosis (white arrows). (C) Oblique coronal CT scan in a 24 year old male with inflammatory bowel disease shows multiple erosions (black arrows), subchondral sclerosis (white arrows), and widening of the joint space bilaterally. (D) Coronal oblique CT scan in another patient shows bony bridges on the right side (black arrow), subchondral sclerosis on iliac sides bilaterally (white arrows), and erosions in the left ilium (small white arrow). (E) Coronal oblique CT scan in a 65 year old male with ankylosing spondylitis shows complete ankylosis of both sacroiliac joints (black arrows)

CT findings in spondyloarthritis-related sacroiliitis [Figures 4 and 5] include the following:

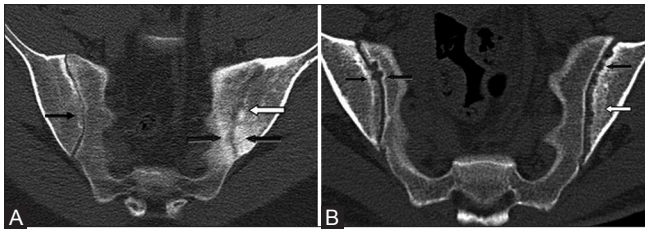
**Figure 5 (A and B):** Asymmetrical sacroiliitis. (A) Coronal oblique CT scan in a 51 year old female with psoriasis shows bilateral diffuse reduction in joint spaces, blurring of articular cartilage on the right side (thin black arrow), multiple erosions in the left ilium (white arrow), and subchondral sclerosis on both iliac and sacral sides (thick black arrow). (B) Coronal oblique CT scan in another case shows multiple erosions in the left ilium (black arrow) with subchondral sclerosis (white arrow) and few erosions on the right iliac and sacral surfaces (black arrows)

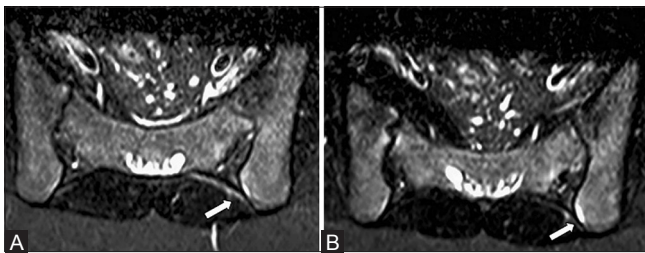
**Figure 7 (A and B):** Findings of acute sacroiliitis on MRI – capsulitis and enthesitis. Axial oblique STIR images show (A) hyperintensity of the posterior capsule (white arrow) which represents capsulitis with (B) hyperintensity of the junctional interface of capsule and bone (white arrow) which represents enthesitis

- Capsulitis and enthesitis: Capsulitis is inflammation of anterior and posterior capsules and seen on MRI as STIR hyperintensity or contrast enhancement of the capsule. Enthesitis represents inflammation involving the junctional interface of bone with ligaments and capsule. It is seen as junctional zone T2W hyperintensity which may extend into the surrounding soft tissue.<sup>[1,2,5]</sup>

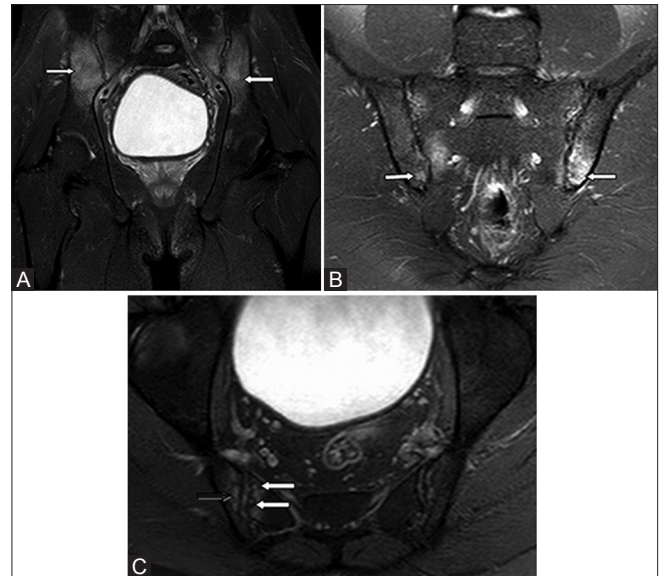
**Figure 6 (A-C):** Findings of acute sacroiliitis on MRI – subchondral edema and erosions. (A) Coronal STIR MR image in a 21 year old female with ankylosing spondylitis shows bilateral symmetrical edema in the subchondral and inferior aspects of the sacroiliac joints (white arrows). (B) Oblique coronal STIR MR image of the sacroiliac joint shows bilateral symmetrical edema in the posteroinferior aspect of the joints (white arrows). (C) Axial STIR MR image through sacroiliac joints shows multiple erosions (white arrows) with subchondral edema (black arrow)

- Subchondral bone marrow edema [Figure 6-8]: It is considered to be an earliest imaging sign of sacroiliitis and forms an important component of the ASAS criteria. It can be symmetrical or asymmetrical and typically involves lower and posterior portion of the joint surface
- Erosions: Erosions are defects in joint surface which can be subtle in the early stage. They involve iliac surface in the early stage with the sacral surface getting involved later
- Synovitis and joint effusion: It is seen as hyperintensity within the joint. Contrast MRI can help differentiate synovitis from joint effusion by demonstrating enhancing synovium in synovitis<sup>[1,2,4,5]</sup>

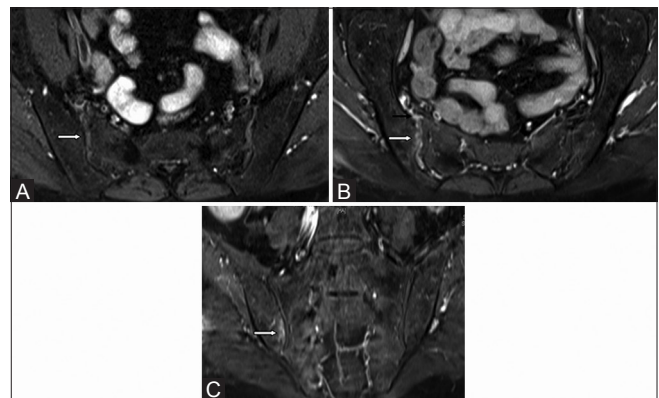
**Figure 8 (A-C):** Findings of acute sacroiliitis on MRI - synovitis and marrow enhancement. Axial T1W fat-saturated (A) pre-contrast and (B) post-contrast MR images in a 52 year old female with psoriasis show enhancing joint synovium on the right side consistent with synovitis (white arrows); enhancement of anterior capsule is also seen (black arrow). (C) Coronal T1W fat-saturated post-contrast MR image shows subchondral bone marrow enhancement in the right iliac bone, findings consistent with active osteitis (white arrow)

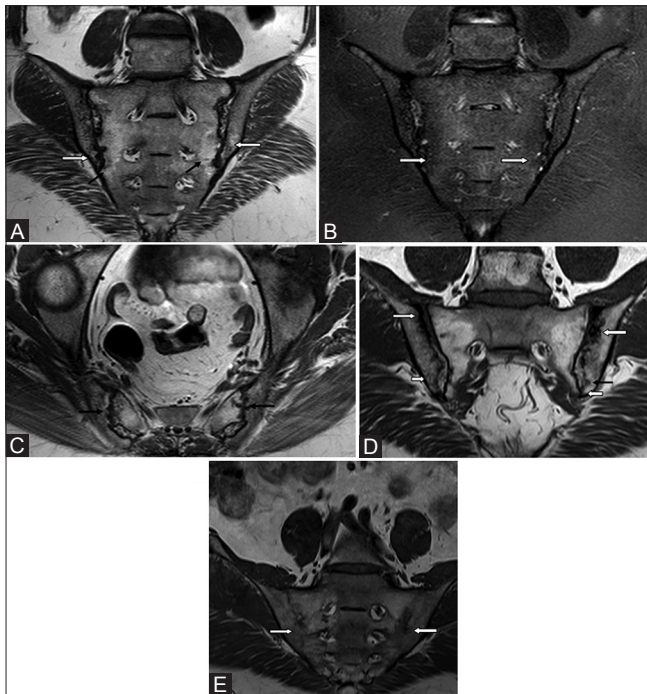
**Figure 9 (A-E):** Findings of chronic sacroiliitis on MRI. (A) Coronal oblique T1W MR image without fat suppression in a 33 year old male with ankylosing spondylitis shows fatty deposition on both iliac (white arrows) and sacral surfaces (black arrows). (B) Corresponding coronal oblique STIR MR image shows suppression of fat signal (white arrows) without any edema. (C) Axial T1W MR image shows multiple subchondral erosions (black arrow), erosion (black arrow), and fatty deposition around the sacroiliac joint (short white arrow). (D) T1W oblique coronal image shows subchondral sclerosis (thin white arrow), erosion (black arrow), and fatty deposition around the sacroiliac joint (short white arrow). (E) Coronal oblique T1W images without fat suppression through sacroiliac joints show complete joint ankylosis (white arrows) in a 60 year old male with ankylosing spondylitis

- Subchondral fatty deposition [Figure 9]: It is an important indicator of chronic sacroiliitis. It is seen as subchondral T1W hyperintensity which gets suppressed on fat-saturated images. As an isolated finding, it is nonspecific and represents sequelae of previous inflammation. However, when associated with other findings like erosions, sclerosis, or bony bridging, it helps in diagnosing spondyloarthritis-related sacroiliitis<sup>[1,2]</sup>
- Subchondral sclerosis: Sclerosis is seen on both iliac and sacral subchondral surfaces, and is seen as T1W and T2W hypointensities on MRI. It should extend at least 5 mm from the SI joint surface
- Erosions: Erosions are seen involving both iliac and sacral surfaces with associated joint space narrowing. Large confluent erosions may result in pseudo-widening of the joints
- Bony bridges and total ankylosis: Fusion of joint

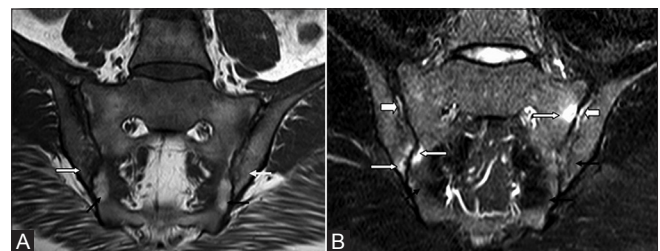
**Figure 10 (A and B):** Acute-on-chronic sacroiliitis. (A) Coronal oblique T1W MR image without fat suppression in a 39 year old female with ankylosing spondylitis shows fat deposition on both sacral sides (black arrows) and iliac sides (white arrows). (B) Corresponding STIR images through sacroiliac joint show subchondral edema (active sacroiliitis) (white arrows), areas of fat suppression (chronic sacroiliitis) (black arrows), and synovitis (thick white arrows)

In the presence of acute-on-chronic sacroiliitis, subchondral bone marrow edema may be seen in a background of subchondral fat deposition and other signs of chronic sacroiliitis [Figure 10]. Active erosions may show underlying

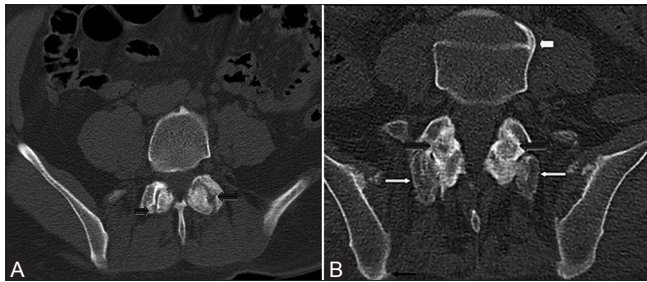
**Figure 11 (A and B):** Associated findings in seronegative spondyloarthritis-related sacroiliitis on CT scan. (A) Axial CT sections in a 51 year old male with sacroiliitis shows erosions in the bilateral facet joints (black arrows). (B) Coronal oblique CT scan in another patient shows bridging syndesmophytes (thick white arrow), facet ankylosis (thick black arrows), and enthesitis (thin black arrow) with periarticular ossification adjacent to facet joints (thin white arrows). Detection of any of these findings in the imaging field in patients with sacroiliitis can support a diagnosis of seronegative spondyloarthritis

Additional findings, when seen in the surrounding structures in the imaging field, can add substantial value to the diagnosis of spondyloarthritis. Additional CT and MRI findings [Figures 11 and 12] in routine SI joint protocol include the following:

- **Facetal arthropathy:** It is seen as facet joint erosions, facet osteophytes, and parafacetal ossification on CT. On MRI, facet joint effusion, facet joint fusion, bone marrow edema, and fatty changes in the superior and inferior facets are seen
- **Enthesitis:** Screening of pelvis may show significant T2W hyperintensity due to enthesitis at greater trochanter and ischial tuberosity<sup>[7]</sup>
- **MRI corner sign and bridging syndesmophytes:** Bone marrow edema involves the anterior and posterior corners of the lower lumbar vertebrae in the acute stage and fatty deposition in the chronic stage.<sup>[8]</sup> Bridging

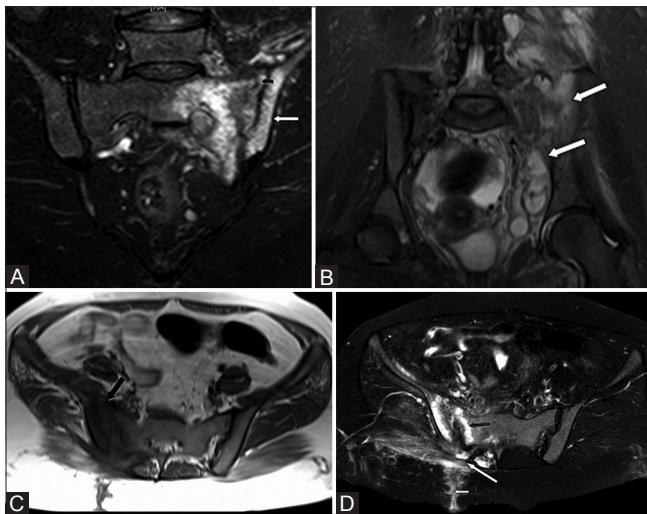
**Figure 13 (A-D):** Infective sacroiliitis. (A) Oblique coronal STIR MR image through sacroiliac joint in a 19 year old female shows left sacroiliitis with bone marrow edema (white arrow) and widening of joint space (black arrow). (B) Coronal STIR MRI image of pelvis shows multiple surrounding hyperintense collections suggesting infective sacroiliitis (white arrow). (C) Axial T1W MRI image in another patient with infective sacroiliitis shows right sacroiliitis with bone marrow edema, subchondral erosions, and joint space widening (black arrow). (D) Axial T2W MRI image in the same patient shows bone marrow edema, subchondral erosions, and joint space widening (black arrow) with multiple surrounding hyperintense soft tissue collections in the right gluteal region (long white arrow) and sinus tract extending upto the overlying skin (short white arrow)

- **Infective sacroiliitis:** Infectious sacroiliitis [Figure 13] should be considered in the presence of unilateral joint involvement and disproportionate bone marrow edema involving either iliac or sacral surface with presence of collection extending into the surrounding soft tissue. However, it is important to note that in some early cases of spondyloarthritis-related sacroiliitis, unilateral joint edema with disproportionate iliac side edema can be seen.<sup>[9]</sup> In such cases, the presence of surrounding soft tissue collection favors an infective etiology. Infective sacroiliitis is treated with antibiotics based on the organism isolated by CT-guided joint fluid/soft tissue

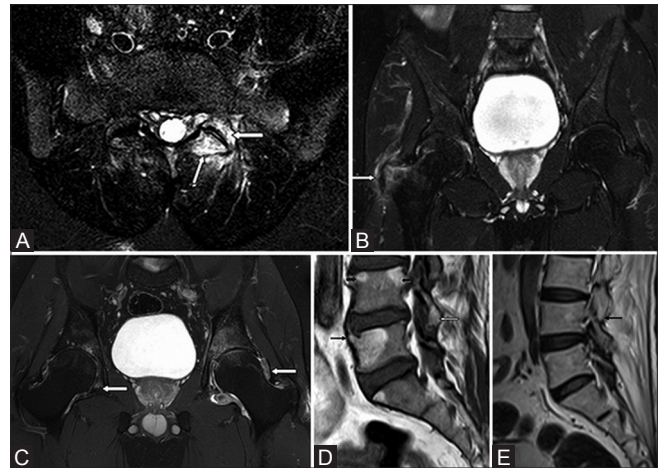
**Figure 12 (A-E):** Associated findings in seronegative spondyloarthritis-related sacroiliitis on MRI. (A) Axial STIR MR image at L5-S1 shows left facet joint subchondral edema (white arrows). (B) Coronal STIR MR image through both hip joints shows edema at tendinous insertion in the right greater tuberosity of femur, suggestive of enthesopathy (white arrow). (C) Coronal STIR MR image through both hip joints shows minimal joint effusion with prominent synovial thickening indicating synovitis (white arrows). (D) Sagittal T1W MR image of lumbosacral spine shows bridging syndesmophyte (thin black arrow), fatty deposition at the superior aspect of anterior and posterior margins of L4 vertebral body indicating shiny corner sign (thick black arrow), and fatty deposition around L4-5 facet joint (white arrow). (E) Sagittal T1W MR image of lumbosacral spine shows ankylosis of the facet joint (black arrow). Detection of any of these findings in the imaging field in patients with sacroiliitis can support a diagnosis of seronegative spondyloarthritis

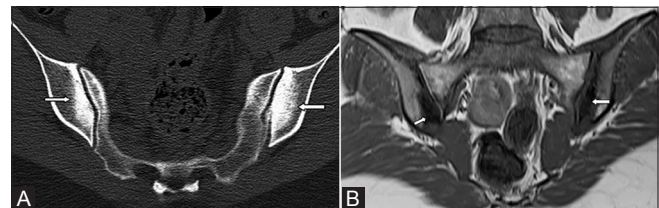
**Figure 14 (A and B):** Osteitis condensans ilii. (A) Oblique coronal CT scan through sacroiliac joint in a 31 year old female shows triangular area of subchondral sclerosis on iliac sides (white arrows) with smooth articular surfaces. (B) Corresponding oblique coronal T1W image without fat suppression shows triangular area of subchondral sclerosis with normal articular surfaces (white arrow)

- Osteitis condensans ilii [Figure 14]: It can resemble subchondral sclerosis seen in chronic stages of sacroiliitis on both CT and MRI. It is commonly seen in multiparous woman. Sclerosis is seen to involve the bilateral iliac surfaces in the absence of bone marrow oedema, erosions, and joint space narrowing
- Degenerative changes [Figure 15]: It is associated with marginal osteophytes, periarticular joint space narrowing, and subchondral cysts in the absence of

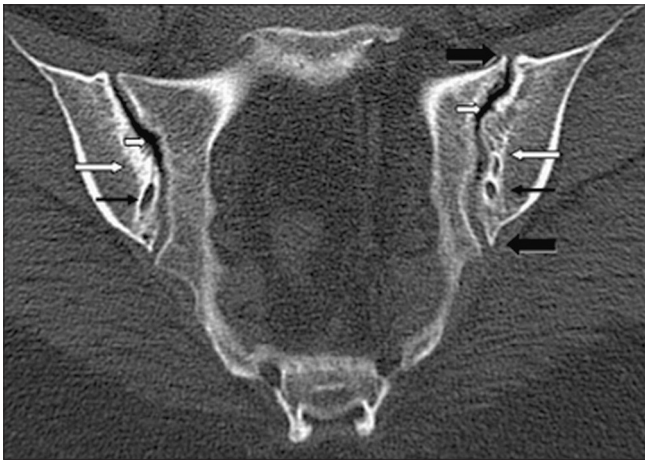
**Figure 15:** Degenerative arthrosis in sacroiliac joints. Oblique coronal CT scan shows osteophytes (thick black arrows), subchondral cyst (thin black arrow), vacuum phenomenon (short black arrow), and subchondral sclerosis (long white arrow)

erosion. The area of involvement is typically anterior and middle half of the SI joint compared to involvement of posterior third in spondyloarthritis-related sacroiliitis<sup>[2]</sup>

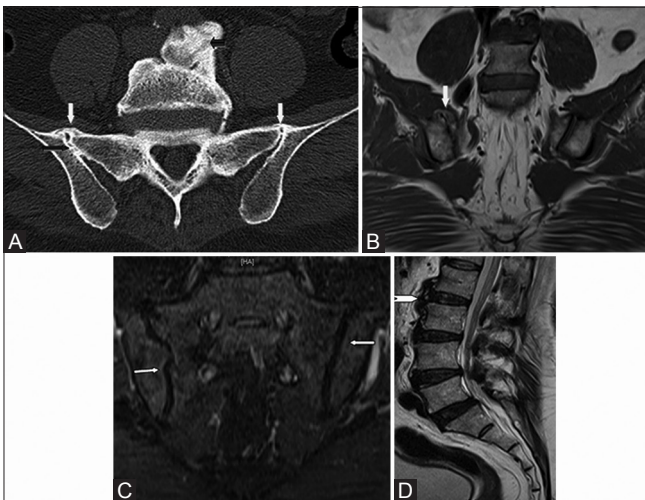
**Figure 17 (A-D):** DISH. (A) Oblique coronal CT scan through sacroiliac joint shows bridging osteophytes in the superior aspect of joint (white arrows), asymmetrical intra-articular fusion of right sacroiliac joint (long black arrow), and flowing anterior osteophytes (short black arrow). (B) T1W coronal MR images show bridging osteophytes in the superior aspect on the right side (white arrow). (C) Corresponding coronal STIR image shows smooth articular surfaces of bilateral sacroiliac joint without erosions (white arrows) and (D) T2W sagittal image through lumbosacral spine shows flowing ossification in the anterior aspect of the vertebral body (white arrow head)

- Stress fracture [Figure 16]: Stress fractures can present with unilateral or bilateral sacral bone marrow edema. Non-involvement of iliac surface and visualization of the distinct fracture line helps in differentiation
- Diffuse idiopathic skeletal hyperostosis (DISH) [Figure 17]: Synovial portion of the SI joints is normal with ossification of the iliolumbar ligaments and anterior and superior articular portions of the SI joint. Spine shows characteristic flowing ossifications along the anterolateral aspect of at least 4 contiguous vertebrae<sup>[10]</sup>

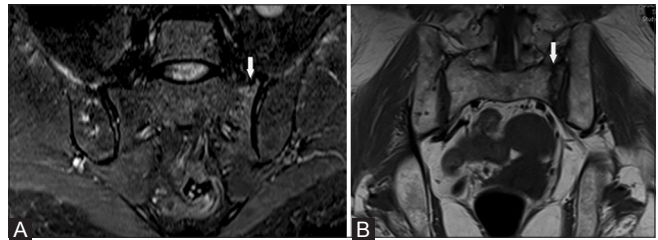
**Figure 16 (A and B):** Stress fracture. (A) Oblique coronal STIR MR image in a 70 year old female with left hip pain shows minimal degree of edema in the subchondral region in left sacrum (white arrow). (B) Corresponding T1W coronal image without fat suppression shows hypointense fracture line (white arrow)

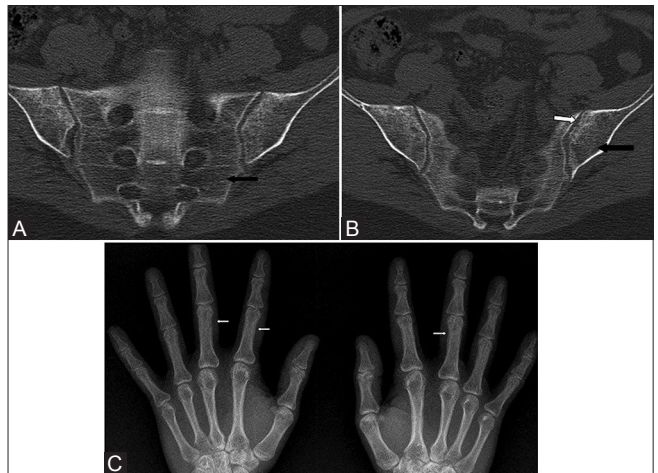
**Figure 18 (A-C):** Hyperparathyroidism. Oblique coronal CT scan images through sacroiliac joint in a 40 year old female (A, B) show diffuse osteopenia (black arrows) with subchondral erosions (white arrows). Bilateral hand radiographs (C) in the same patient demonstrate generalized osteopenia with subperiosteal bone resorption (white arrows) particularly involving the radial aspects of the second and third middle phalanges

- Hyperparathyroidism [Figure 18]: Hyperparathyroidism can present with bilateral symmetric or asymmetric SI joint widening with subchondral erosions. Presence of abnormal bone density, subperiosteal, subligamentous erosions, and involvement of other bones helps in differentiation.
