Evaluating a groundwater supply contamination incident attributed to Marcellus Shale gas development

Garth T. Llewellyn^{a,1}, Frank Dorman^b, J. L. Westland^b, D. Yoxtheimer^c, Paul Grieve^c, Todd Sowers^c, E. Humston-Fulmer^d, and Susan L. Brantley^{c,1}

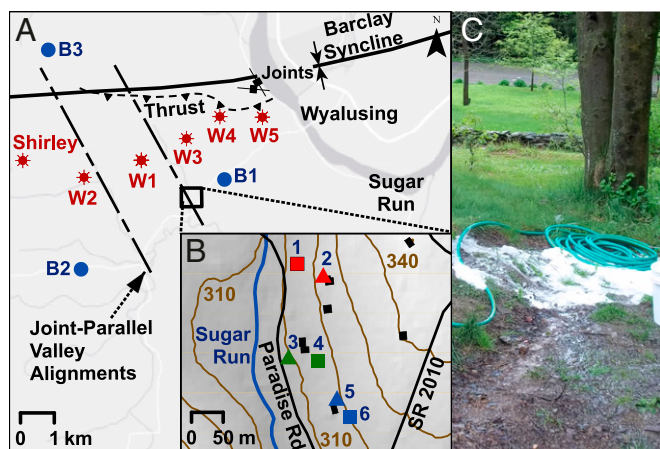
Fig. 1. (A) Study area showing the communities of Wyalusing and Sugar Run located on Susquehanna river (dark grey), gas wells (Shirley, Welles 1–5 well pads labeled as W1 through W5), domestic water wells not impacted by gas drilling activities (B1–B3), and notable geologic features (thrust fault surface expression, regional joint orientation, axis of syncline). (B) Expanded view of tributary of Sugar Run creek (blue line) showing domestic water Wells 1–6 impacted by gas drilling activities. Wells 2, 3, and 5 (triangles) are original impacted wells. Wells 1, 4, and 6 (squares) are replacement wells provided by gas company that also showed contamination. Brown lines are elevation contours (m-msl). Black squares are structures and lines are roads. (C) Foam emitted during purging of domestic water Well 2 in Spring, 2012.

The impacted water wells (Fig. 1) were sampled by environmental consultants and the PADEP and analyzed by commercial laboratories between July 2010 and May 2012 (Fig. 2 and Table S2). The gas company installed replacement groundwater wells (e.g., Wells 1, 4, and 6 illustrated in Fig. 1B); however, these wells also exhibited impacts, and treatment systems were installed for each household in late summer of 2010.

Hydrogeologic Considerations. The impacted homeowner wells lie along the north branch of Sugar Run valley between the axes of two east–west aligned structural folds (Fig. 1 and Fig. S9). The concave Barclay fold (syncline), is located 1–3 km to the north of Welles 1–5 pads; the convex Wilmot fold (anticline) lies to the south at a distance of 5–7 km (Fig. S9). Under the impacted valley (between the folds), bedrock strata dip ~ 5 –10 degrees downward to the northwest toward the Welles series gas wells.

Even though drinking water consistently foamed in three households in Bradford County (e.g., Fig. 1C), commercial laboratories reported no compounds other than natural gas present at concentrations above regulatory recommended action levels, and no constituents were detected above regulatory drinking water standards. However, commercial laboratory analyses did sporadically detect ethylene and propylene glycol and surfactants near microgram-per-liter detection limits (*SI Text*). When we analyzed a subset of the household waters with GCxGC-TOFMS in 2012, we detected very low concentrations of 2-BE. This compound is of special interest because the US Environmental Protection Agency (USEPA) has suggested that 2-BE could be an indicator of contamination from HVHF activities (29). Additional information on 2-BE is provided in *SI Text*. GCxGC-TOFMS also documented a UCM of organic contaminants in all three water wells analyzed. Background groundwater outside of the affected area had no such contamination (Fig. 4B and Fig. S8). It is not possible to prove unambiguously that the UCM and 2-BE were derived from shale gas-related activities. However, the timing (Fig. 2 and Table S1) and the presence of UCMs and 2-BE in flowback/production waters in PA (Fig. 3) are consistent with shale gas activity as the most probable source.

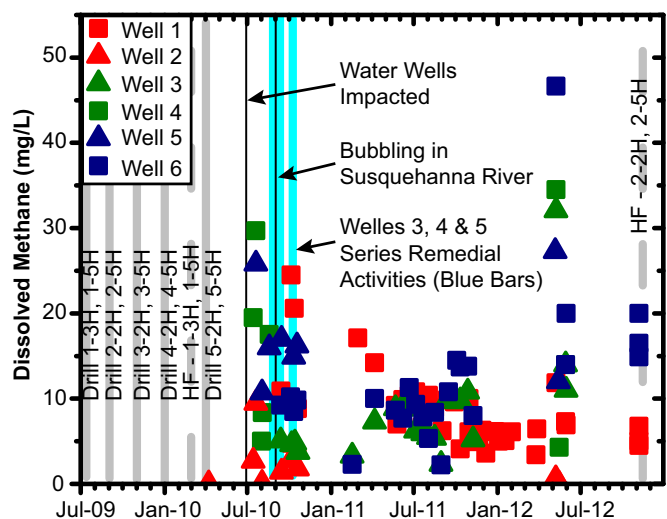
Fig. 2. Time series plot of dissolved methane concentrations with notable events, such as gas drilling, high-volume hydraulic fracturing (dashed grey lines labeled HF), gas well remedial activities, and onset of impacts to water Wells 1–6.

concentrations of dissolved methane in a predrill analysis of Well 2 (Figs. 1B and 2), (ii) groundwater quality time series data, (iii) comparison of isotopic signatures of natural gas from gas well annular spaces and in the potable wells, (iv) timing of the issues after gas drilling (Fig. 2 and Table S1), (v) excessive gas well annular pressures, and (vi) documentation of hydrogeologic conditions conducive to gas migration.

Dissolved Gas and Isotopic Analyses. The dissolved methane concentrations measured in the impacted wells reached as high as 46.6 mg/L between 2010 and 2012 (Fig. 2 and Table S2). Such a high value is similar to methane concentrations we measured in three samples from Salt Springs State Park, where ABB is emitting naturally (Susquehanna County, 35.2 ± 1.53 mg/L, Table S5). In contrast, the predrill concentration in Well 2 was reported as <0.02 mg/L (e.g., plotting at the origin in Fig. 2). Likewise, the 1,701 drinking water wells collected by gas companies before drilling in adjacent Susquehanna County between 2008 and 2011 and analyzed in commercial laboratories (27) varied from a high (90th percentile) of 1.8 mg/L for valleys to a low of 0.017 mg/L for uplands. A steady decrease in dissolved methane was observed for at least one impacted household well (Well 1) with ample time series data, subsequent to the remediation of the Welles 3, 4, and 5 series gas wells (Fig. 2). An anomalous concentration spike was observed for all sampled wells in May 2012;

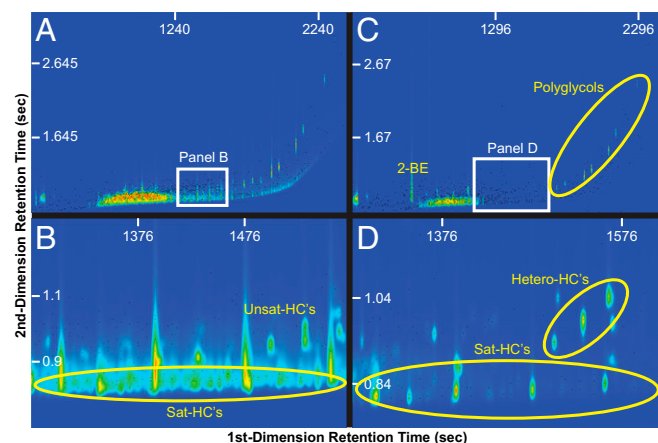
Fig. 3. GCxGC-TOFMS chromatograms of flowback water. (A) Example from a gas well in Connelsville, PA. (B) Magnified portion of A as indicated by white rectangle. (C) Example from a gas well in Kittanning, PA. (D) Magnified portion of C as indicated by white rectangle. General compound classes are illustrated in panels. Unresolved complex mixture (UCM) concentrations are relative to each panel, but increase in concentration from cool (e.g., blue) to bright (e.g., red) color.

Dissolved Organic Analysis. Every flowback/produced water sample we analyzed had a similar UCM of hydrocarbons when evaluated with GCxGC-TOFMS (*Fig. 3*). All groundwater samples from impacted sites (Wells 1, 3, and 6; see *Fig. 1*) that were analyzed with GCxGC-TOFMS showed UCMs similar to those detected in the flowback/production waters (e.g., *Fig. 4A* and *Figs. S4–S6*). Well 1 was analyzed both before and after purging (at which time the water no longer foamed). Peak intensities for the UCM were generally greater after purging (compare *Fig. 4A* and *Fig. S6*).

ratios (m/z) of 50–550. Each flowback/production water sample had a similar but distinct pattern of saturated versus branched chain alkanes (compare *Fig. 3A* and *C*).

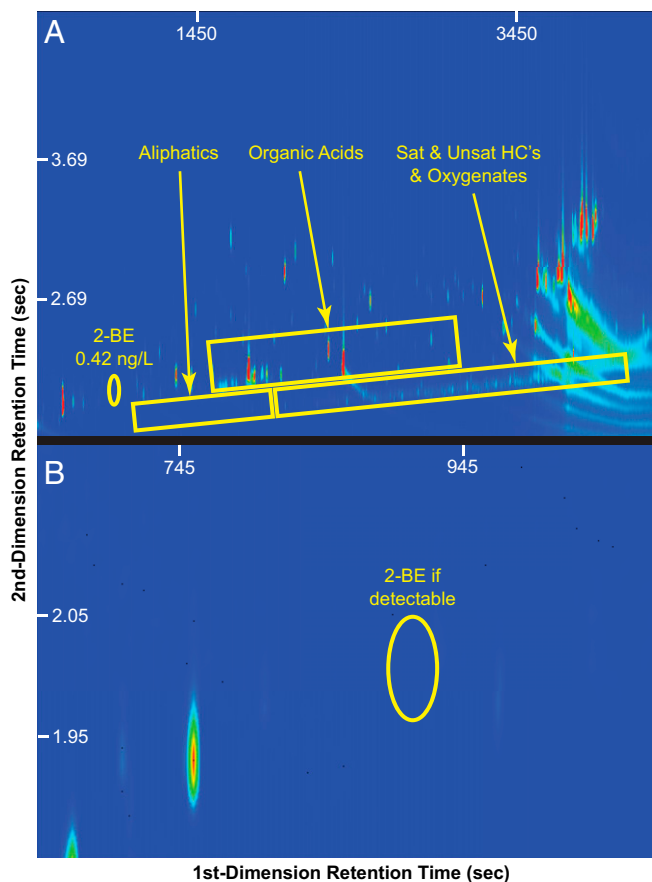
Fig. 4. GCxGC-TOFMS chromatograms for (A) Well 1 (PLG-12-67A) before purging and (B) background Well B1 (PLG-13-7A) that was not impacted by gas drilling activities. The hydrocarbon UCM observed in Well 1 is similar to that observed in flowback samples (e.g., *Fig. 3*). The 2-BE was positively identified in Well 1 (impacted by gas drilling activities), but not as part of background water quality. B is magnified to illustrate the absence of 2-BE.

2-BE above detection (~ 0.01 ng/L). Likewise, neither UCM nor 2-BE were detected from groundwater (e.g., Fig. 4B and Fig. S8) sampled from three household wells (e.g., B1, B2, and B3 illustrated in Fig. 1) located outside of the impacted area and used to evaluate background conditions.

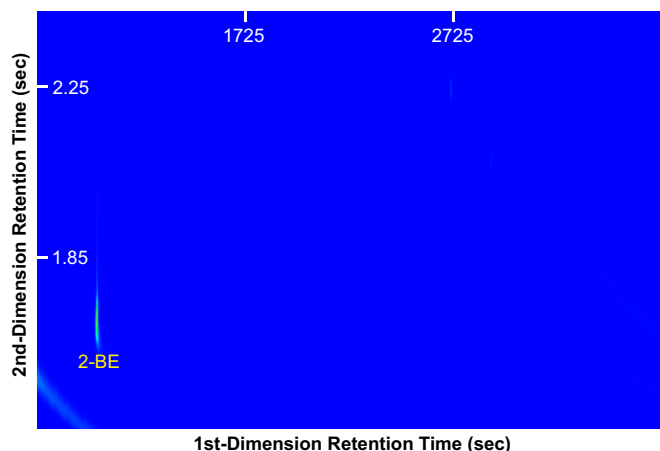
Fig. 5. GCxGC-TOFMS chromatogram for Airfoam illustrating 2-BE as the sole detectable component.

There are no reports of 2-BE as a natural constituent in waters from shale (30). However, the common drilling additive Airfoam HD contains 2-BE as the only detectable organic component from our analyses (Fig. 5). Although we have no evidence that Airfoam HD was used in the Welles series gas wells in drilling fluids, this substance has been commonly used in northern and central PA. Indeed, it was cited by the PADEP as the cause of foam from a spring discharging to the canyon wall above Pine Creek in Lycoming County (PA) that began 15 March 2010. Further, a more recent PADEP contamination determination

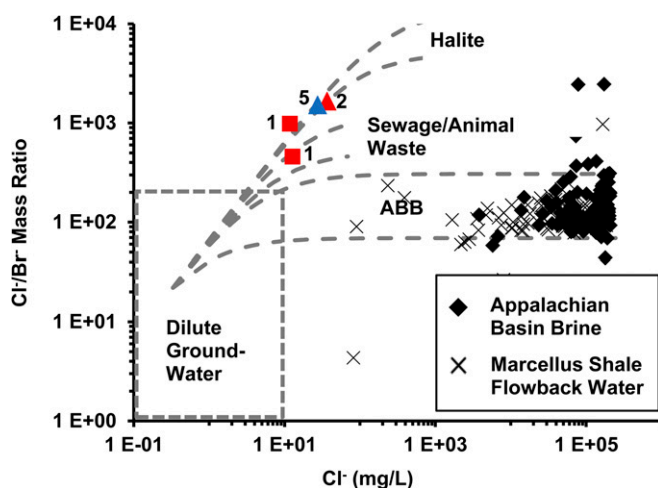
Fig. 6. Crossplot of Cl/Br mass ratio vs. Cl concentrations for samples collected from Wells 1, 2, and 5 (labeled) with bounding upper and lower conservative mixing curves for various endmembers (e.g., Appalachian Basin brine, sewage and animal waste, and halite sources). Appalachian Basin brine samples (20–22, 24) and Marcellus Shale flowback samples (23, 25, 26) are also plotted for comparison.

Inorganic Analysis. Conservative inorganic constituents (e.g., Cl and Br) can be used to determine if flowback or production waters have contaminated groundwater because these wastewaters can contain total dissolved solids in concentrations greater than 300,000 mg/L (6, 18). Further, if upward migration of HVHF fluids occurred after mixing with formation waters, dissolved Cl/Br mass ratios are more likely to be useful as effective fingerprints than the HVHF fluid components themselves, due to their more conservative behavior in groundwater (6, 10). Crossplots of Cl/Br (mass ratio) versus Cl concentration (Fig. 6) can help elucidate the source of Cl. For example, the natural water quality data for Salt Spring in Susquehanna County, PA, documents that Appalachian Basin brine (ABB) up-wells naturally into groundwater and surface water in Susquehanna County in that location as well as others (18). Although diluted, this spring water has a similar composition to flowback/production waters throughout PA and a few other brine springs and deep formation waters in the state (18–26) (Fig. 6 and Table S6). Conversely, Fig. 6 illustrates that the Cl concentrations and Cl:Br ratios of the impacted household waters from Bradford County are more likely gaining dissolved salts from sources with higher Cl:Br mass ratios than ABB.
