U-Shape Kissing Chimney Thoracic Endovascular Aneurysm Repair for a Traumatic Arch Rupture in a Polytraumatized Patient

Aortic Arch Rupture • Percutaneous TEVAR • Chimney

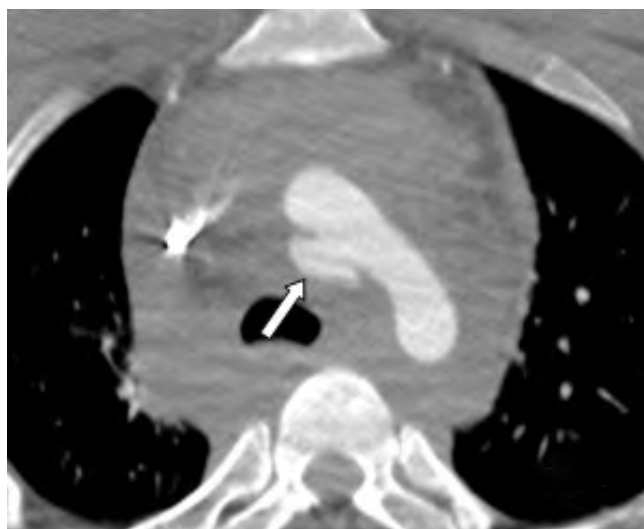
Figure 1. Mediastinal bleeding caused by a rupture of the aortic arch. White arrow: Posterior wall pseudoaneurysm.

to a posteriorly located rupture of the aortic arch with formation of a pseudoaneurysm (Figure 1).

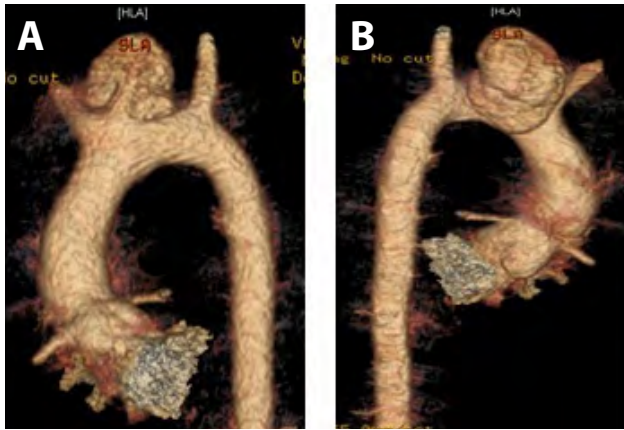
Figure 2. CT-reconstruction, note the bovine arch and rupture in close proximity to the brachiocephalic trunk. A) anterior view. B) posterior view.

A more detailed examination of the CT scan showed a bovine arch with common origin of the brachiocephalic trunk and the left common carotid artery (LCCA), complicating the procedure (Figure 2). Debranching of the LCCA was not possible because the rupture was too close to the origin of the brachiocephalic trunk, thus inducing an unacceptable proximal landing zone (Figure 2).

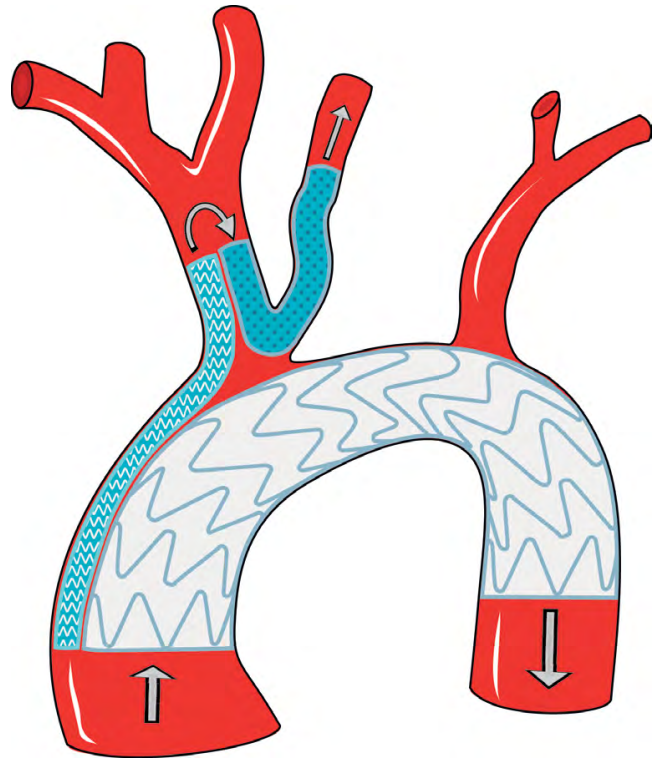
Figure 3. Schematic diagram of the construction used in this patient: Large waved area: 2 subsequent endoprotheses (Valiant Captivia, Medtronic, Minneapolis, Minnesota, USA) overriding the brachiocephalic trunk. Small waved area: 2 Advanta V12 stents from the ascending aorta, entering the brachiocephalic trunk. Dotted area: U-shaped Viabahn stent allowing blood to enter the LCCA from the brachiocephalic trunk. Arrows: blood

Therefore a more complex option was chosen: This began with an elongation of the endoprosthesis with a second Valiant Captiva placed more distally and overriding the brachiocephalic trunk, which meant placing kissing chimney stents. At the most proximal part of this “kissing chimney” configuration were two Advanta V12 10x38mm and 10x59mm stents (Maquet Cardiovascular, Wayne, New Jersey, USA) introduced via the right brachial and subclavian arteries. This allowed for blood from the ascending aorta to enter the trunk and proceed through the right subclavian artery and the right common carotid artery. The second portion of the chimney allowed blood to enter the LCCA from the trunk in a retrograde manner. This part consisted of a 7x100mm Viabahn stent (Gore Medical, Flagstaff, Arizona, USA) introduced after puncture of the LCCA and wiring of this vessel back and upwards,

between the endoprosthesis and the aortic wall, into the right common carotid artery in a U-shape pattern (see Figure 3 for a schematic version of the entire construction) [1]. The left subclavian artery received blood via a steal phenomenon through the left carotid artery system. The entire procedure was possible under low heparin dosage (Activated Clotting Time < 250 seconds) with immediate antagonistic Protamine administration afterwards.

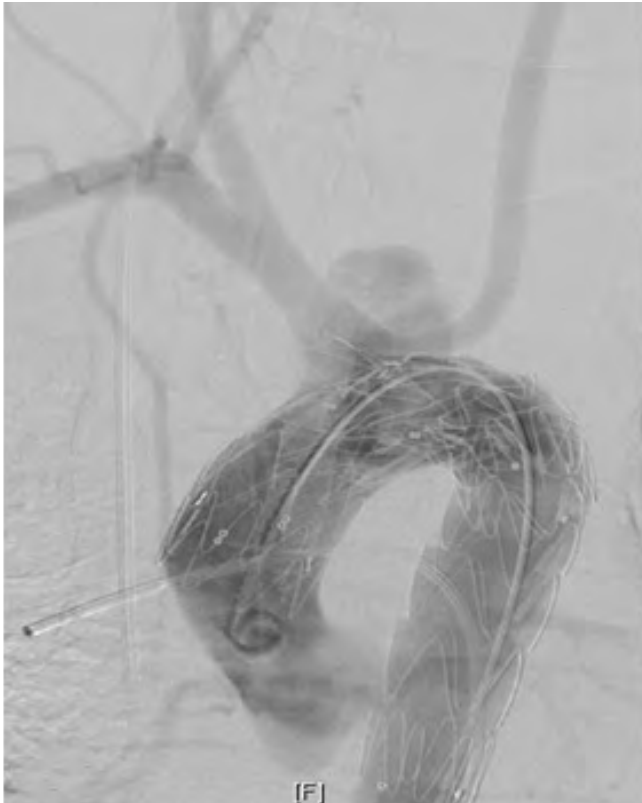
Figure 4. Post procedure visualization of Type 1A endoleak with filling of the pseudoaneurysm.

Although the procedure went well, immediate control comparison revealed a type IA endoleak (Figure 4) which was treated additionally by direct suprasternal puncture of the pseudoaneurysm. Once the correct position of the sheath was verified, filling of the space with Gianturco coils (Cook Medical, Bloomington, Indiana, USA) and Glubran glue (GEM S.R.L., Lu, Italy) resulted in immediate success (Figure 5).

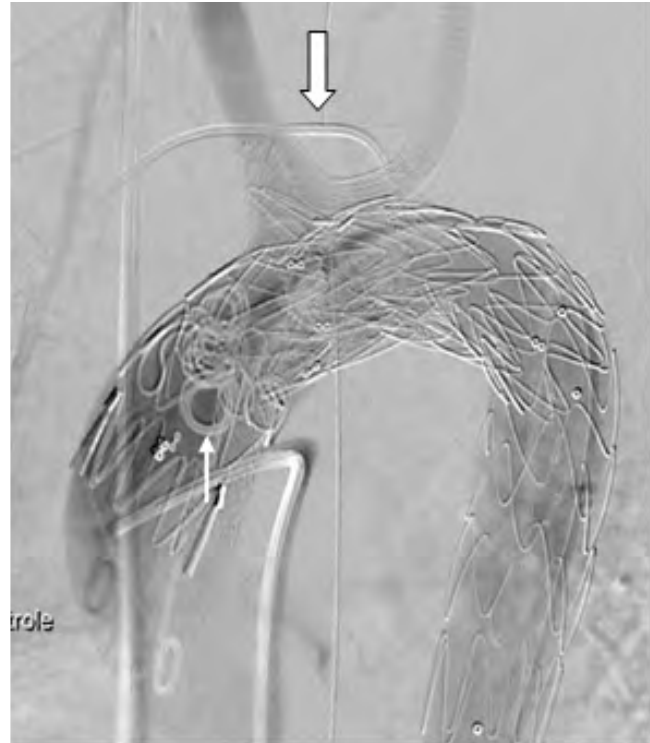
Figure 5. Post-treatment of the endoleak. Large white arrow: suprasternal sheath; Thin white arrow: coils.

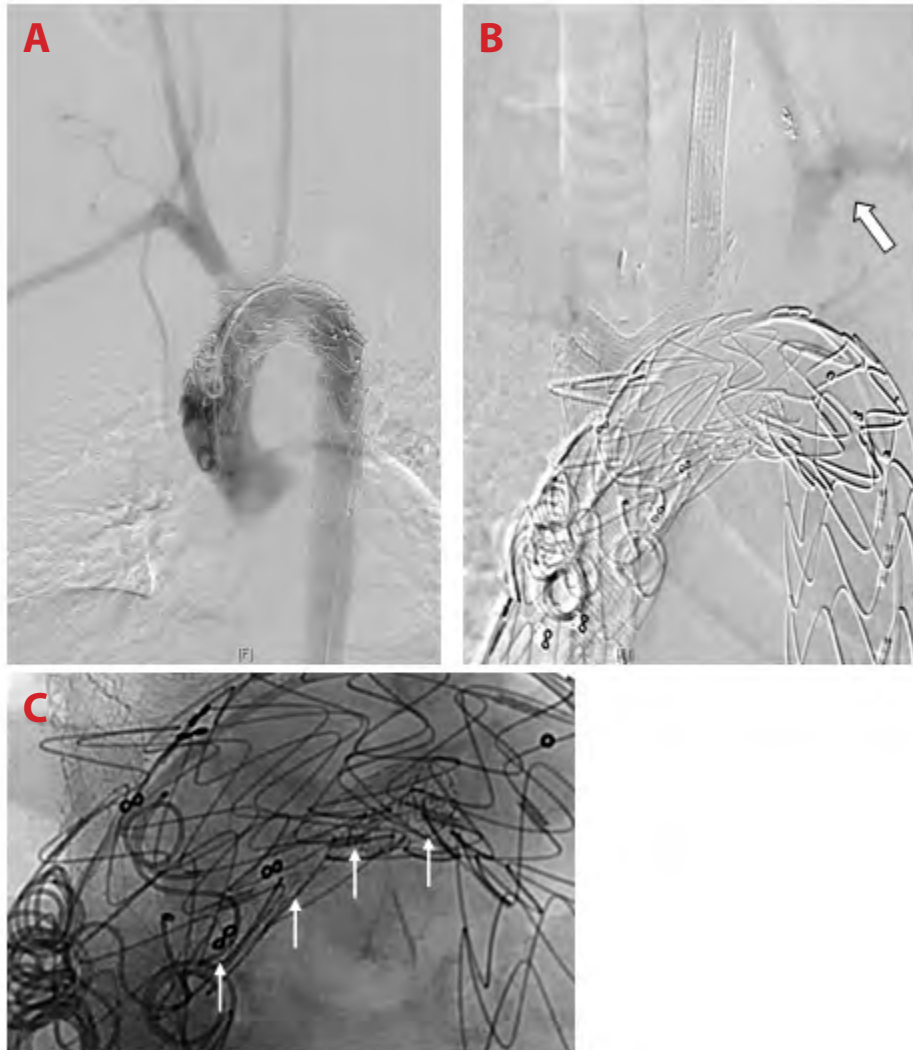
Figure 6. Stable control at 1 year. A) frontal view, early contrast phase. B) frontal view, late contrast phase. C) enhanced image. Note the subclavian steal to the left upper extremity (large arrow) and the luxated V12 stent still in situ (small white arrows).

Today, the patient is in perfect clinical condition without any problems regarding the extensive endovascular repair of his aortic arch and supraaortic vessels. A control CT scan and intraarterial angiogram 1 year later showed a good construction with patent chimneys and no type I or II leakage (Figure 6).
