Periprosthetic Femoral Fracture With Broken Implant Insitu: - A Treatment Prospect

Case Report: We present here a case of periprosthetic fracture Vancouver type B1 with a broken cemented bipolar prosthesis insitu, in which the broken implant was firmly fixed in the proximal fragment and could not be removed following which the whole of the proximal fragment along with the broken implant was removed and replaced by a customized steel long stem cemented mega prosthesis.

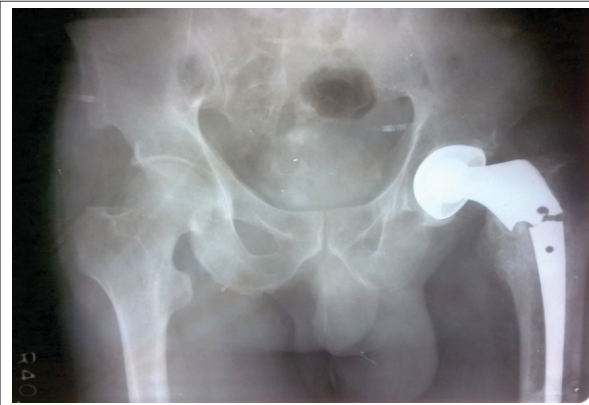
Figure 1: Preoperative radiograph of the patient - Plain radiograph of the left hip and thigh region showing a Vancouver type B1 periprosthetic fracture with a broken cemented bipolar prosthesis in situ.

Routine blood investigations were under normal limits. Plain radiographs of the left hip and thigh showed a Vancouver type B1 periprosthetic fracture with a broken cemented bipolar prosthesis in situ [14]. There was sufficient bone stock and there was no osteopenia and osteolysis.

The patient was planned for surgery with options for internal fixation of the fracture with revision of the prosthesis, and reconstruction of proximal femur with proximal femoral mega prosthesis.

The hip was opened by posterior approach. The head of the broken prosthesis was removed easily but the stem was well fixed in the bone stock and could not be removed despite of all the efforts. So we opted for proximal femoral replacement with customized hip mega prosthesis. An osteotomy of the greater trochanter was performed and it was raised separately along with the attached abductors. The rest of the proximal part of the femur up to the fracture site was resected and removed along with the broken prosthesis. It was replaced by long stem steel cemented proximal femoral mega prosthesis. The remaining portion of the greater trochanter along with the abductors was attached to the ports provided at the lateral side of the prosthesis. Wound was closed over a suction drain. The patient was allowed to bear weight after removal of the stitches on the 12th post operative day with the help of four post walker. He has completed 2 years of follow up and is totally asymptomatic, pain free and walks independently without support.

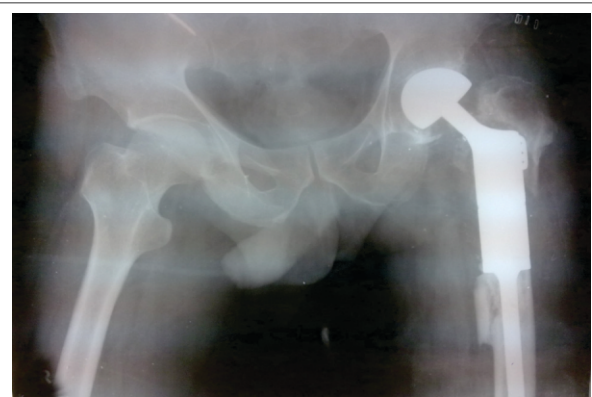
Figure 2: Postoperative radiograph of the patient – Plain radiograph of the left hip and thigh region showing the fracture treated by a custom made long stem cemented bipolar prosthesis.

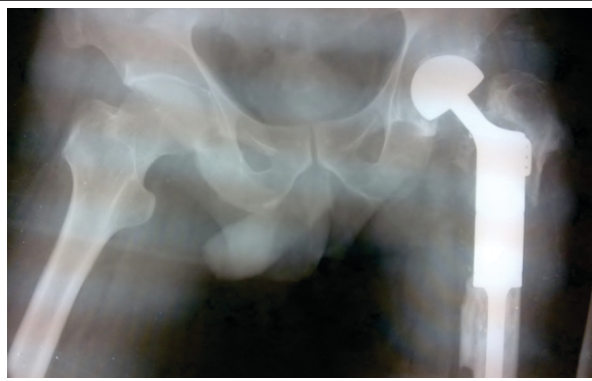
Figure 3: One year follow up radiograph of the patient – Plain radiograph of the left hip and thigh region after one year of follow up showing a stable prosthesis with no signs of loosening or any other complication.
