The Bony Bankart Lesion: How to Measure the Glenoid Bone Loss

Jarosław Skupiński^A, Małgorzata Zofia Piechota^{CDI}, Wojciech Wawrzyniek^A,
Jarosław Maczuch^A, Anna Babińska^A

Department of Radiology, District Hospital of Orthopedics and Trauma Surgery, Piekary Śląskie, Poland

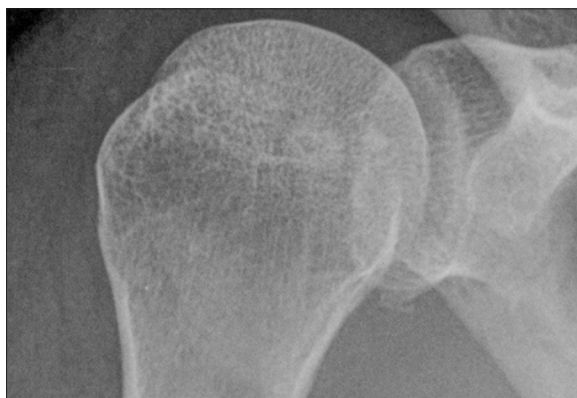
Figure 1. AP radiograph of a stable shoulder presents a preserved sclerotic line.

When diagnosing anterior shoulder instability, the usual initial imaging modality is an anteroposterior radiograph of the shoulder. Radiographs of a stable shoulder present a sclerotic line which represents the normal anterior glenoid rim (Figure 1). The absence of that line for more than 5 mm from the inferior glenoid edge indicates bone lesion of the anterior glenoid rim (Figure 2). That sign is described as LSGL (loss of sclerotic glenoid line) [6]. Jankauskas et al. compared the LSGL sign on true AP radiographs with CT images. It appears that LSGL is moderately sensitive and highly specific for the detection of anterior osseous lesions. Several other projection of radiographs have been used for the imaging of anterior shoulder

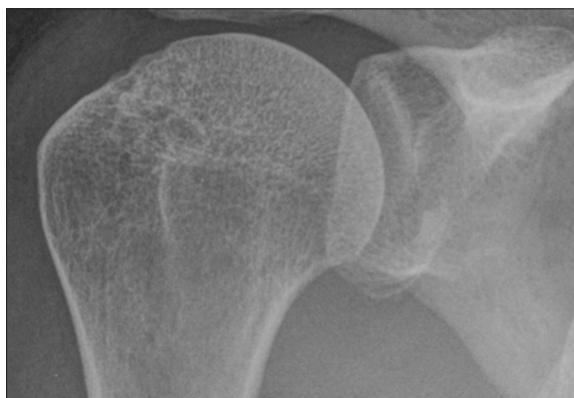
Figure 2. AP radiograph of the shoulder presents the loss of sclerotic line which indicates glenoid anterior rim bone lesion.

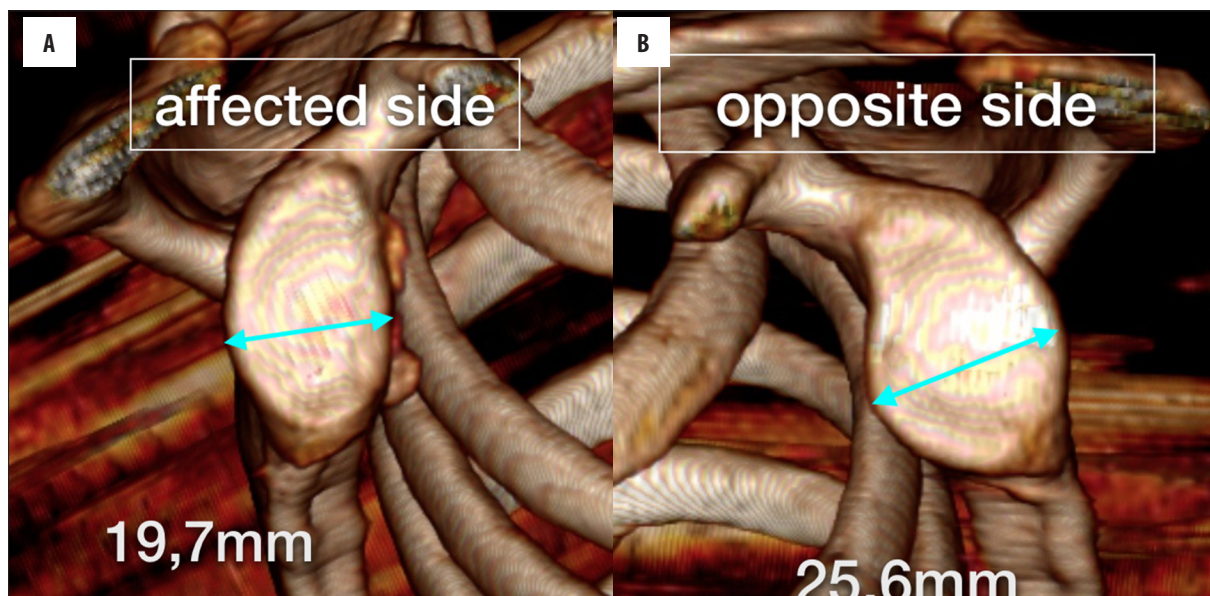
Figure 3. (A) CT 3D reconstruction of the glenoid surface of both shoulders. Affected side: the bone loss in the anterior part of the glenoid is present. (B) Opposite side: the surface of the unaffected glenoid is visualised with unchanged maximum width.

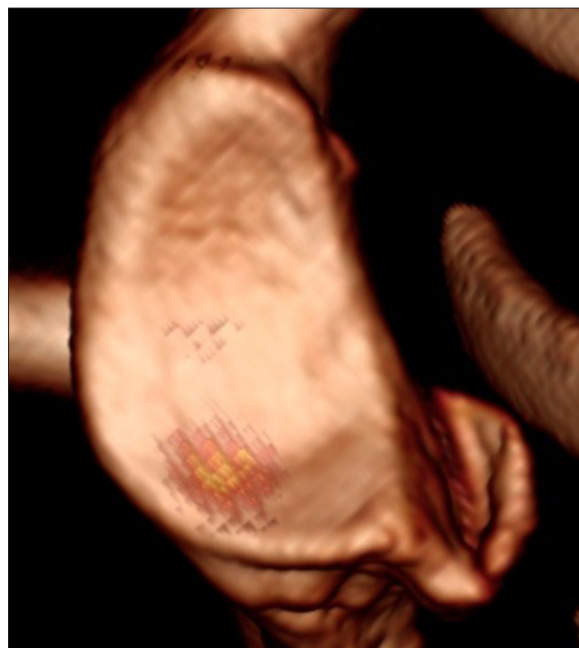
Figure 4. CT 3D reconstruction of the glenoid surface on sagittal en-face view. The bone loss of the anterior part of glenoid is present with a large bone fragment.

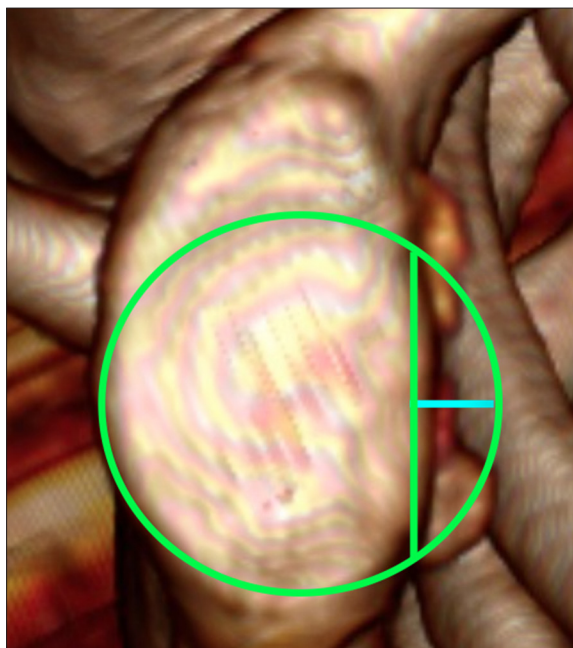
Figure 5. CT 3D reconstruction of the glenoid surface. Best fit circle method. Blue line presents the width of the missing bone fragment.

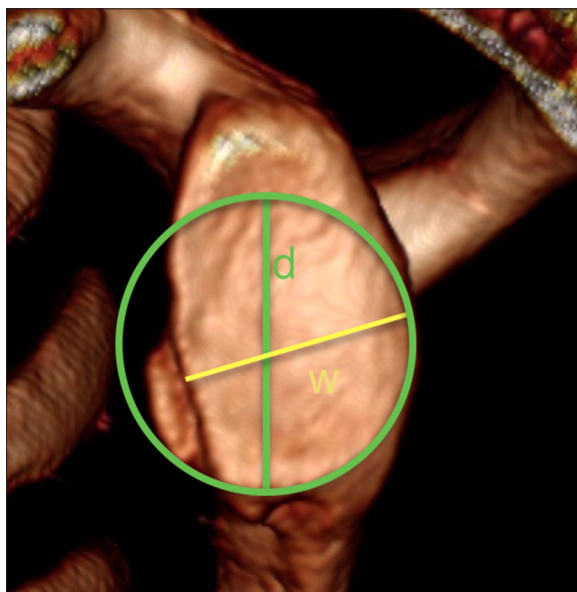
Figure 6. CT reconstruction of the glenoid surface. Best fit circle method with the use of Chuang measuring technique where „d” is the width of the unaffected glenoid and „w” represents the width of the injured glenoid.

Another technique using 3D CT reconstructions is the glenoid index described by Chuang et al. The glenoid index is the ratio between the width of the injured glenoid and the width of the unaffected glenoid before an injury (Figure 6) [13]. This technique is similar to the Pico technique, where the shoulder before an injury is tantamount to the contralateral healthy shoulder described by Baudi. Finally, a unilateral quantification of the unstable shoulder in 3D CT images was used in Barchilon et al. study. These authors proposed a simple method of measuring the size of the glenoid defect by calculating the ratio between the depth and the radius of the best-fitted circle. The depth was defined as the line drawn from the centre of the circle to the injured anterior glenoid margin [14].

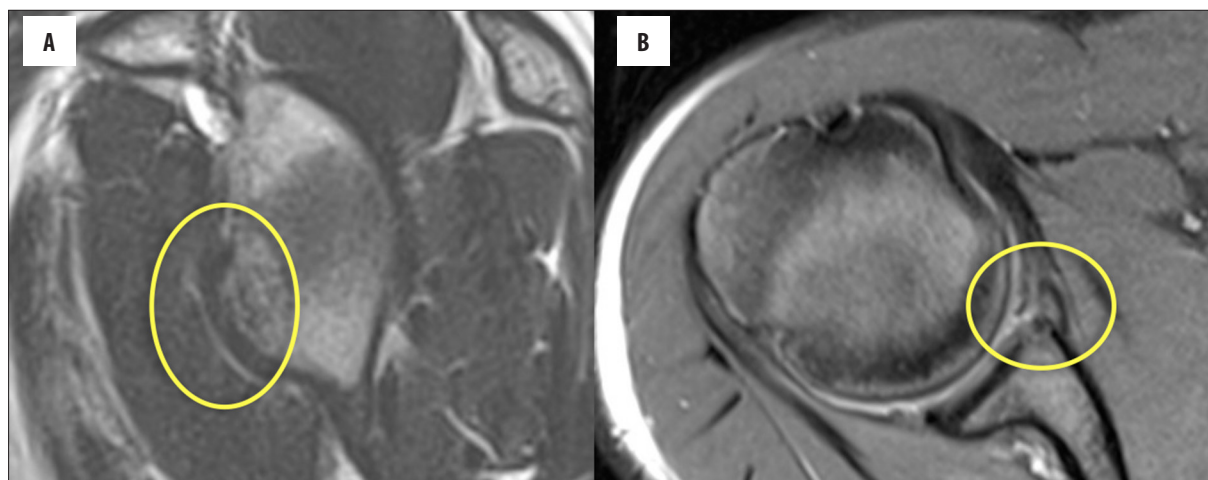
Figure 7. Sagittal and axial T2 images of the shoulder. The bony Bankart lesion is visible.

Recently, new studies have investigated the use of 3D MR reconstructions to evaluate glenoid bone loss. The possibility of using 3D MR reconstruction instead of 3D CT may benefit the patients with soft Bankart who are suspected for extra glenoid bone loss, by sparing them the cost, time and radiation dose of an extra CT examination. So far, MR has been the gold standard for imaging soft tissue lesions but in several clinical studies it has also appeared to be an accurate modality for measuring glenoid bone loss [17–19]. The best-fit circle method is exactly the same when using CT or MR reconstructions (Figure 7). Gyftopoulos et al.,
