# Clinical and radiological outcome for TruFit Plug in the treatment of chondral and osteochondral lesions at a minimum of 2 years

Amir Azam<sup>a,\*</sup>, Mark Forster<sup>b</sup>, Angus Robertson<sup>b</sup>

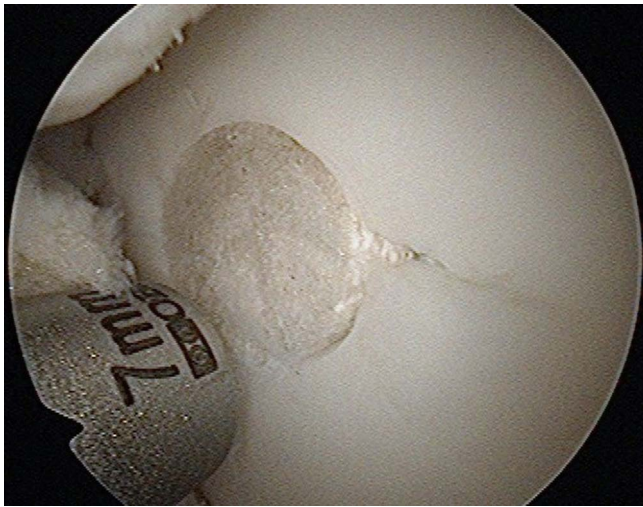
**Picture 1.** Arthroscopic view showing Trufit plug insertion into the femoral chondral defect.

The TruFit plug, a bi-layer scaffold implant, (Smith&Nephew) (Picture 1) has been developed to treat chondral and osteochondral defects. This synthetic plug is designed to be inserted into the articular surface providing a scaffold to encourage chondrocyte regeneration to

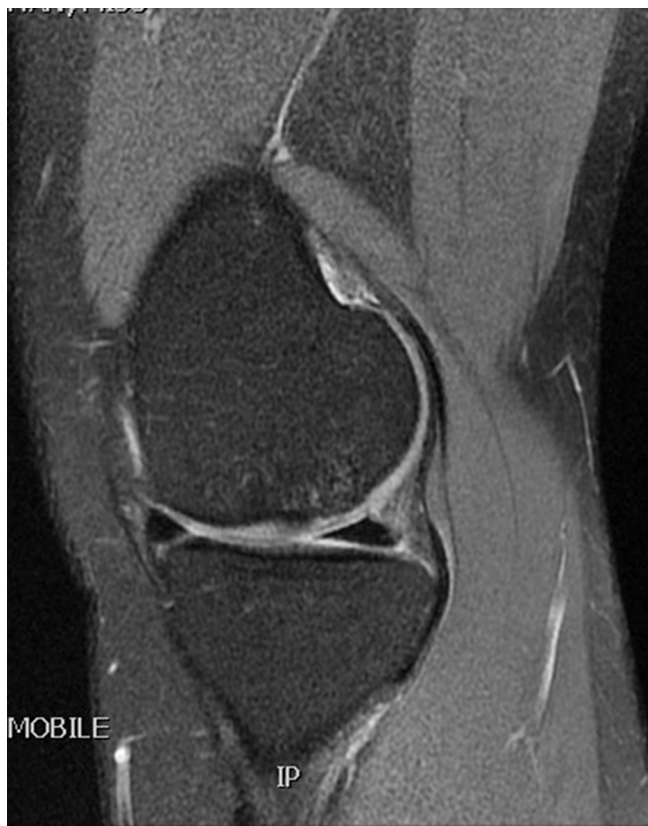
Picture 2. T2 weighted MRI scan sagittal section showing full incorporation of Trufit plug in femoral condyle defect.

**Table 1** summarizes the result of the MOCART scoring. 8 of 12 lesions showed congruent articular cartilage cover with a surface with a similar thickness and signal to the surrounding articular cartilage and reconstitution of the subchondral bone plate (**Pictures 2 and 3**). 2 lesions had a thicker congruent articular surface with a similar signal to the surrounding articular cartilage without restoration of the subchondral bone plate. 2 lesions showed no graft incorporation at all and were filled with granulation tissue (**Picture 6**). Full incorporation of the bony portion of the plug had occurred in only 3 lesions with partial incorporation in 7 lesions. The remaining portion of these 7 lesions looked cystic on MRI (**Pictures 4 and 5**).

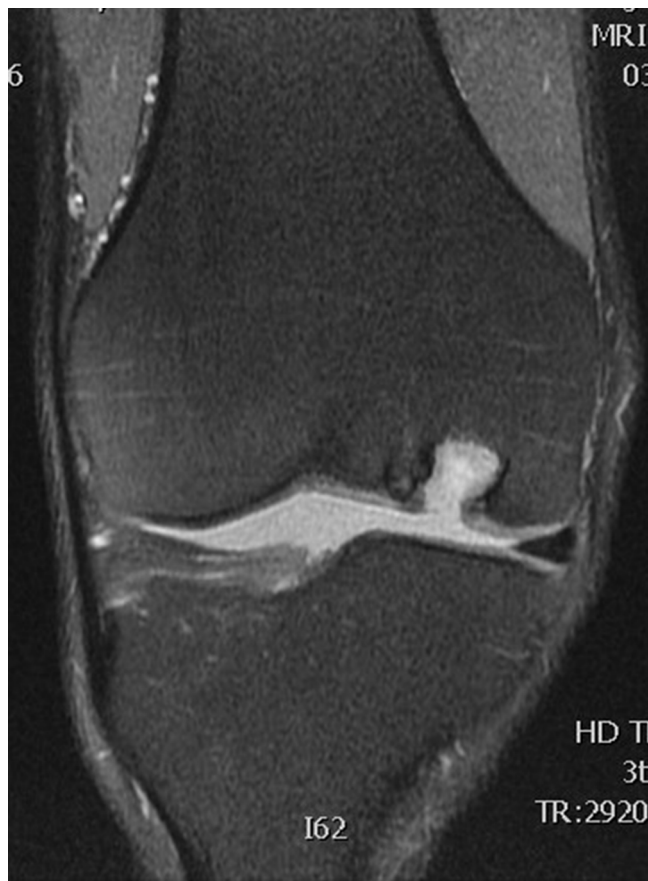
Picture 4. T2 weighted MRI scan coronal section showing no incorporation and the entire Trufit plug replaced by granulation tissue.

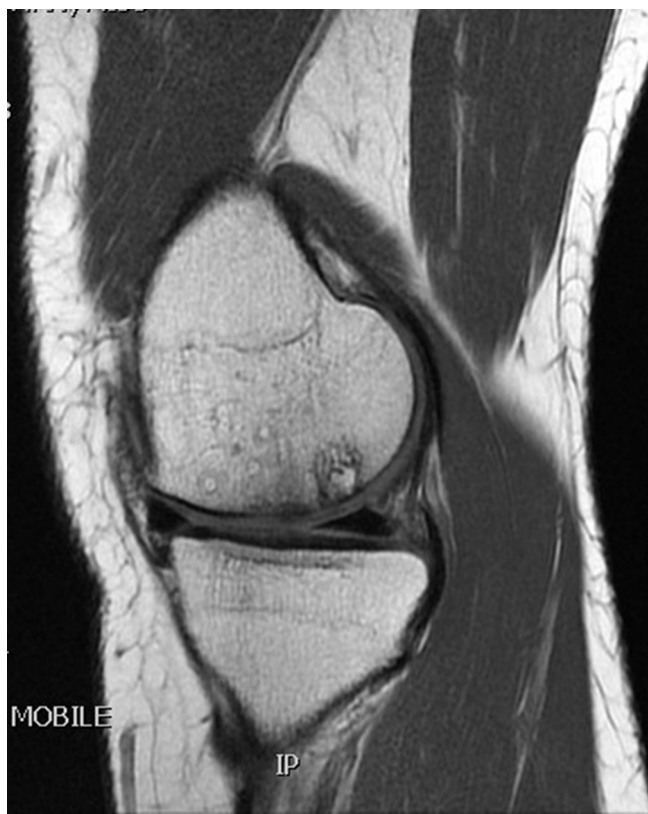
Picture 3. T1 weighted MRI scan sagittal section showing the full incorporation of Trufit plug.

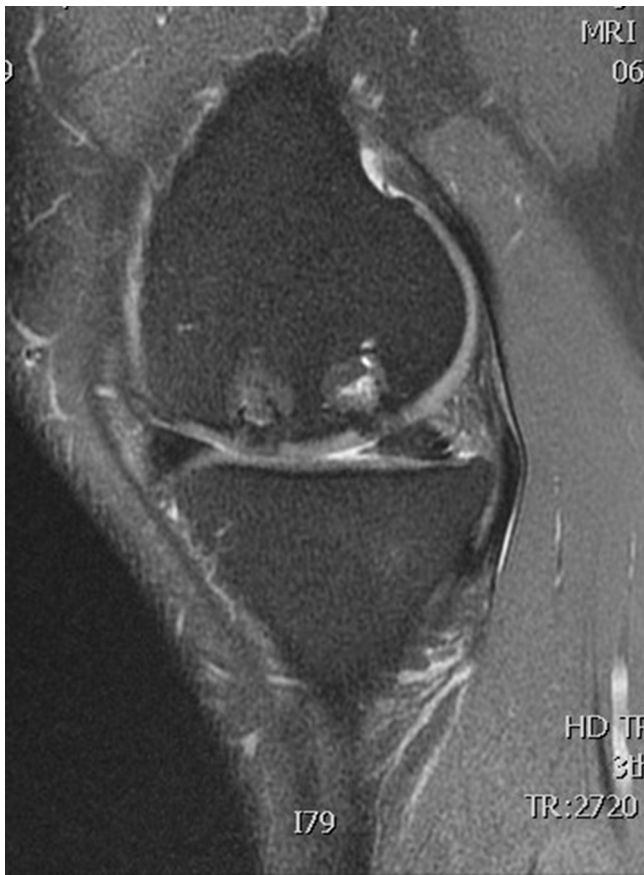
**Picture 5.** T2 weighted MRI scan sagittal section showing partial incorporation of TruFit plugs in femoral condyle.

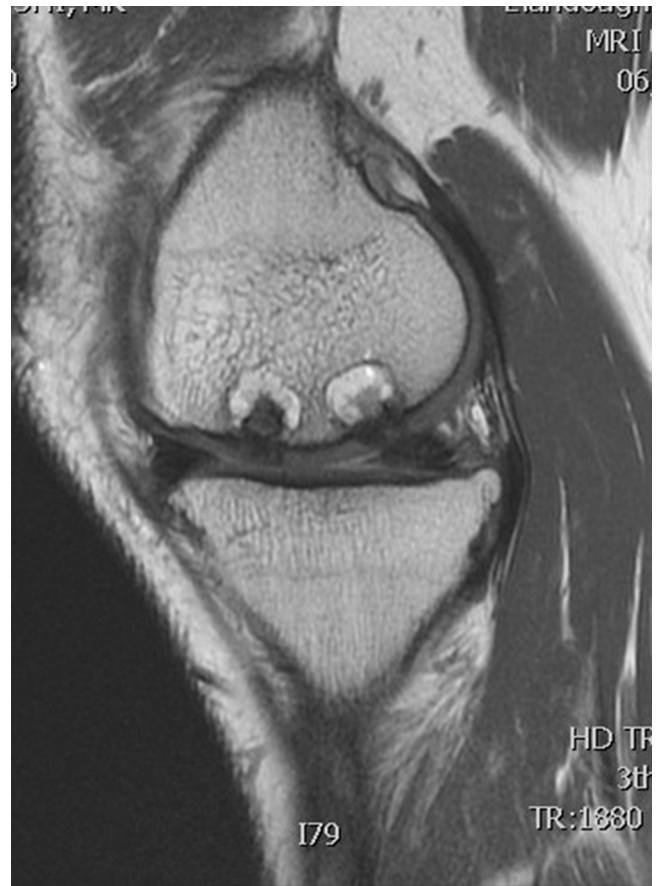
**Picture 6.** T1 wted MRI scan sagittal section showing partial incorporation of TruFit plugs.
