Article

Environmental Sustainability and Mold Hygiene in Buildings

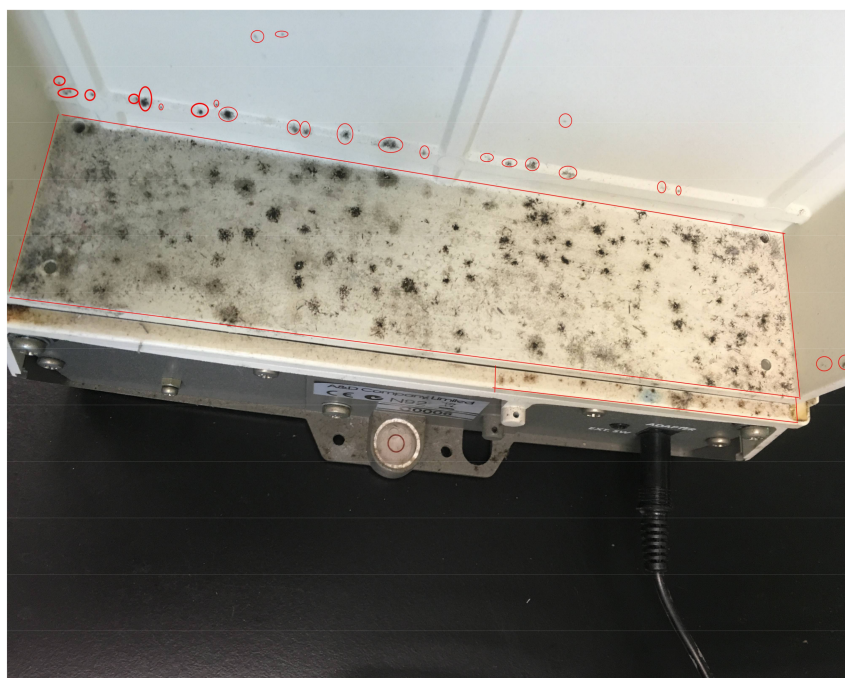
Figure 1. Mold patches behind an analytical balance (M008). The red circles indicate individual mold colonies. The red rectangular area represents one mold patch area because individual colonies are numerous and cannot be separated.

Finally, molds contaminated the back of an analytical balance (M008). The balance was the only mold-contaminated item on the right side of the laboratory (Figure 2). It had the lowest a_w (0.65 a_w), and received little light exposure (Table 2). The mold density was approximately 86 CFU/cm² covering 70 cm², around 3% of the total surface. *Tritirachium* sp. was the most dominant species, which accounted for more than 50% of the total mold count (43 CFU/cm²), and followed by *C. halotolerans* (26%) and *C. cladosporioides* (23%) (Figure 3). On the right side of the laboratory, there is an office for 10 people and the air conditioning was operated in the same pattern as the laboratory (18 h operation and turned off throughout the weekend).

Tritirachium sp. is not a common indoor mold and its presence on the balance (M008) relates to the unique organic dust, e.g., powder of various culture media deposited on the back of the balance. This powder is usually hygroscopic and nutritious to support mold growth.

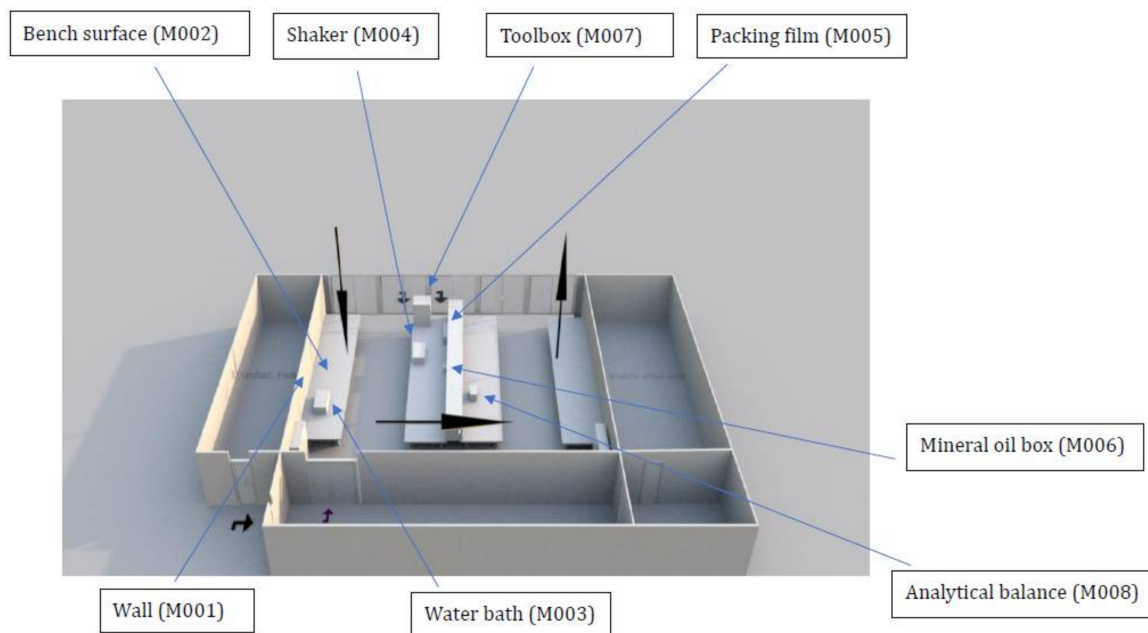
Figure 2. Laboratory layout and sample sites. The arrows in the laboratory indicate the air flow direction. The downward arrow on the left indicates the supply air coming out from the air diffusers and the upward arrow on the right points to the direction of the return air into the air-cooling units. The arrows shown outside the laboratory indicate the movement of the air into the laboratory. The room on the left of the laboratory is for the lab attendant and on right for the scientific officers. There are windows at the back of the laboratory. The windows are always kept closed.

Information about the contaminated areas and their environmental conditions are presented in Figure 2 and Table 2. In total, eight contaminated areas were identified, and all the contaminated surfaces had a higher a_w than the room RH (60.5%) in the laboratory. The contaminated areas were mainly located on the left side of the laboratory where the cooled supply air (according to the facilities management data, temperature and RH of the supply air were generally around 16 °C and 60%, respectively under similar environmental conditions) circulated before returning to the air-conditioner on the right side of the laboratory (Figure 2). The culturable mold abundance (in terms of mold density, colony-forming unit (CFU)/cm²) and diversity in each contaminated area is shown in Figure 3. In aggregate, seven species were isolated—two *Cladosporium* spp. (*Cladosporium cladosporioides* and *Cladosporium halotolerans*), two *Aspergillus* spp. (*Aspergillus penicillioides* and *Aspergillus sydowii*), *Rhizopus azygosporus/microsporus*, *Tritirachium* sp., and *Trichoderma harzianum*. Except for *C. halotolerans* and *Tritirachium*, all other molds were matched with their corresponding species-specific primers (Table 1).

A plastic toolbox (M007) located the back of a bench and next to a window was also contaminated by molds on the top surface (Figure 2). Due to its placement, the toolbox received room light and sunlight. The box was covered by dust since it was rarely used. Its a_w was 0.73 and the temperature was 21.1 °C (Table 2). The mold density was about 6 CFU/cm² in the 270 cm² sampled area. The highest number of molds (5 species) was isolated including *C. halotolerans* (46%), *C. cladosporioides* (14%), *A. sydowii* (28.5%), *Tritirachium* sp. (8.5%) and *R. azygosporus/microsporus* (3%) (Figure 3).

Most of the mold contamination sites were found near the laboratory door, bench surface (M002), water bath (M003), shaker (M004) and toolbox (M007), where the warm and humid air enters the laboratory. Even if the door is closed, air can still infiltrate the laboratory through the door gap. This study clearly showed that this warm and humid air could easily condense on various surfaces. To reduce infiltration, one cost effective solution could be to seal the gaps in windows and doors. In addition, when designing the ventilation system, the airflow of the laboratory in relation to the outside air should also be considered. Items in hidden locations, packing film (M005), the mineral oil box (M006) and toolbox (M007), were also prone to condensation after the air-conditioning system was

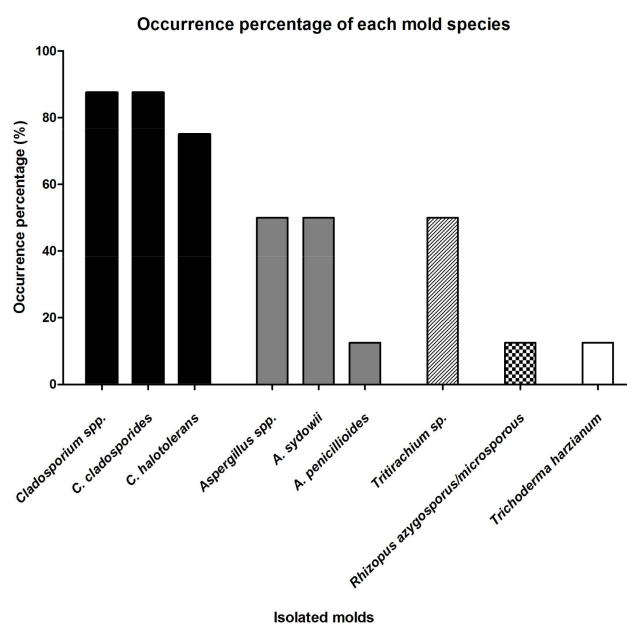
Figure 4. Occurrence percentage of each mold species.

Figure 4 summarizes the occurrence percentage of the isolated molds in the laboratory. Both *Cladosporium* spp. had higher occurrence percentage than other species in the laboratory, where *C. cladosporioides* was 88% (seven out of eight areas) and *C. halotolerans* was 75% (six out of eight areas).

A. sydowii was present in four areas but its population on the packing film (M004) was very low, while *A. penicillioides* was found in the shaker (M004) only and contributed half of the population on this contaminated area with *A. sydowii*. *Tritirachium* sp. appeared on four areas, and its occurrence always coincided with *C. cladosporioides* and *C. halotolerans*. Its population level was the highest on the balance (M008) compared to other areas (50%). Together with *A. penicillioides*, *R. azygosporus/microsporus* and *T. harzianum* were present in only one contaminated area and their population levels were low.
